Washington Irving Campus Building Rehabilitation

Informational Meeting with NYC Council Member Rosie Mendez and the NYC SCA.

April 24, 2017

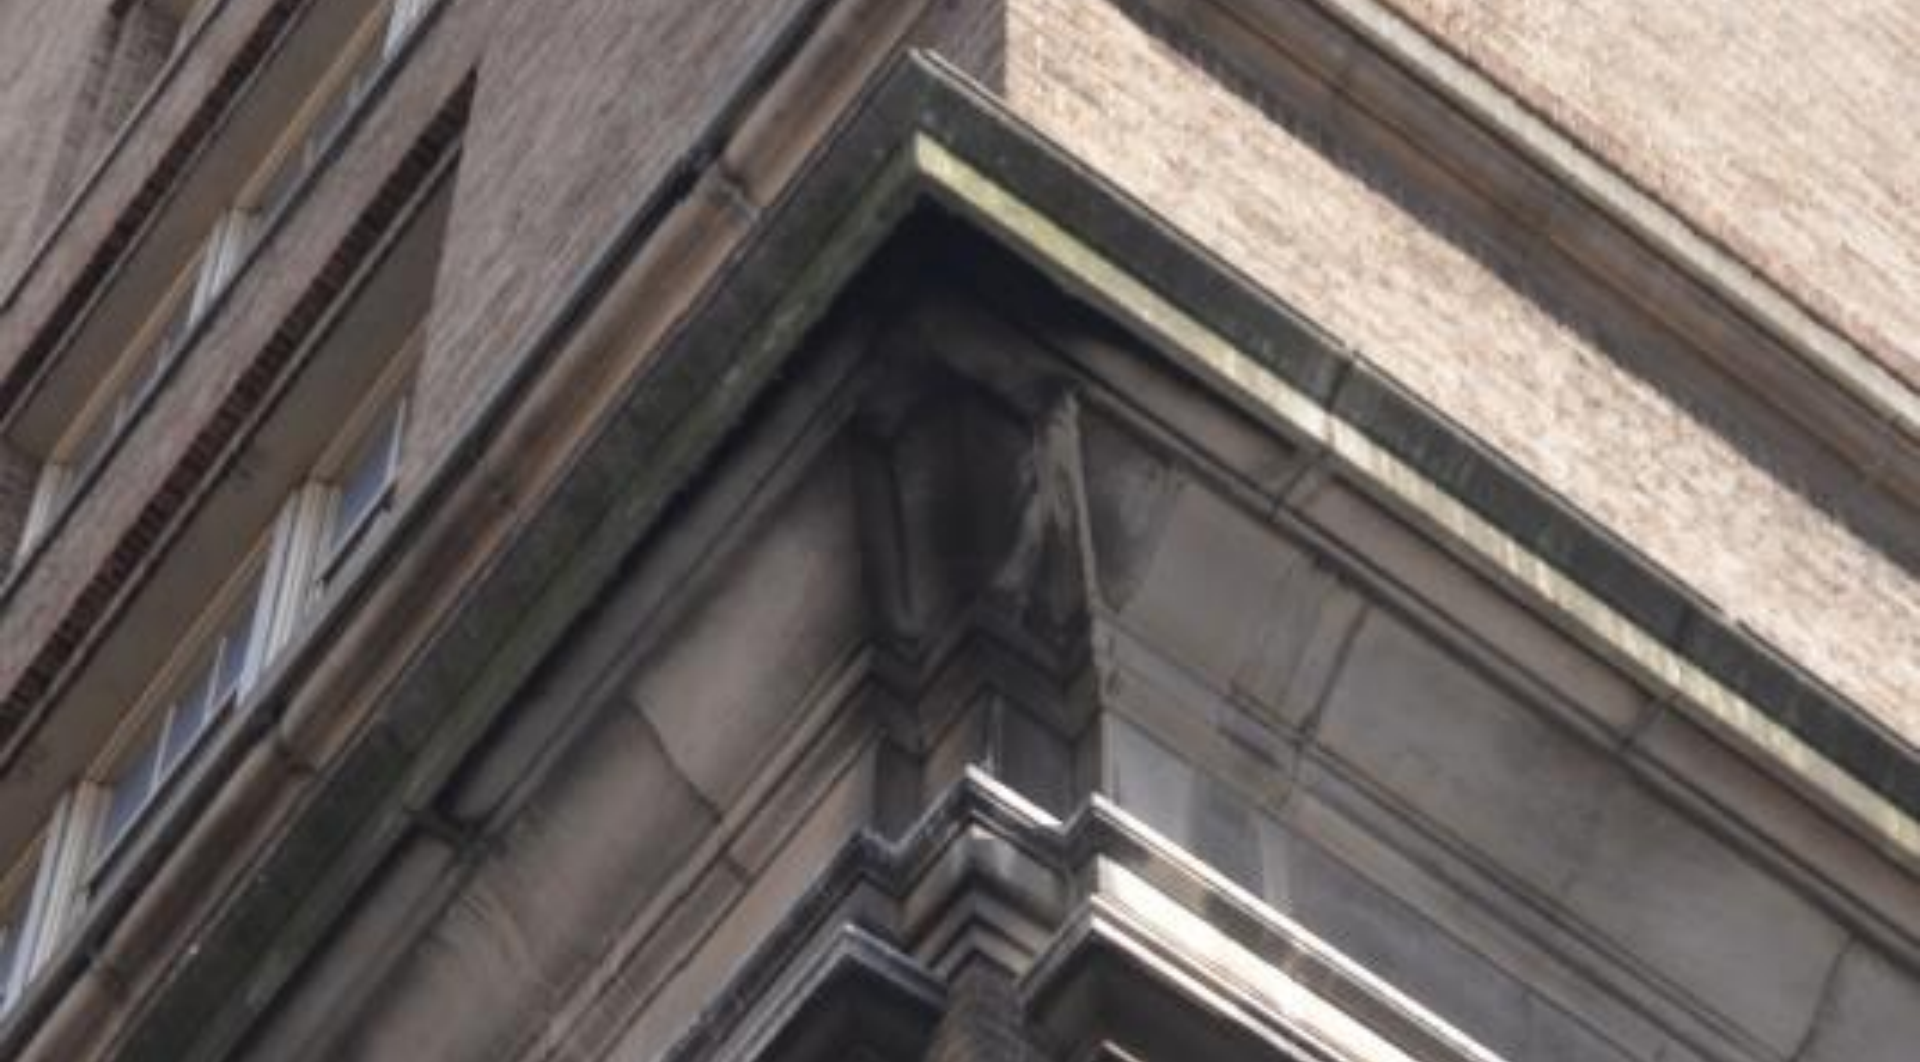
Photo 385: Cornice above the 2nd floor at the Northwest corner of Original Building

CRACK IN LIMESTONE

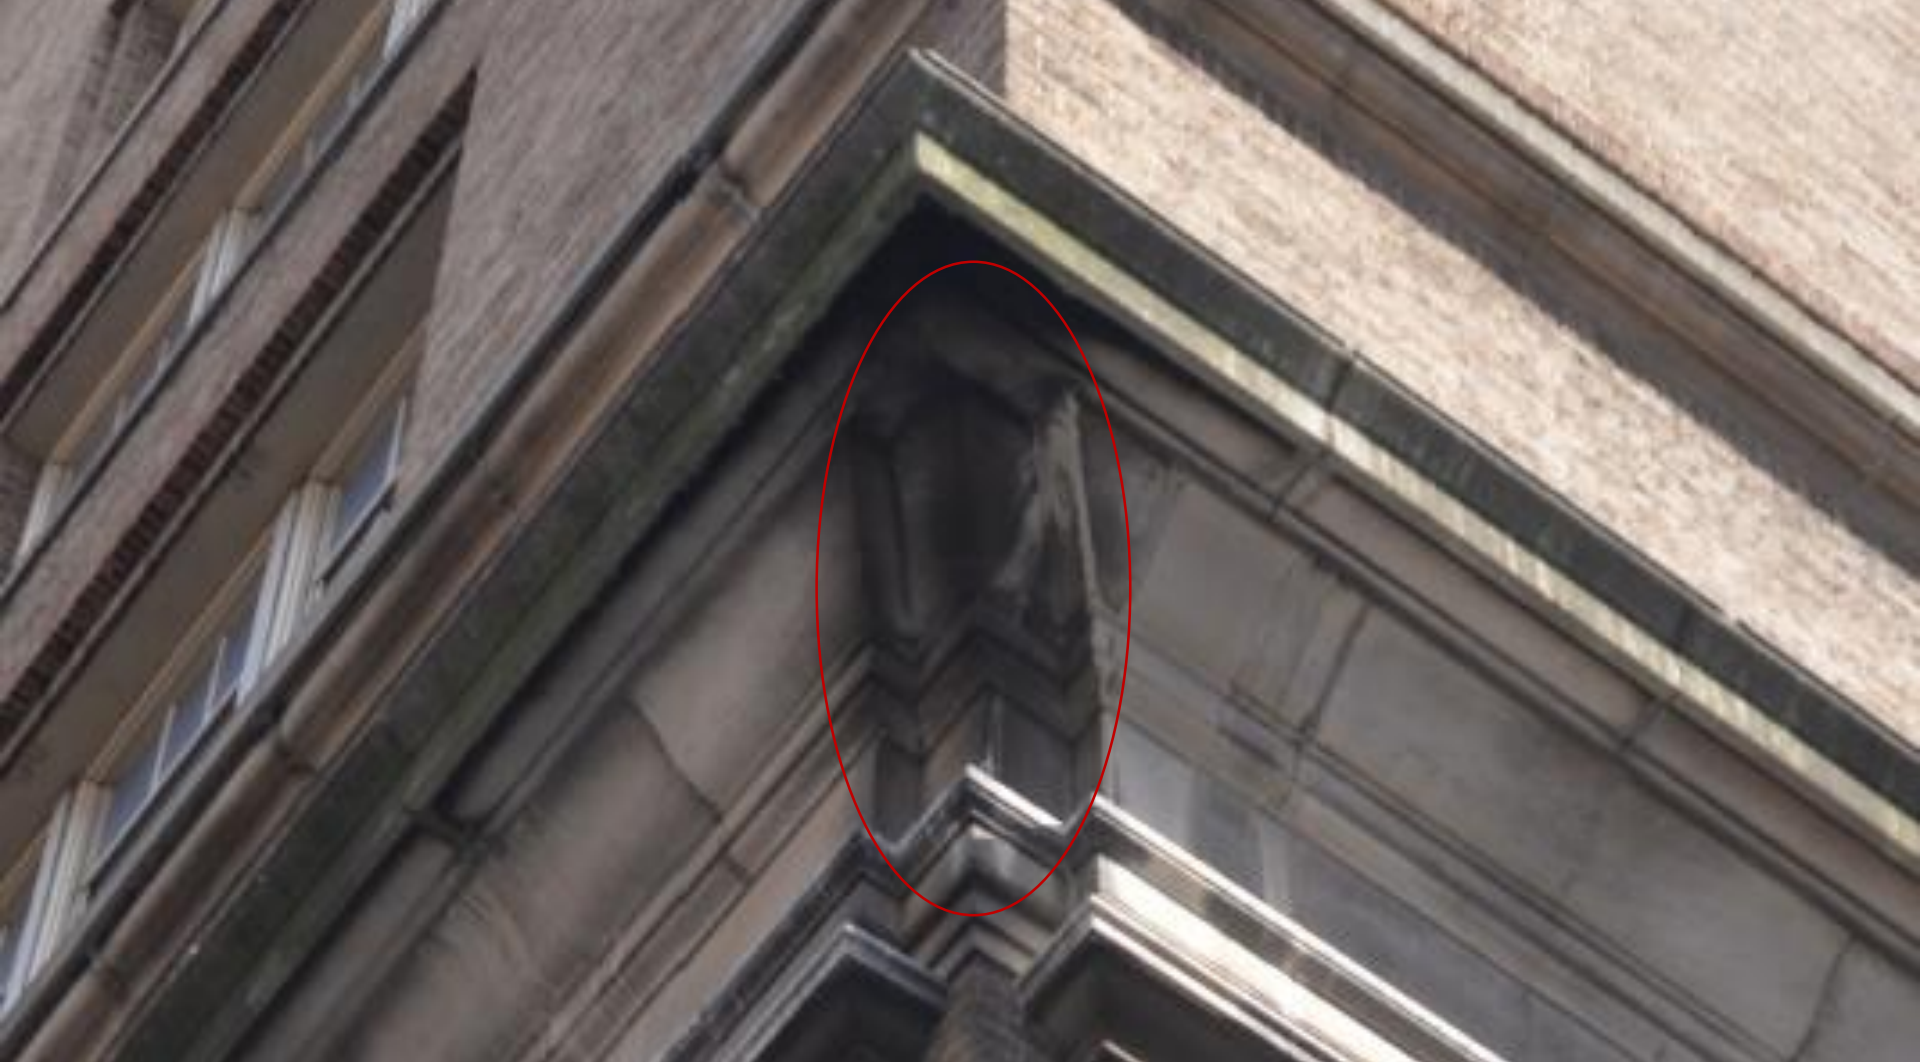
Photo 385: Cornice above the 2nd floor at the Northwest corner of Original Building

CRACK IN LIMESTONE

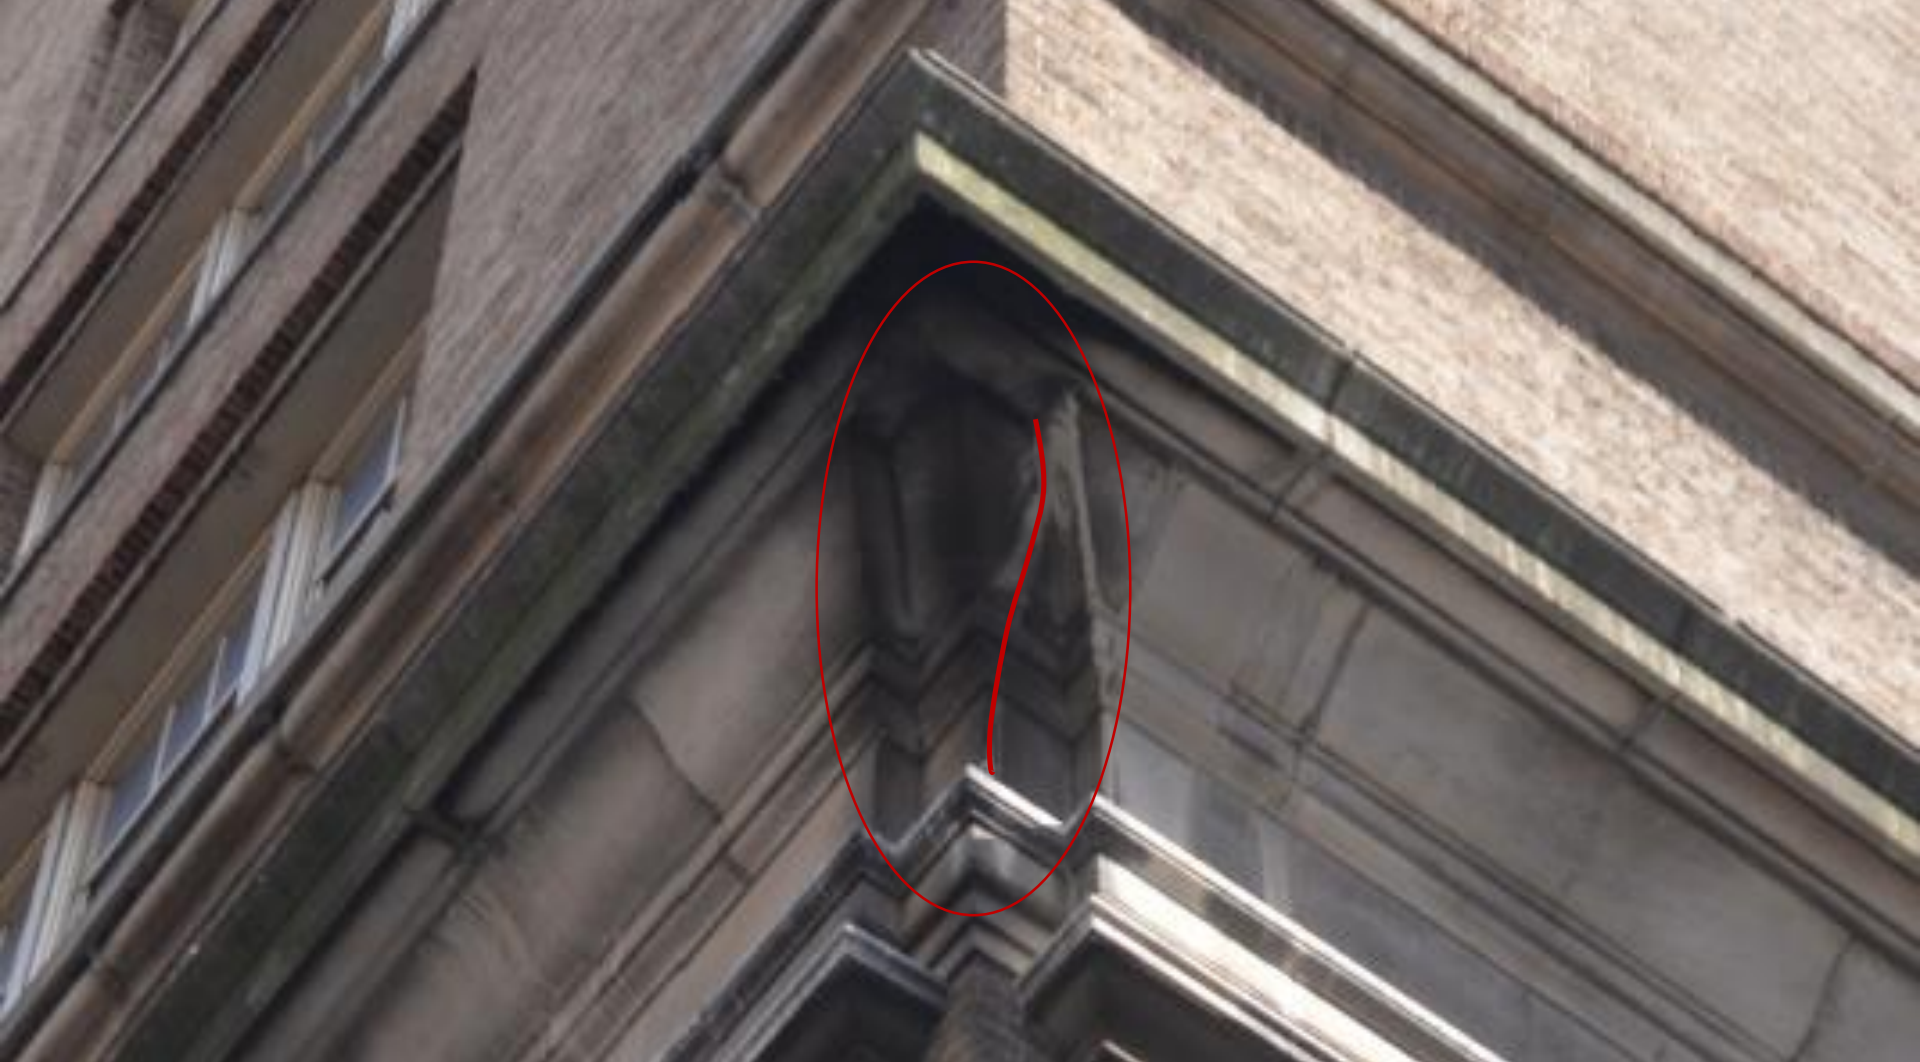
Photo 385: Cornice above the 2nd floor at the Northwest corner of Original Building

CRACK IN LIMESTONE

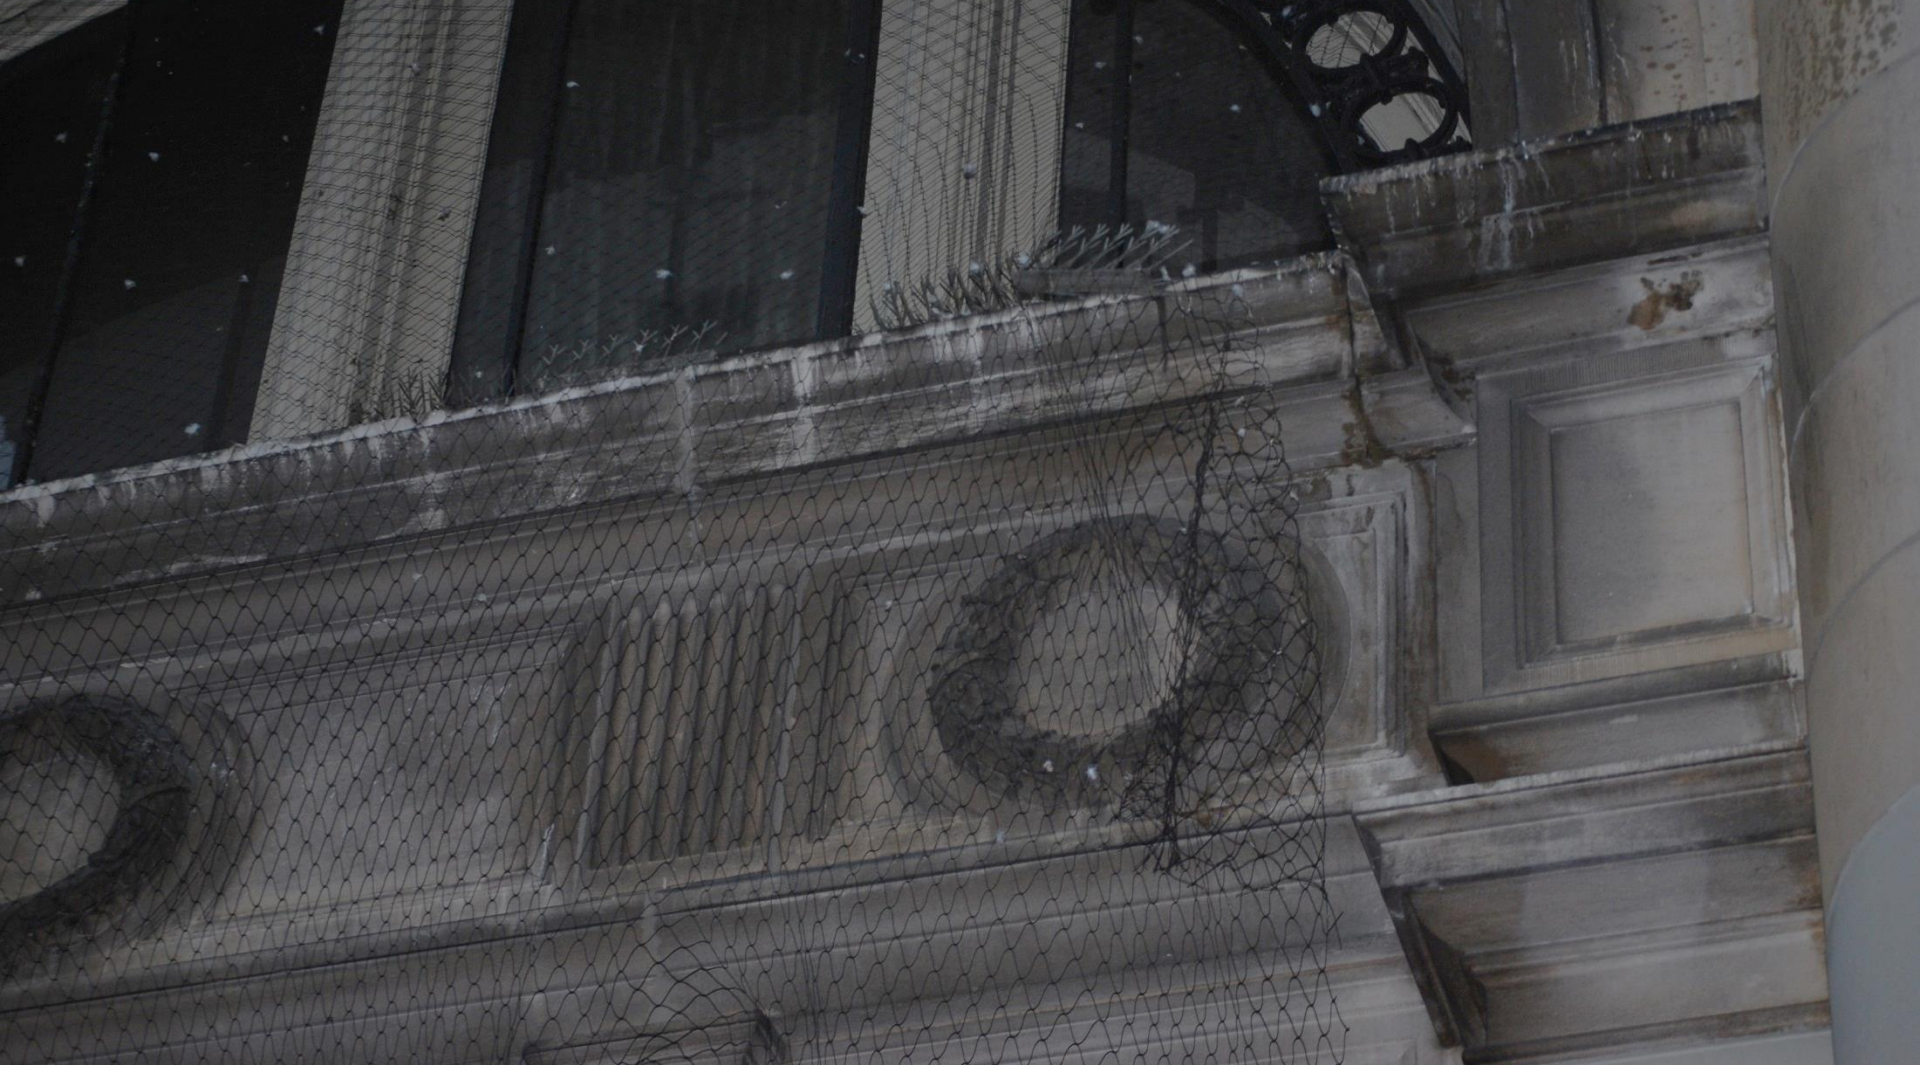
Irving Place entry

LOOSE METAL BIRD CONTROL SPIKES AND CRACK IN LIMESTONE

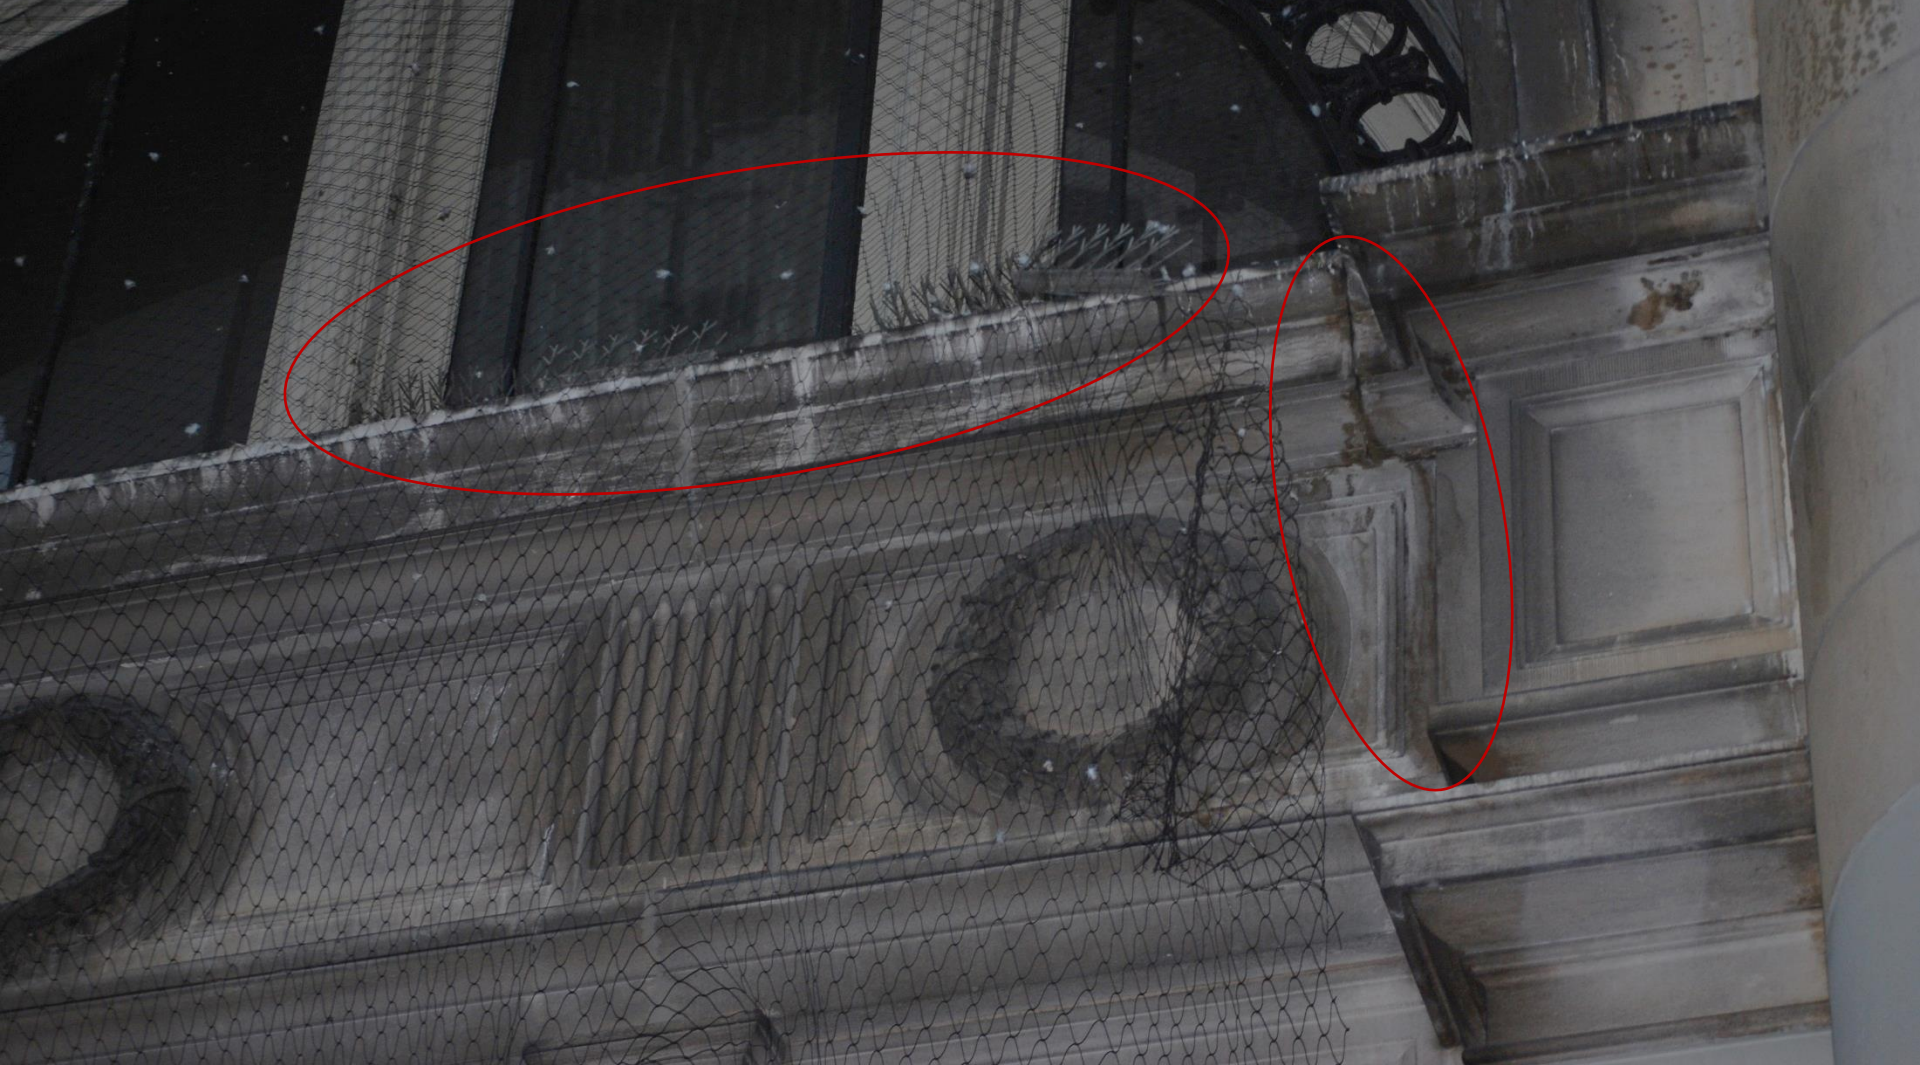
Irving Place entry

LOOSE METAL BIRD CONTROL SPIKES AND CRACK IN LIMESTONE

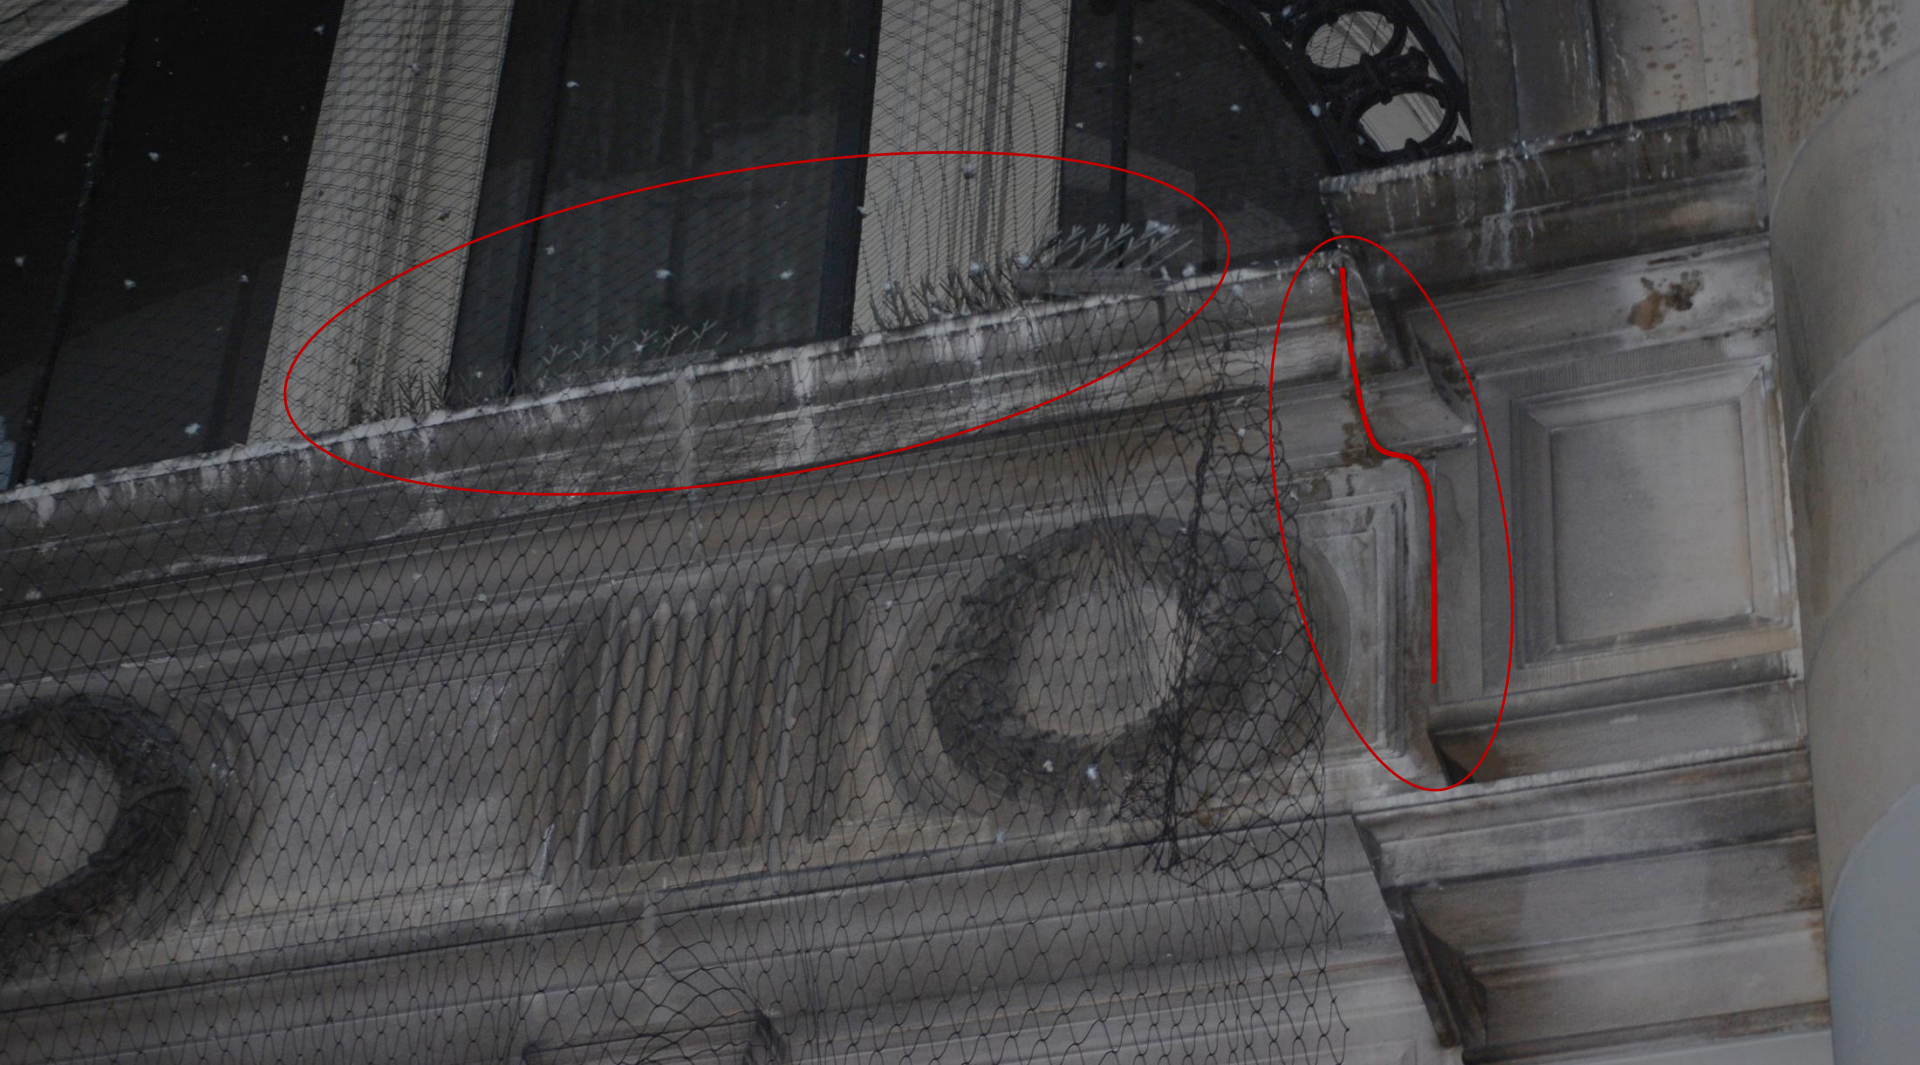
Irving Place entry

LOOSE METAL BIRD CONTROL SPIKES AND CRACK IN LIMESTONE

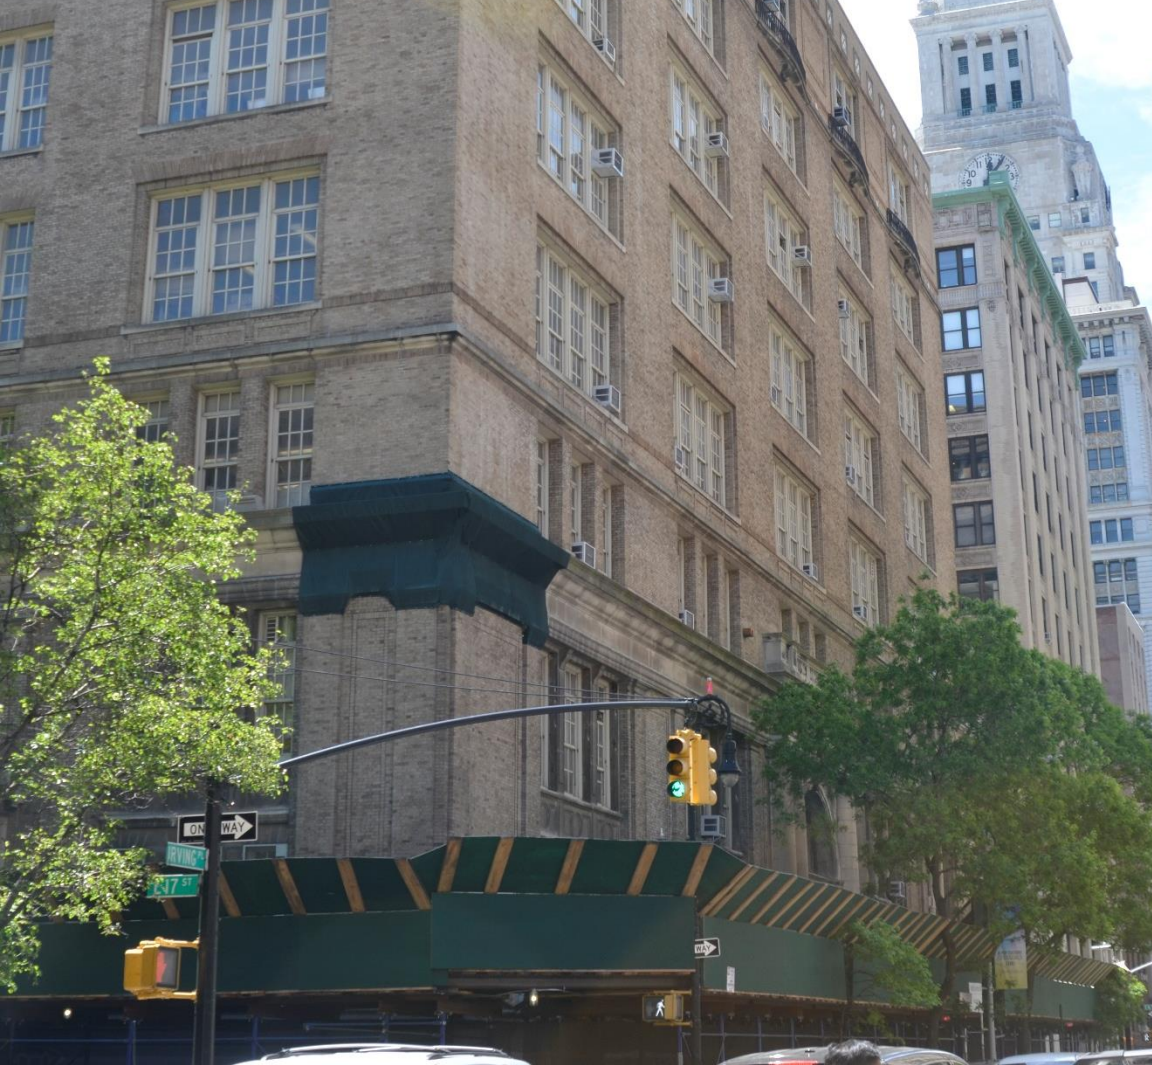
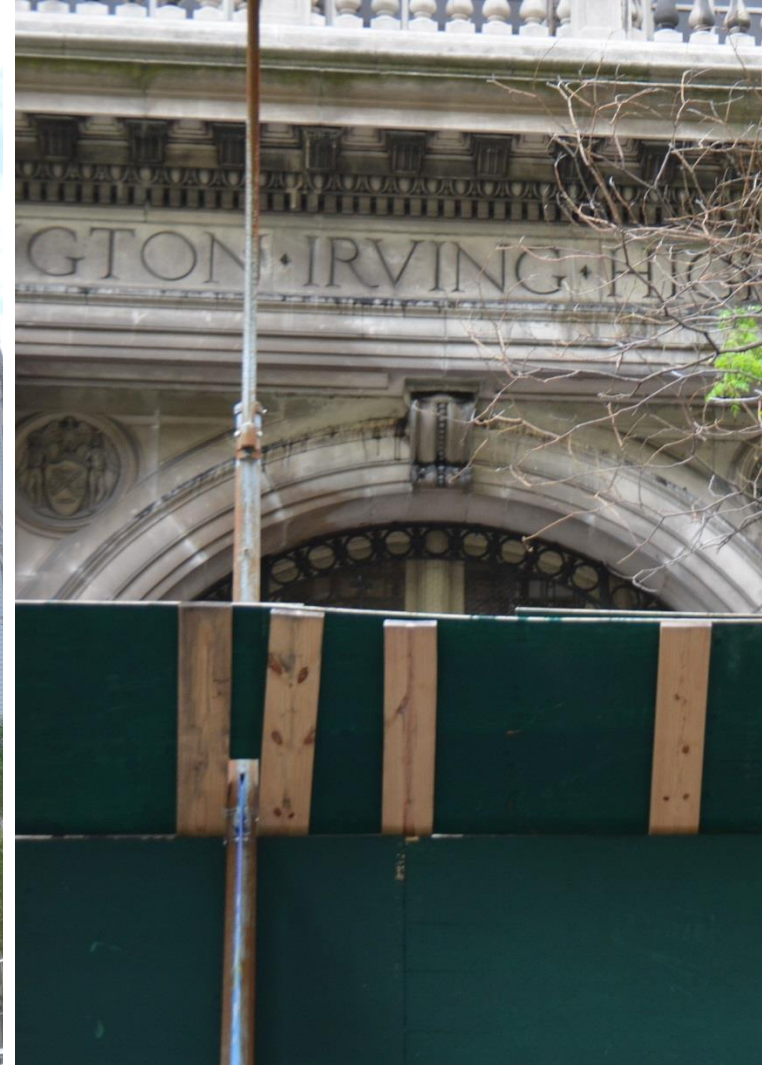
Netting at the northwest corner of the cornice and Sidewalk Sheds surrounding the facades

ADOPTED MEASURES IN RESPONSE TO THE UNSAFE CONDITION REPORTED

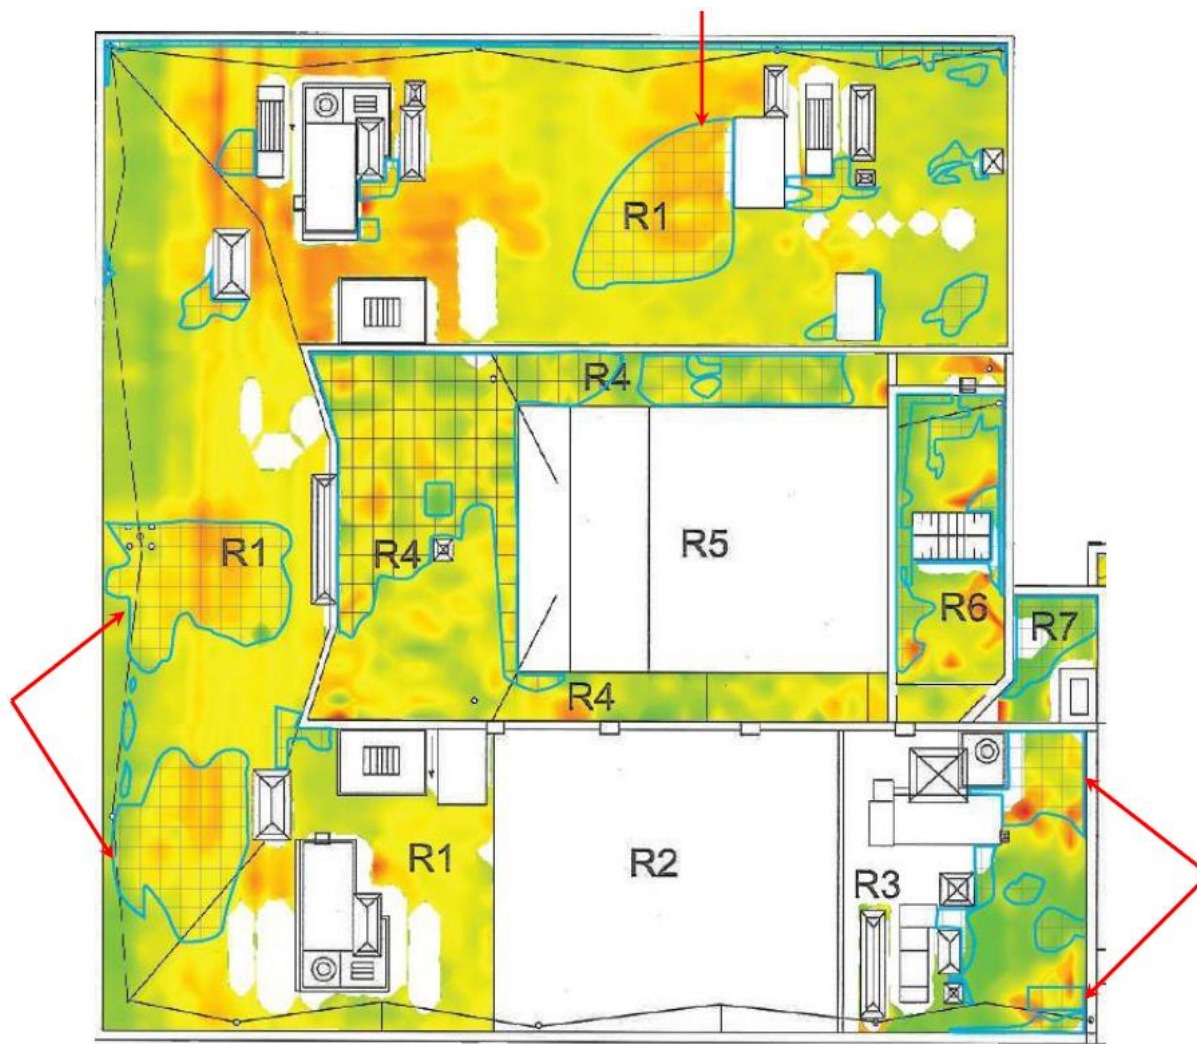
1910 Building Roof Plan, indicating areas of thermal anomalies

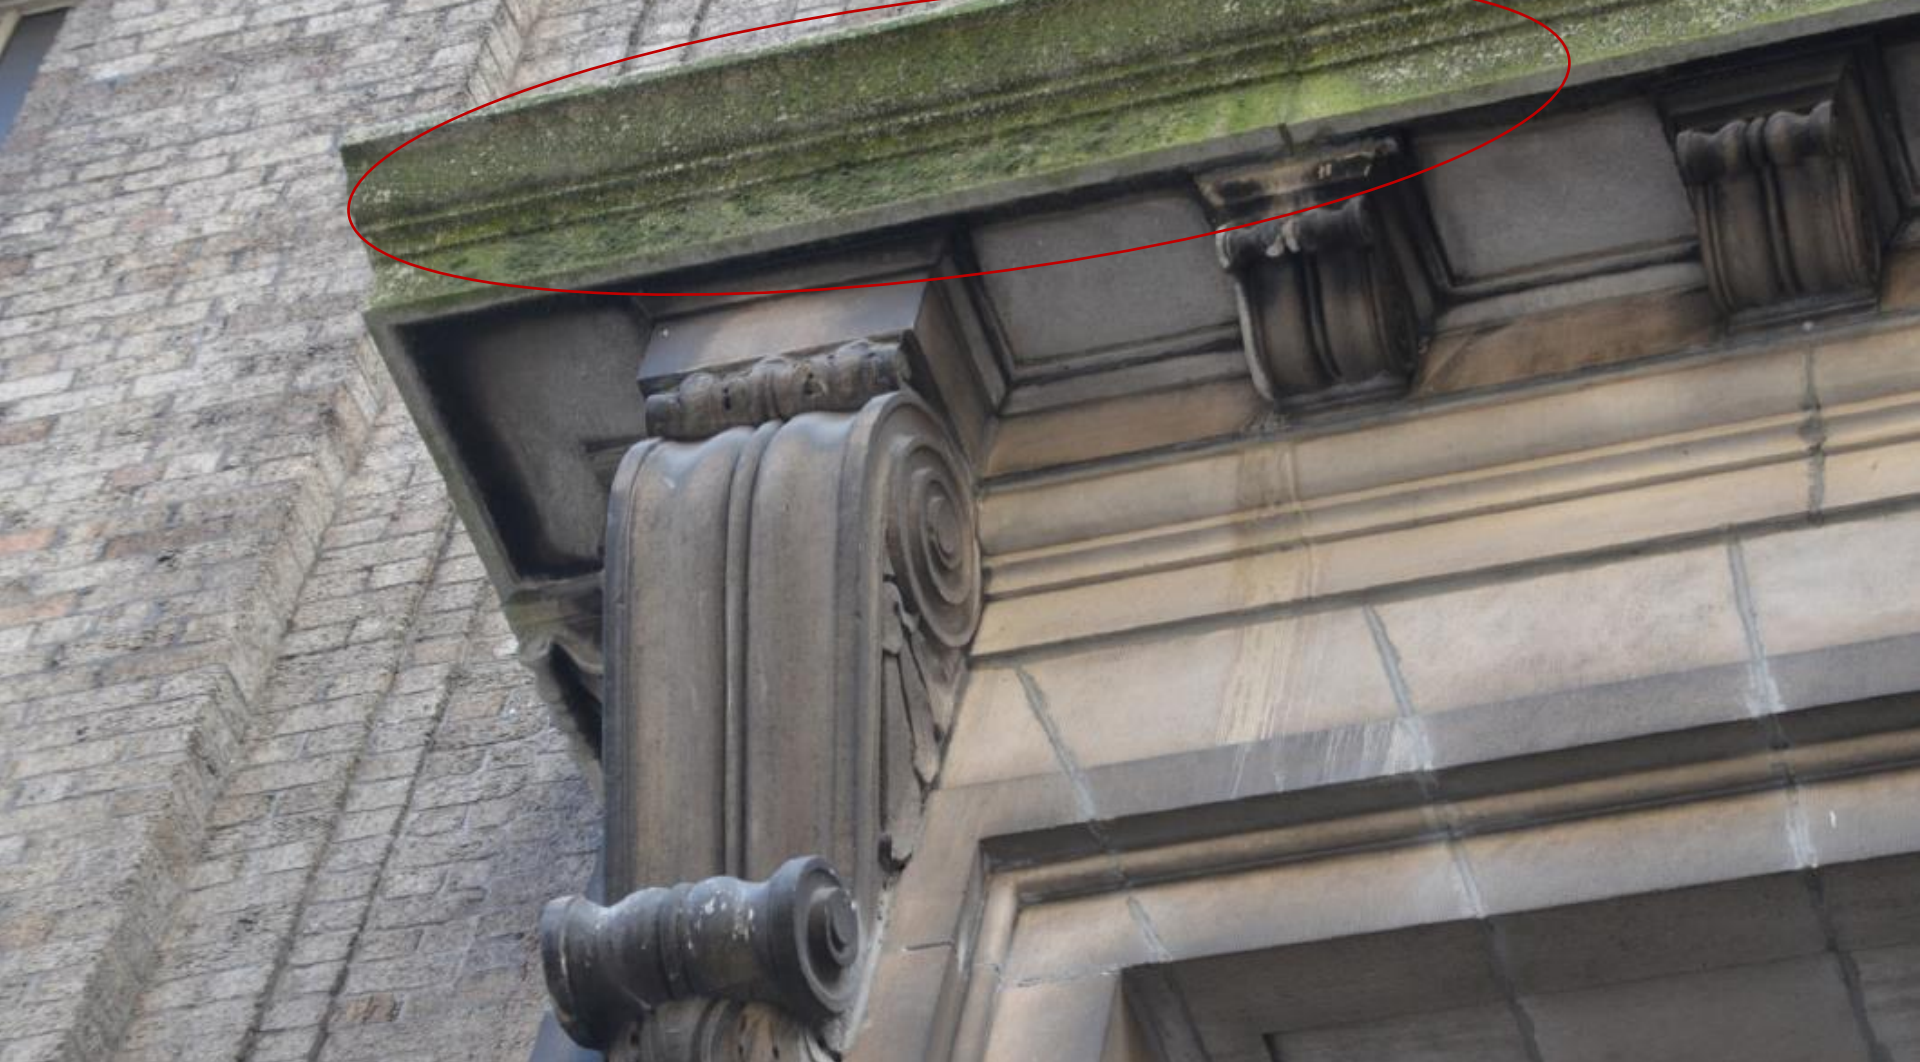
Photo 365: Original Building, North facade

WORN, STAINED LIMESTONE – ORGANIC MATERIAL GROWTH

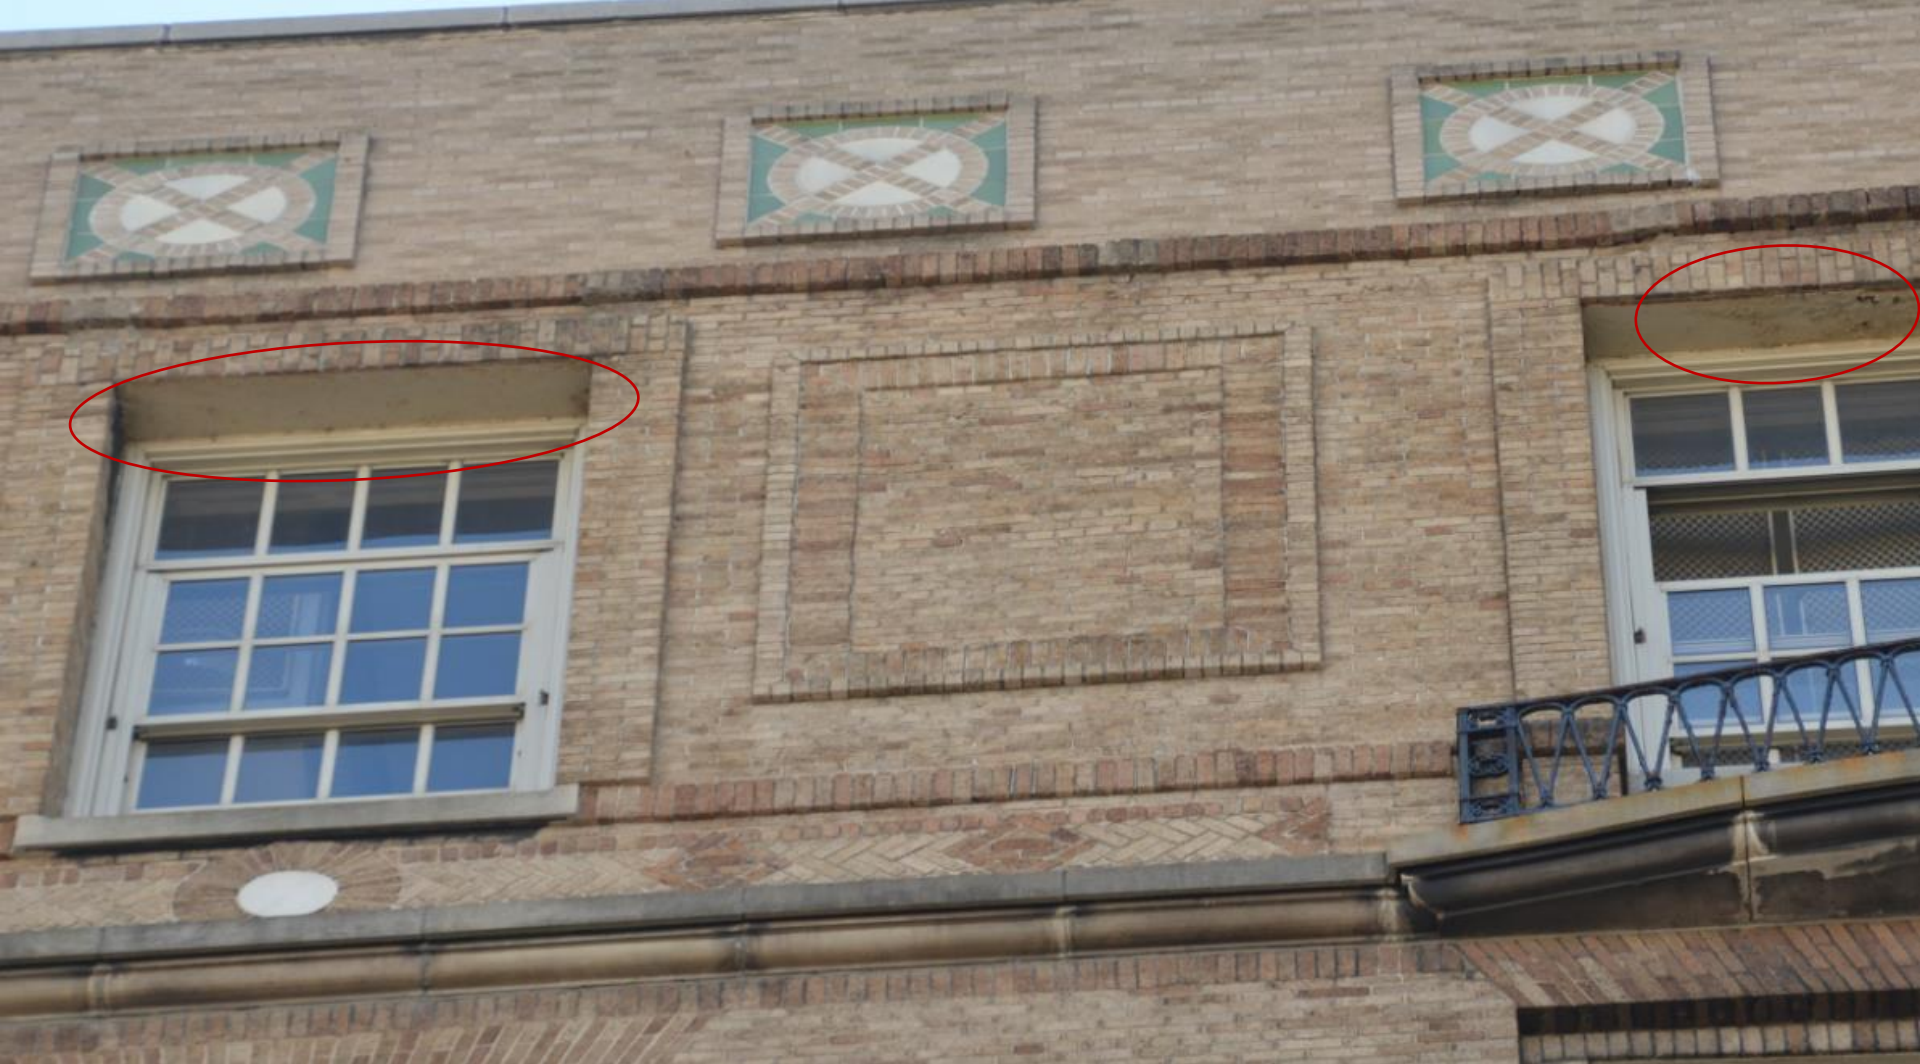
Original Building North facade

CORRODING WINDOW LINTELS

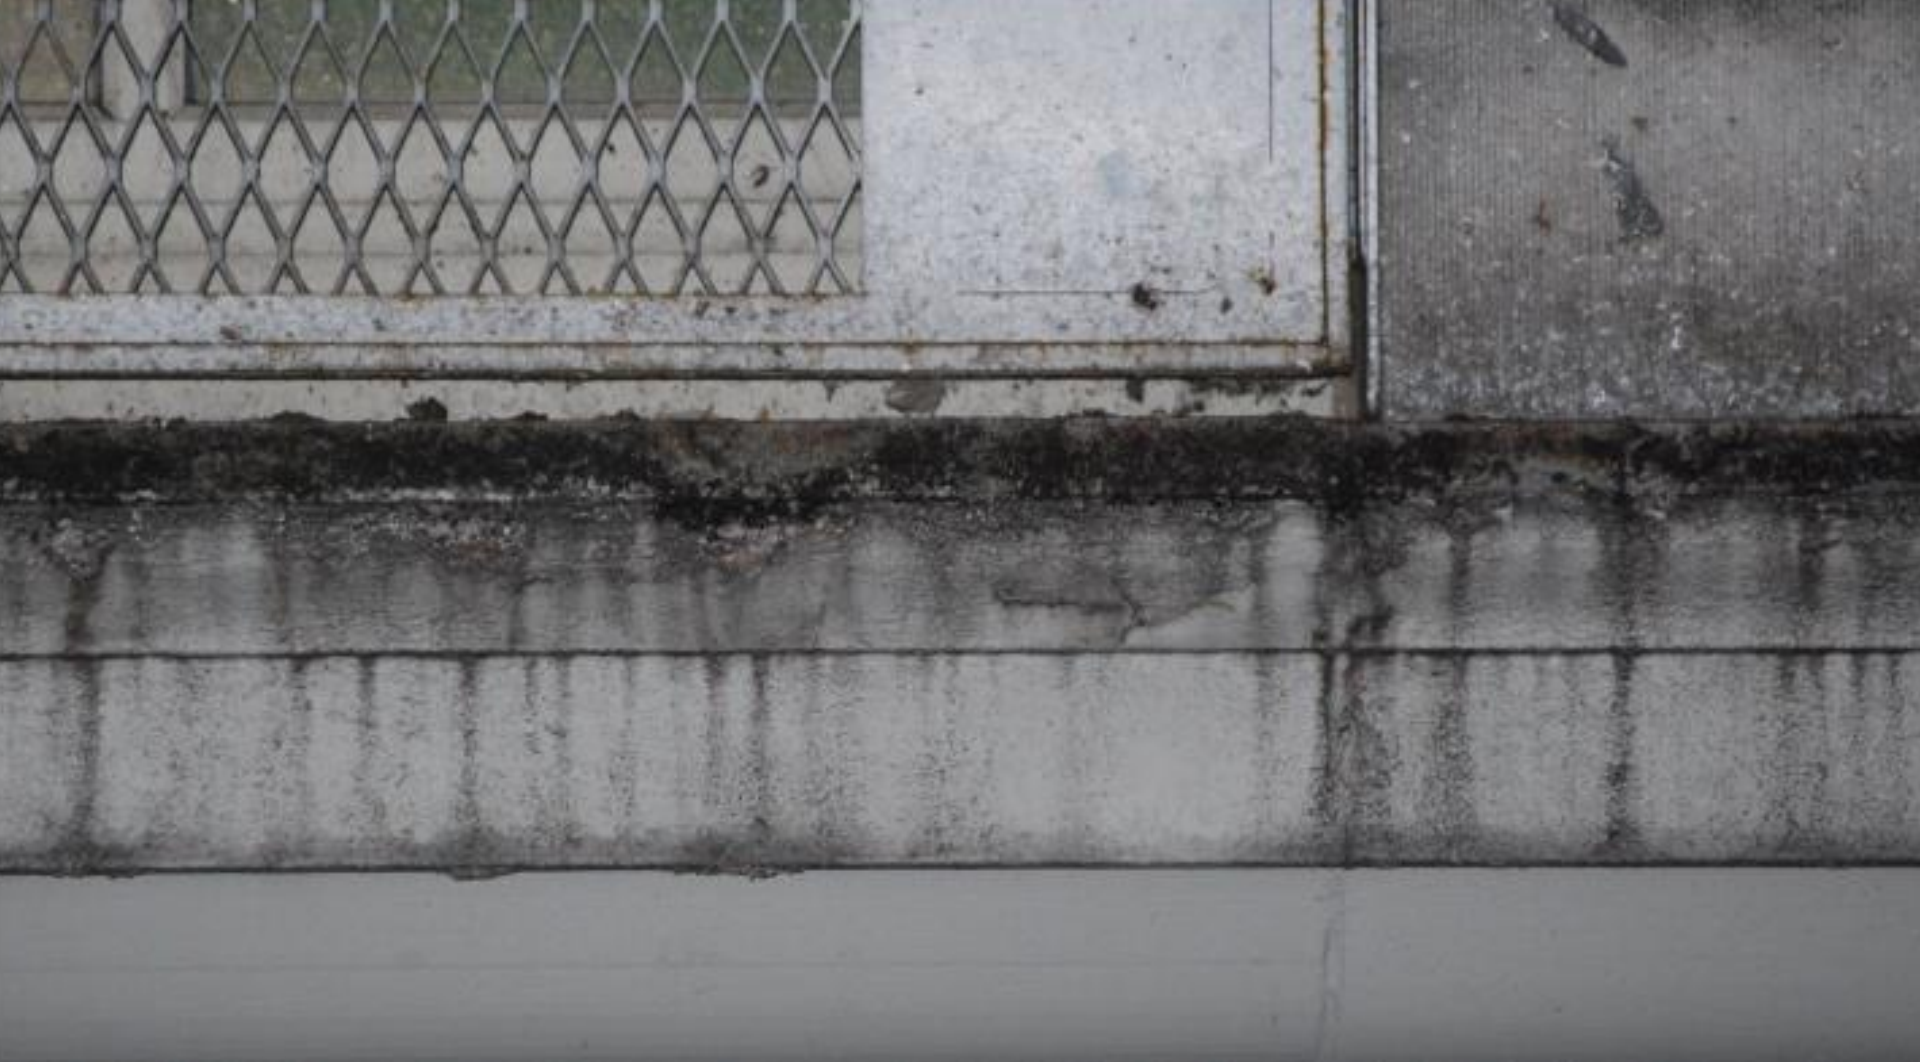
Photo 355: Original Building West façade, 1st floor

EXTENSIVE STAINING AT LIMESTONE BASE
