Washington Irving Campus Building Rehabilitation

Informational Meeting with NYC Council Member Rosie Mendez and the NYC SCA.

April 24, 2017

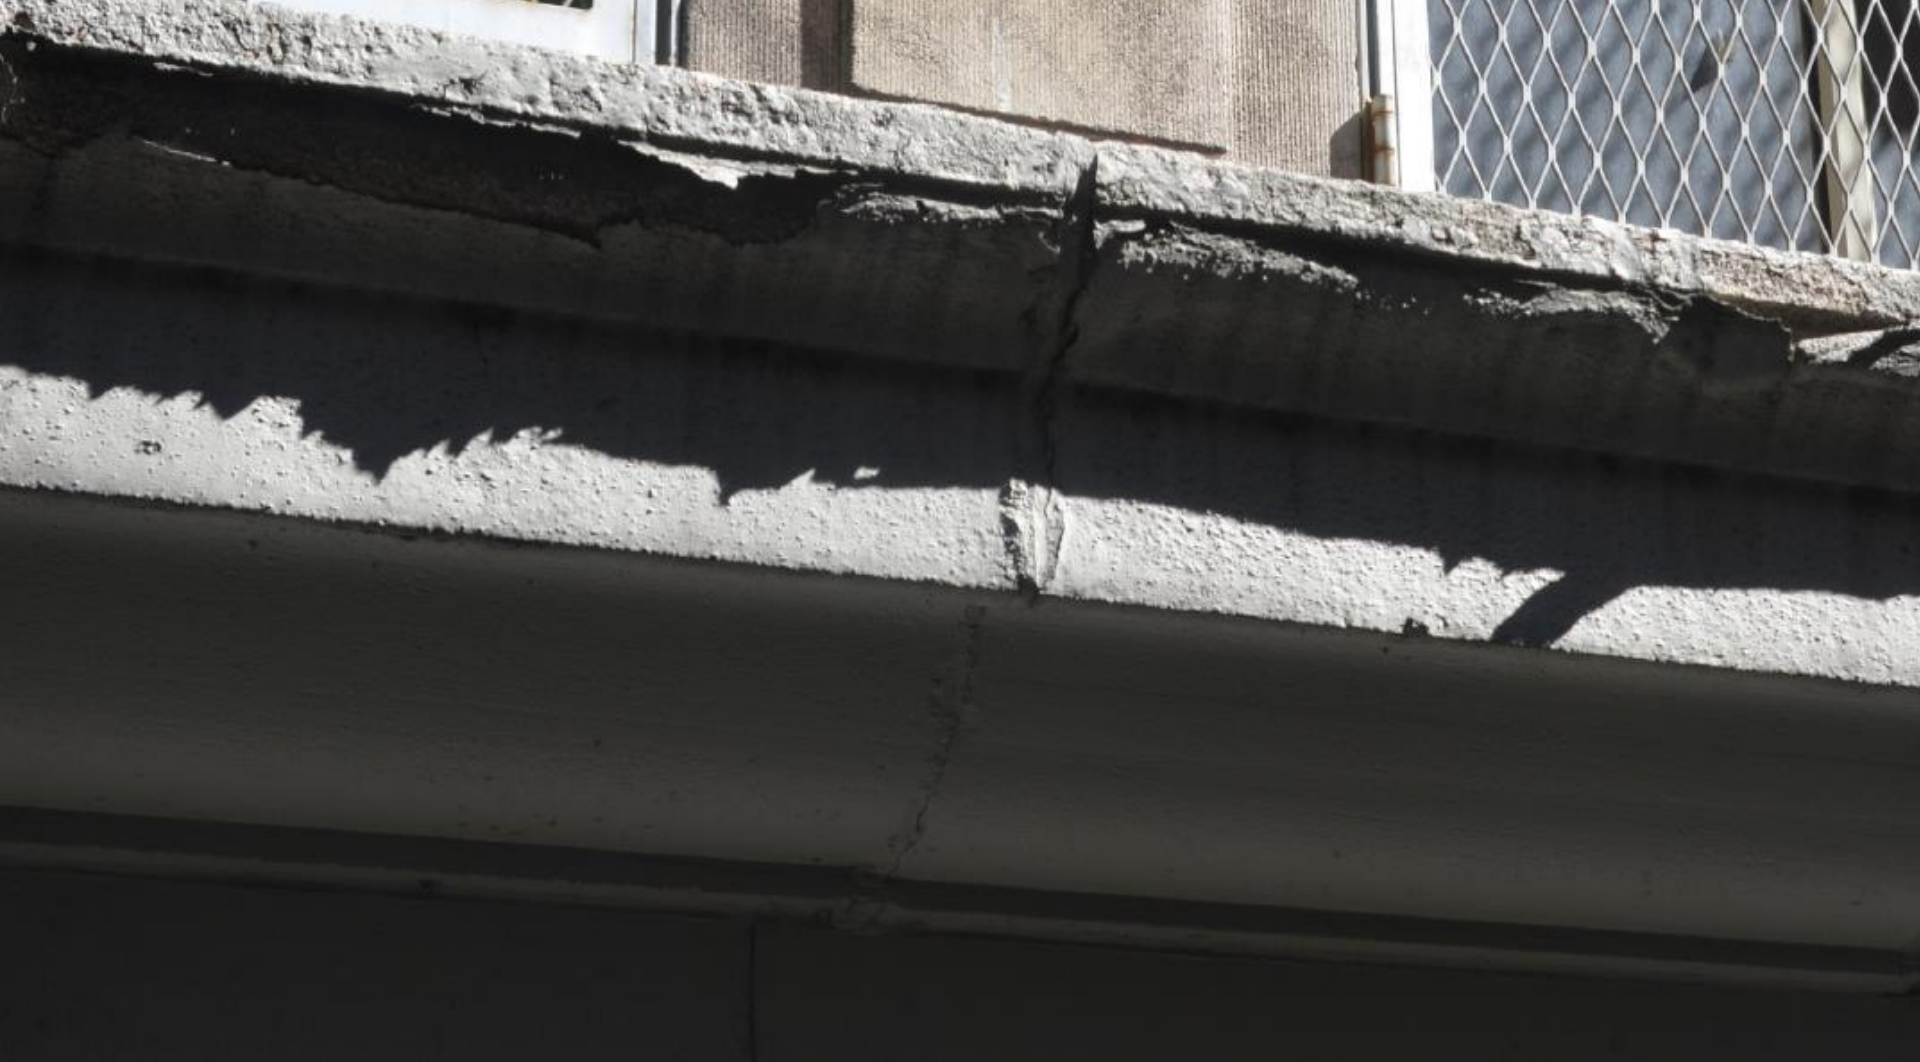
Photo 343: Original Building West façade

CHIPPED, CRACKED LIMESTONE

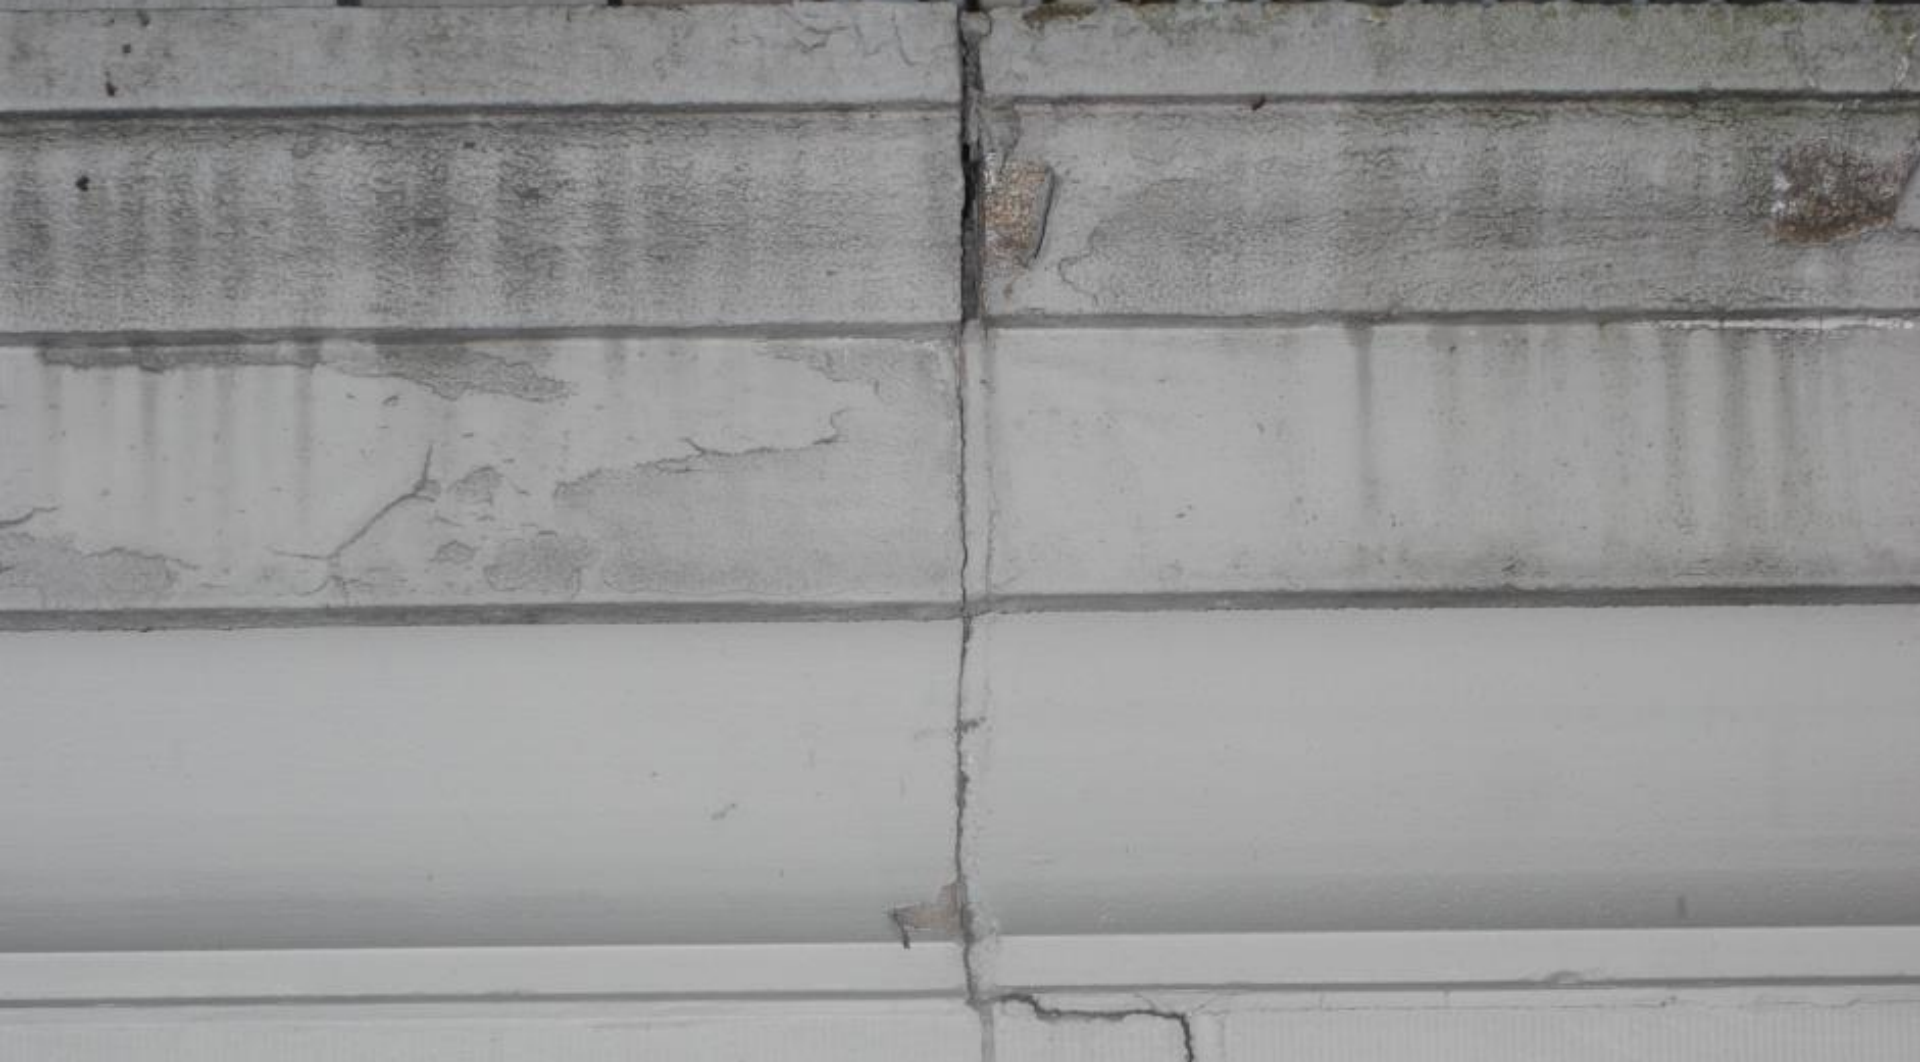
Photo 354: Original Building West façade, first floor

CHIPPED, CRACKED LIMESTONE

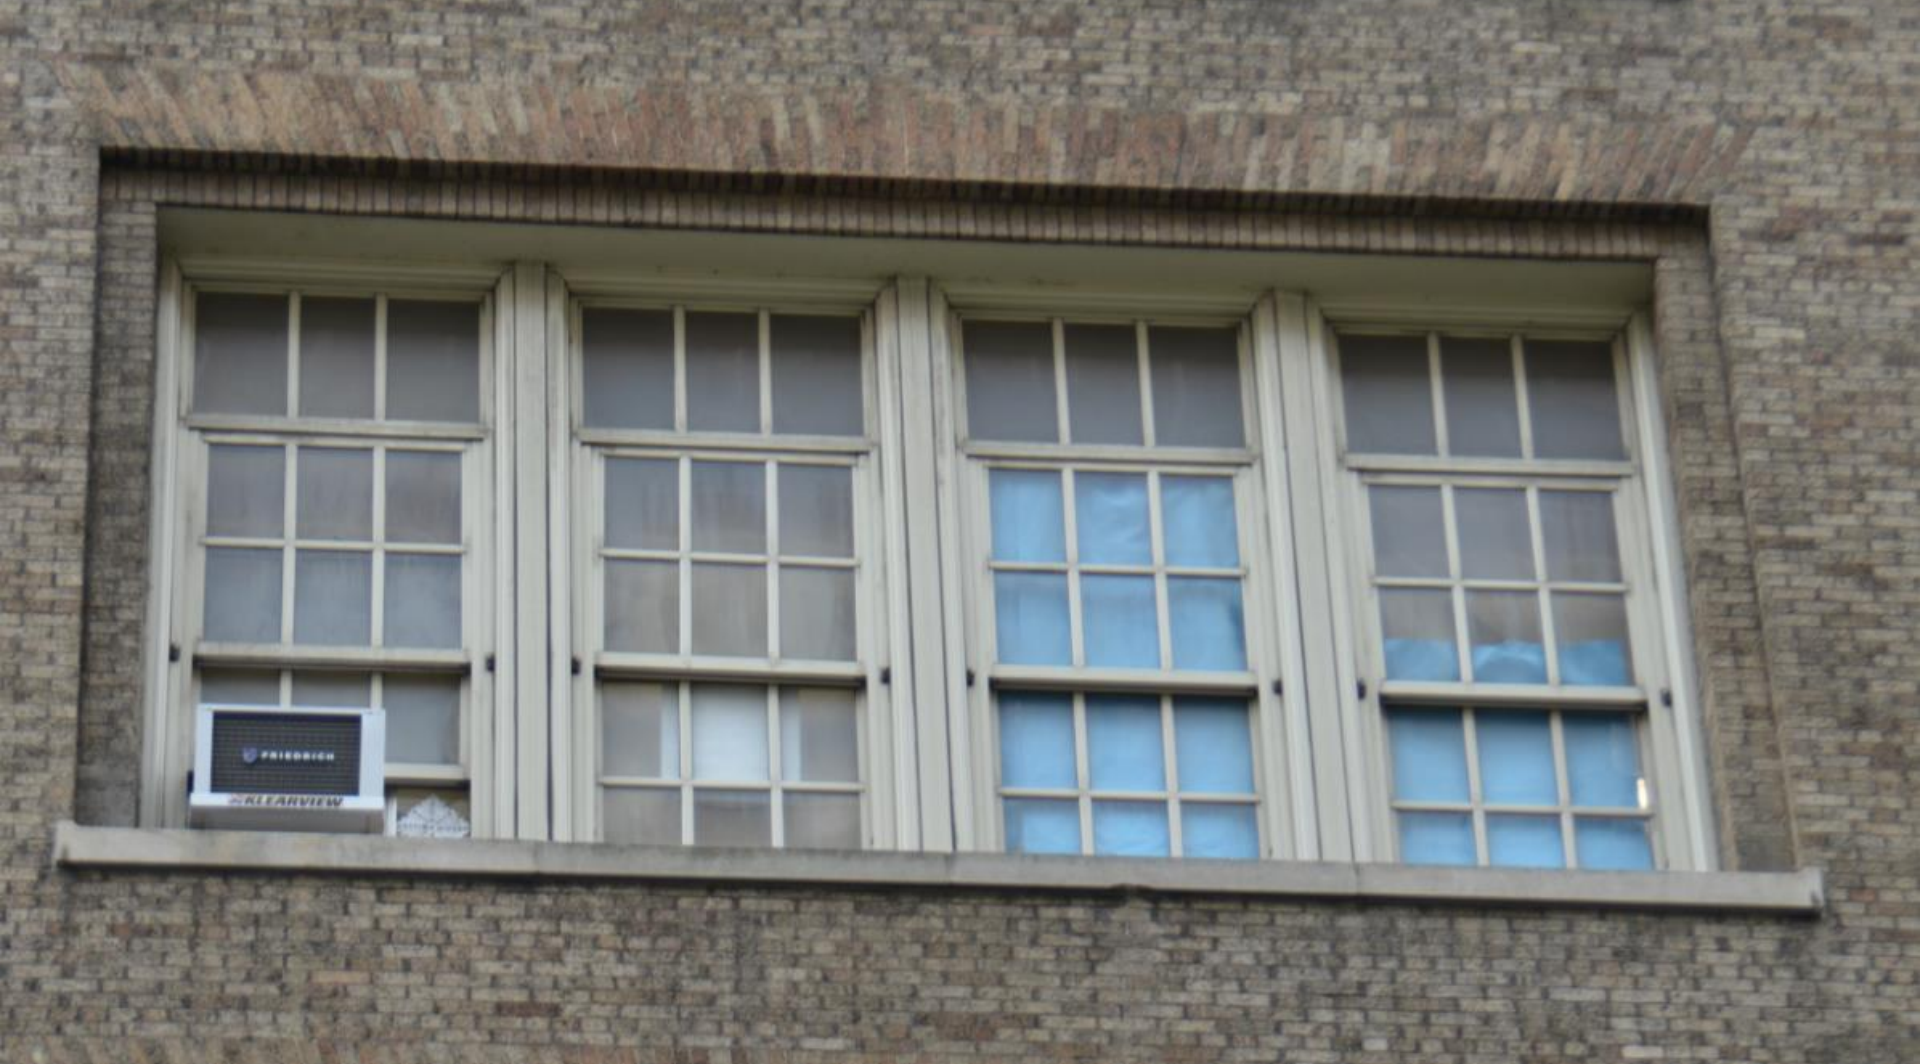
Original Building West façade, 5th floor

MASONRY CRACKS

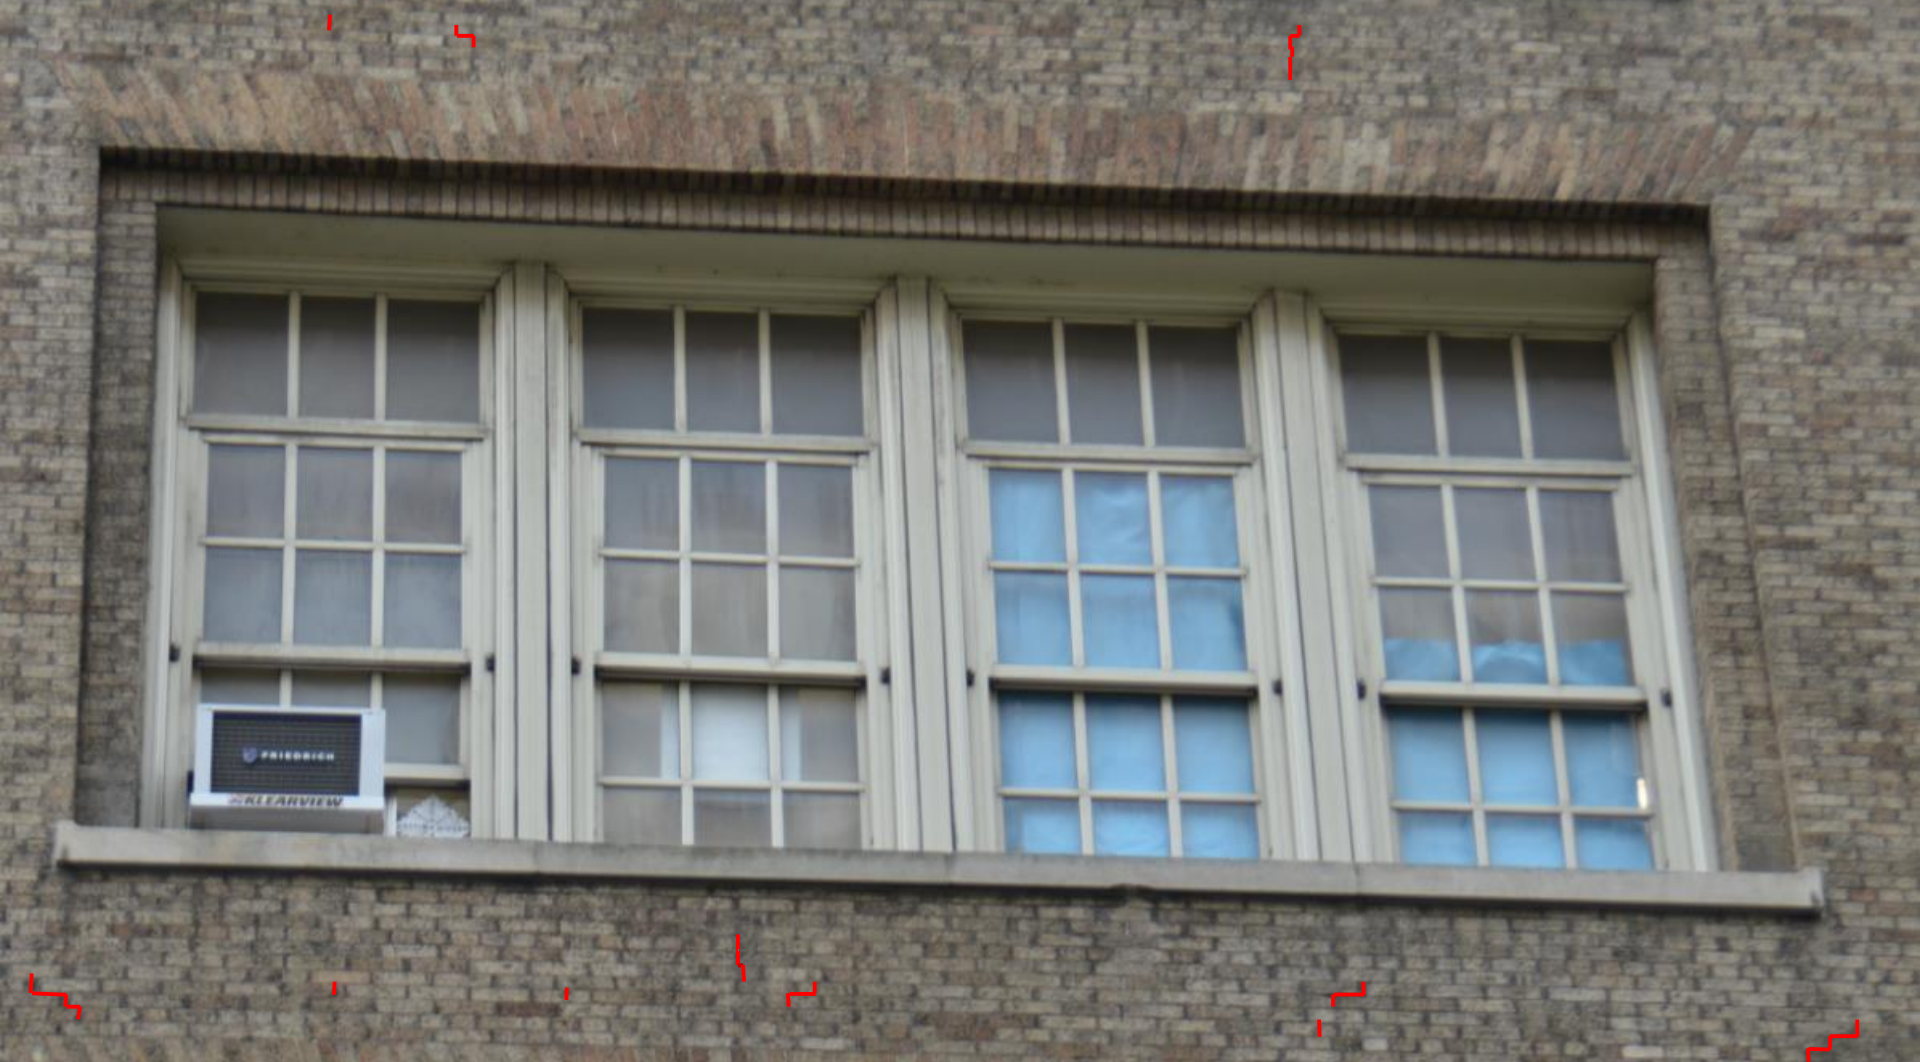
Original Building West façade, 5th floor

MASONRY CRACKS

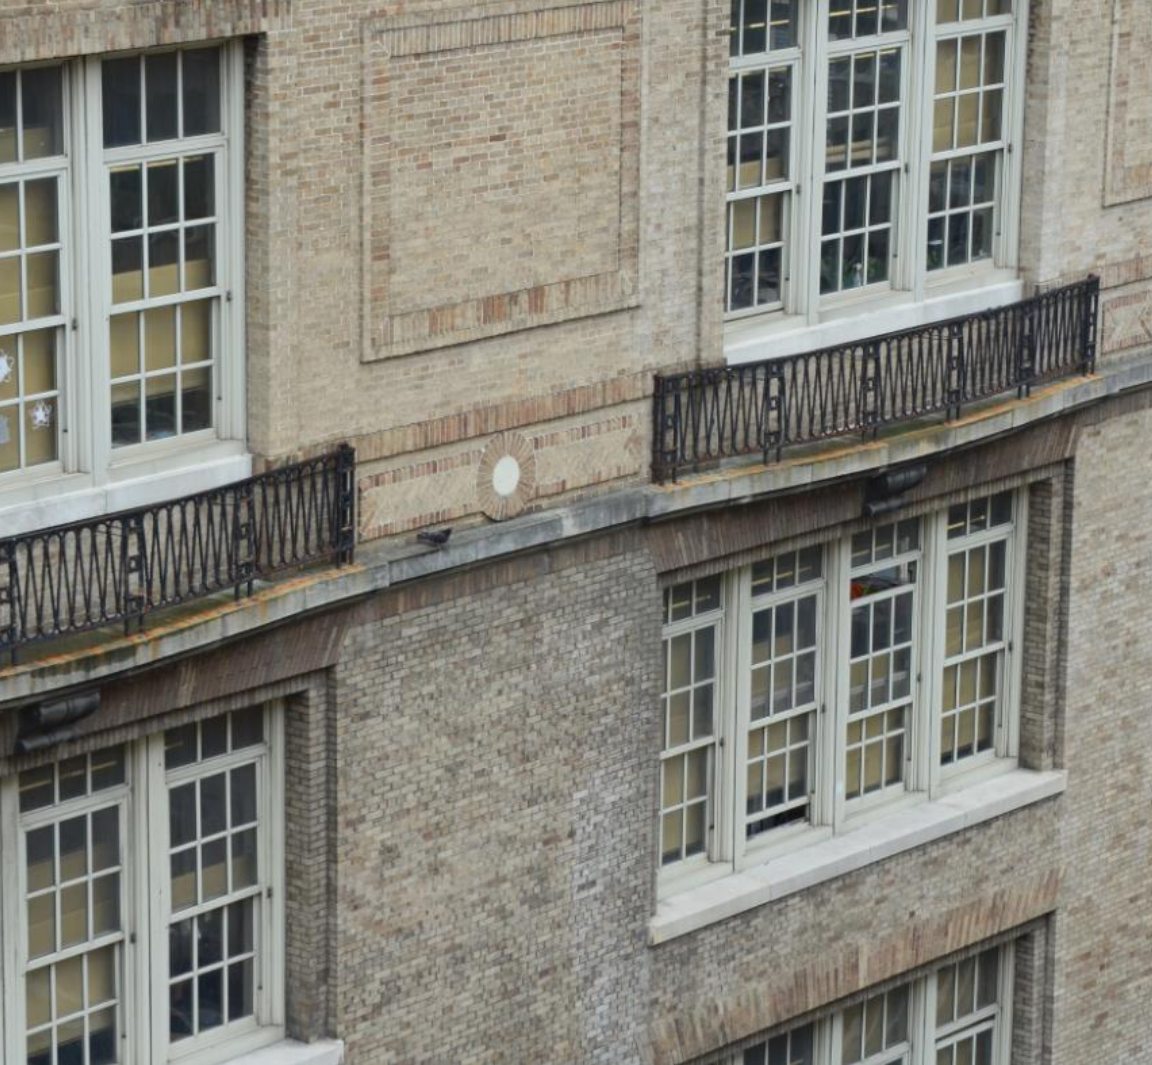
West Elevation, Irving Place

RUSTED GUARDRAIL

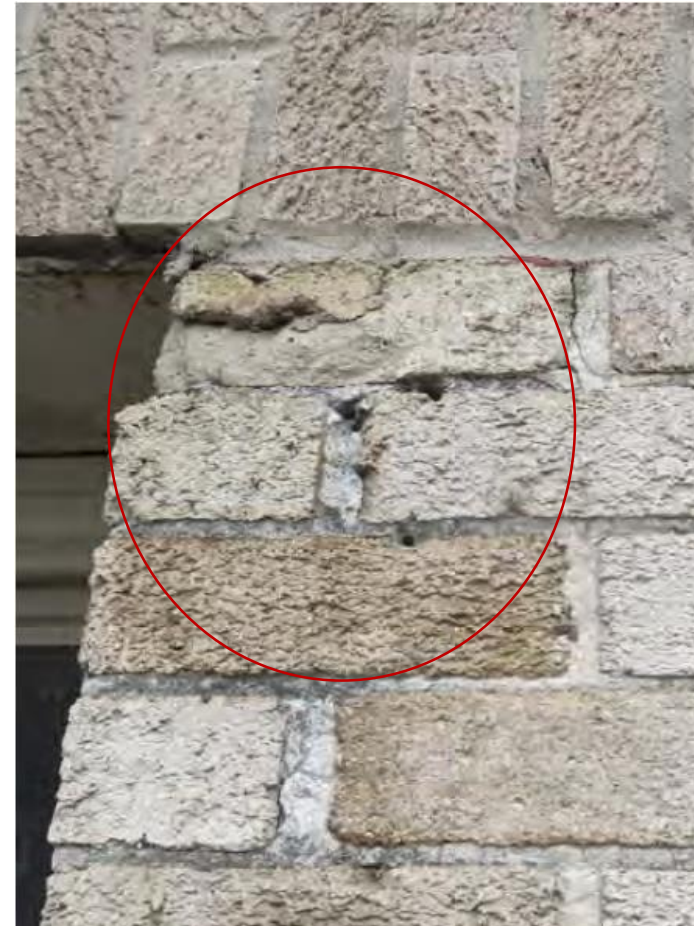
Drop Location # 2 – South Elevation; eighth floor

DETERIORATED MORTAR JOINTS AND BRICK SPALLING

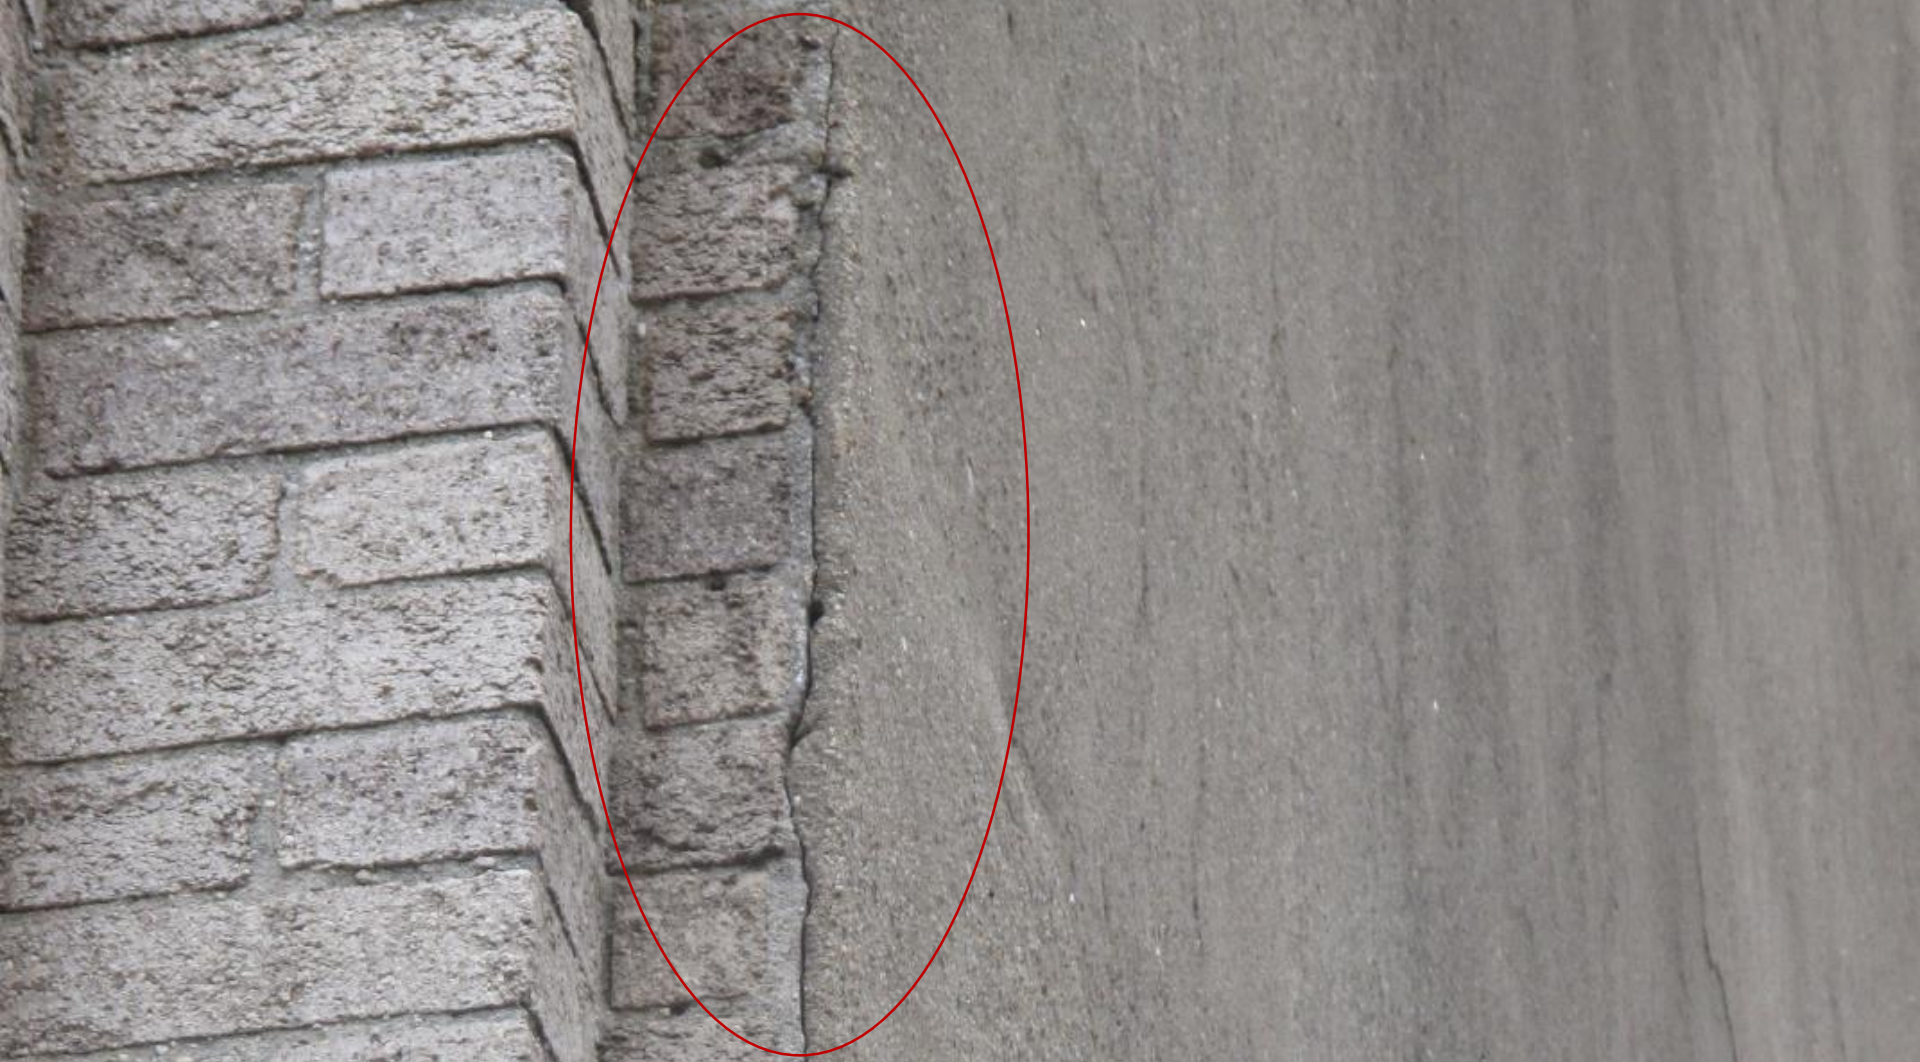
Photo 337: Original Building, Southwest Corner

EXTENSIVE CRACKS

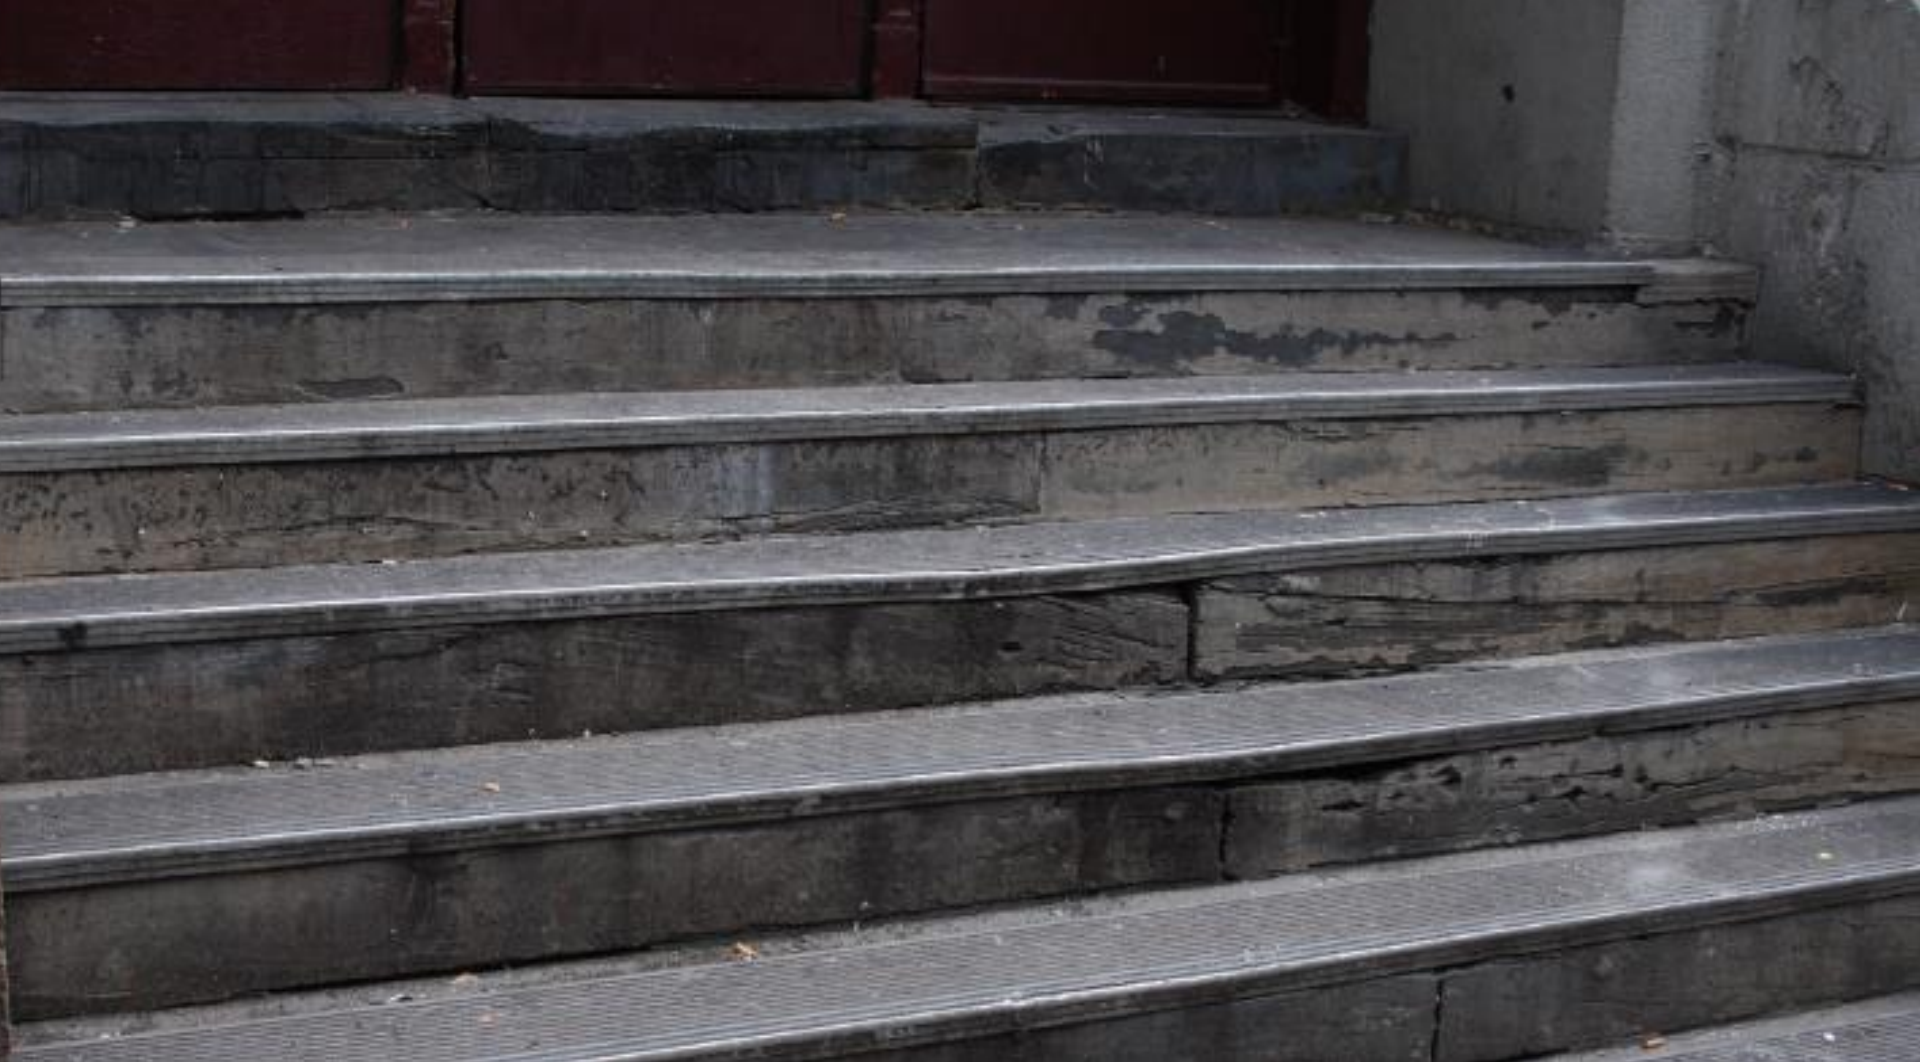
Photo 325: Original Building South facade

CHIPPED, CRACKED BLUESTONE AT ENTRY STEPS

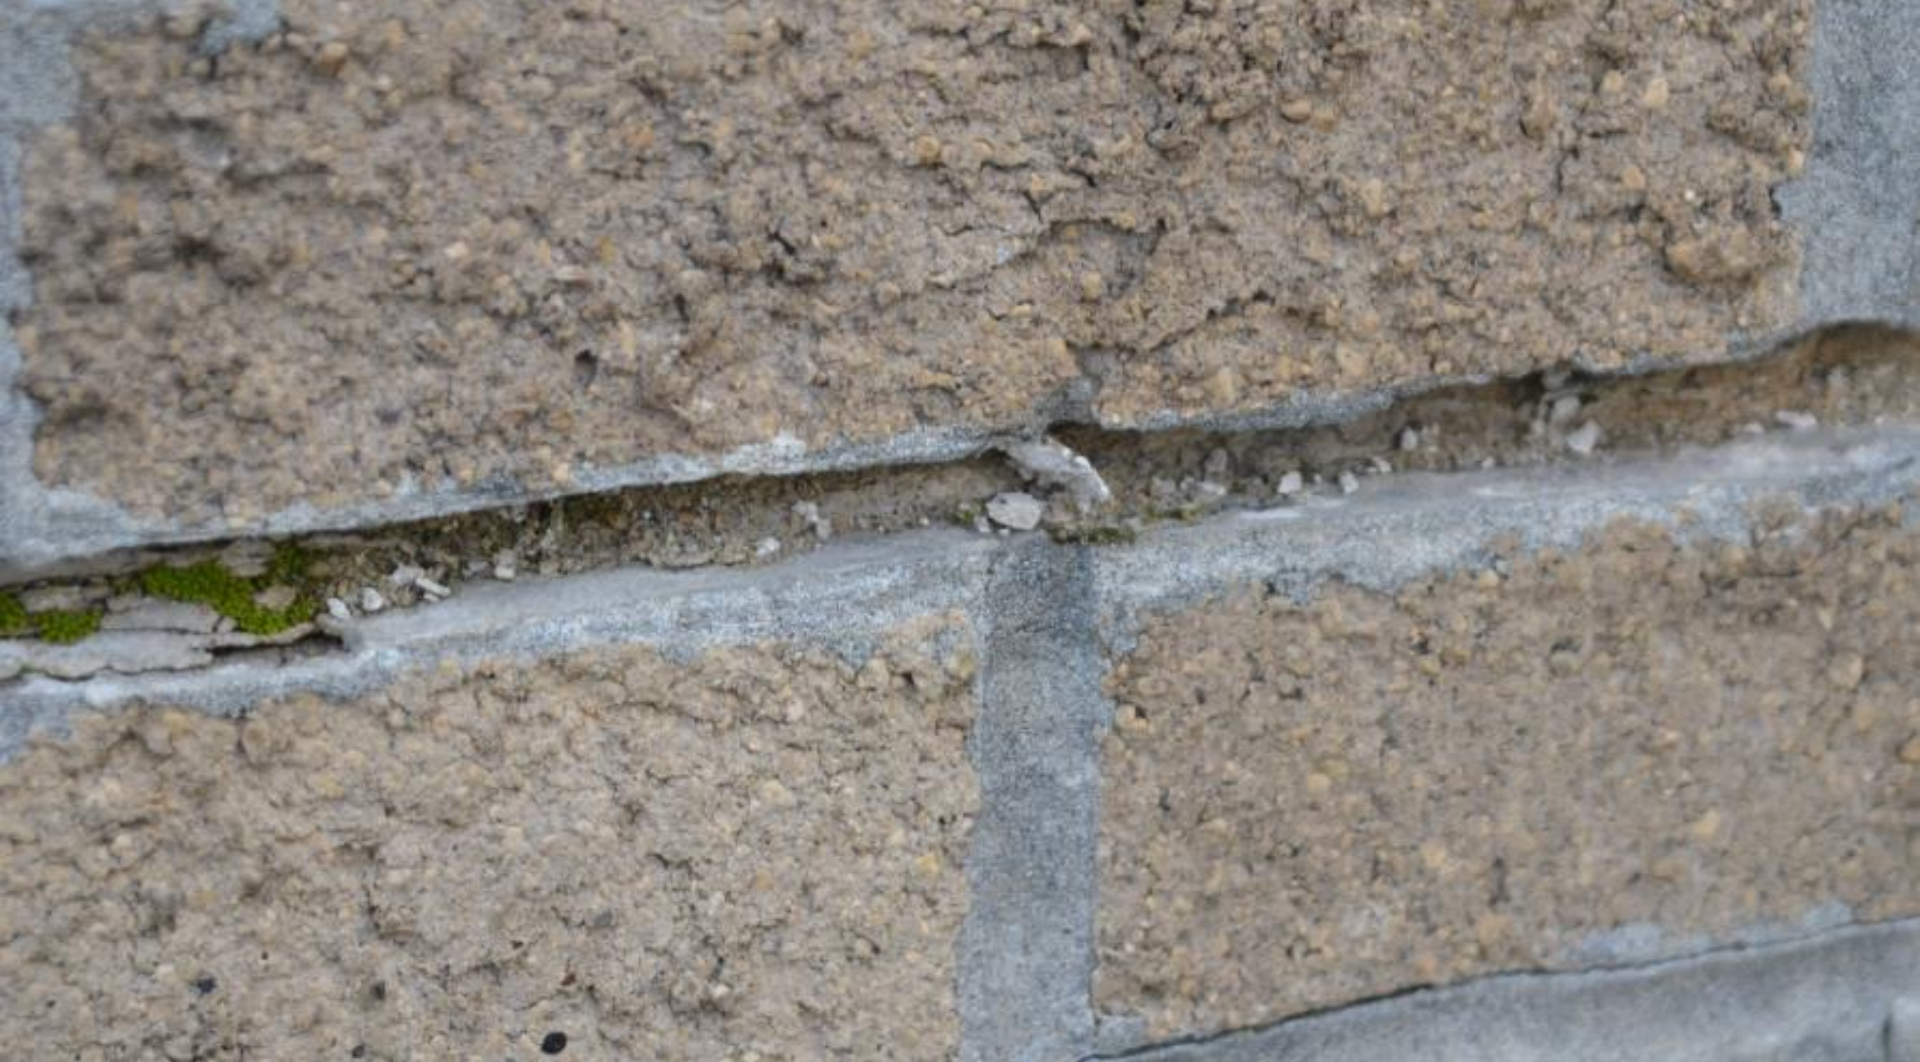
Photo 312: Additional Buildings Roof, looking south

MISSING MORTAR AND CRACKING

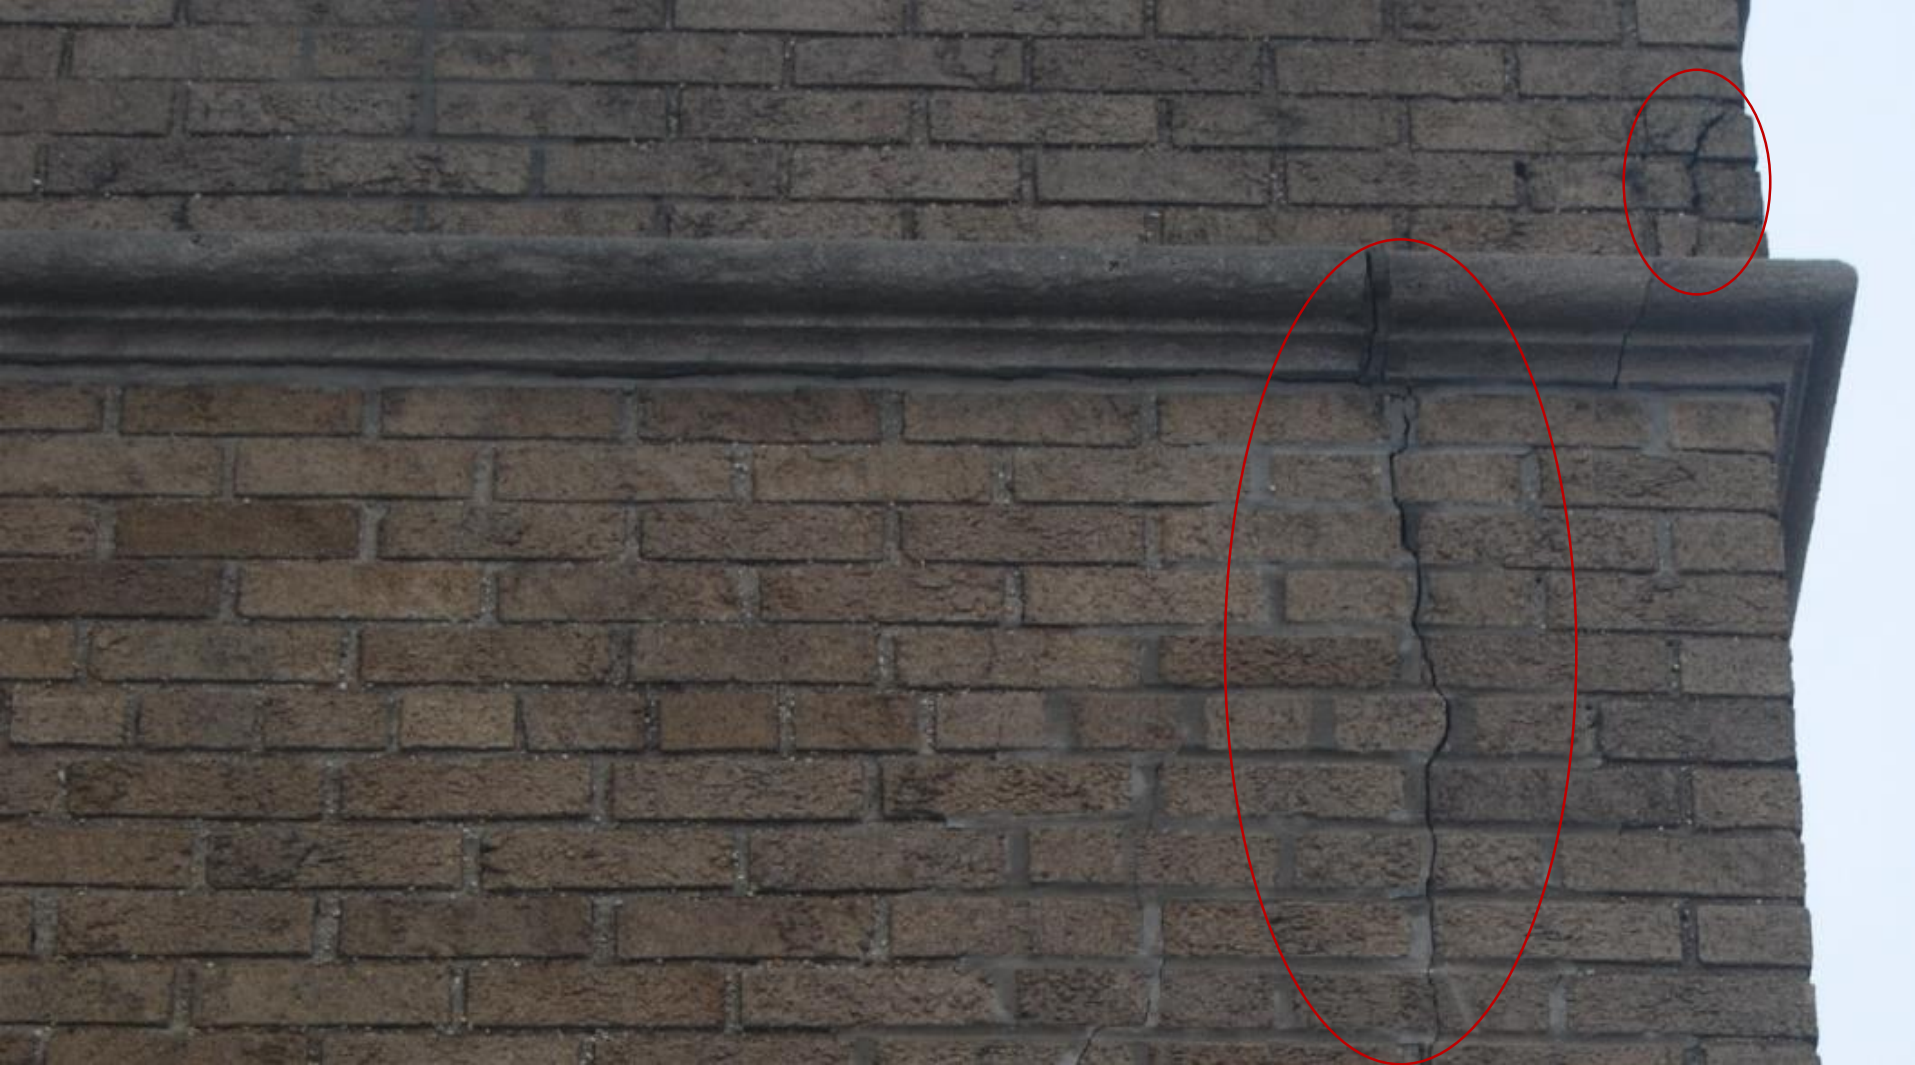
Photo 386: Additional Building Bulkhead, northeast corner

CRACK AT BRICK, MORTAR JOINTS AND LIMESTONE

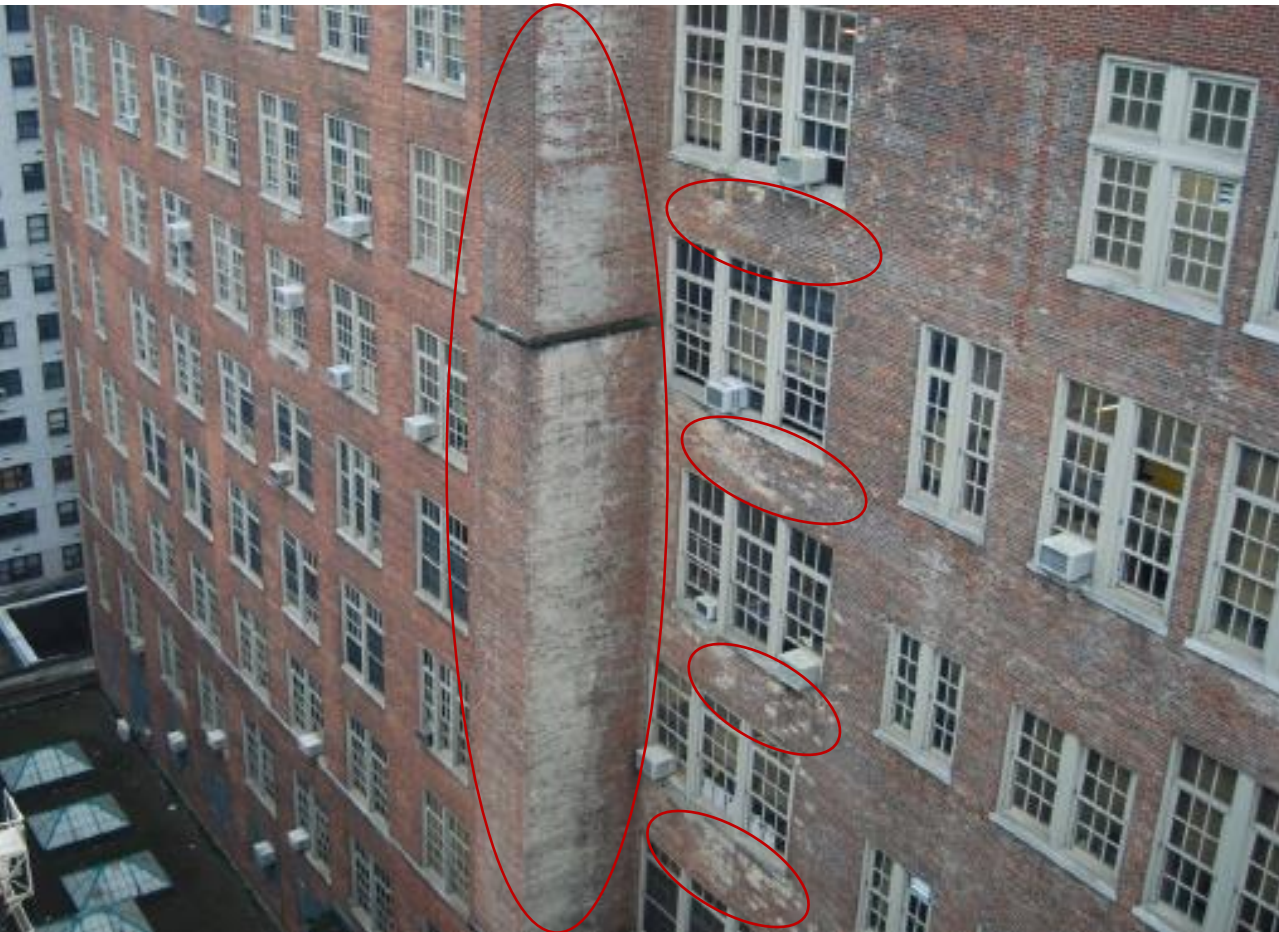
Original and Additional Building, South Court Facade

BADLY WORN, STAINED AND EFFLORESCING MASONRY

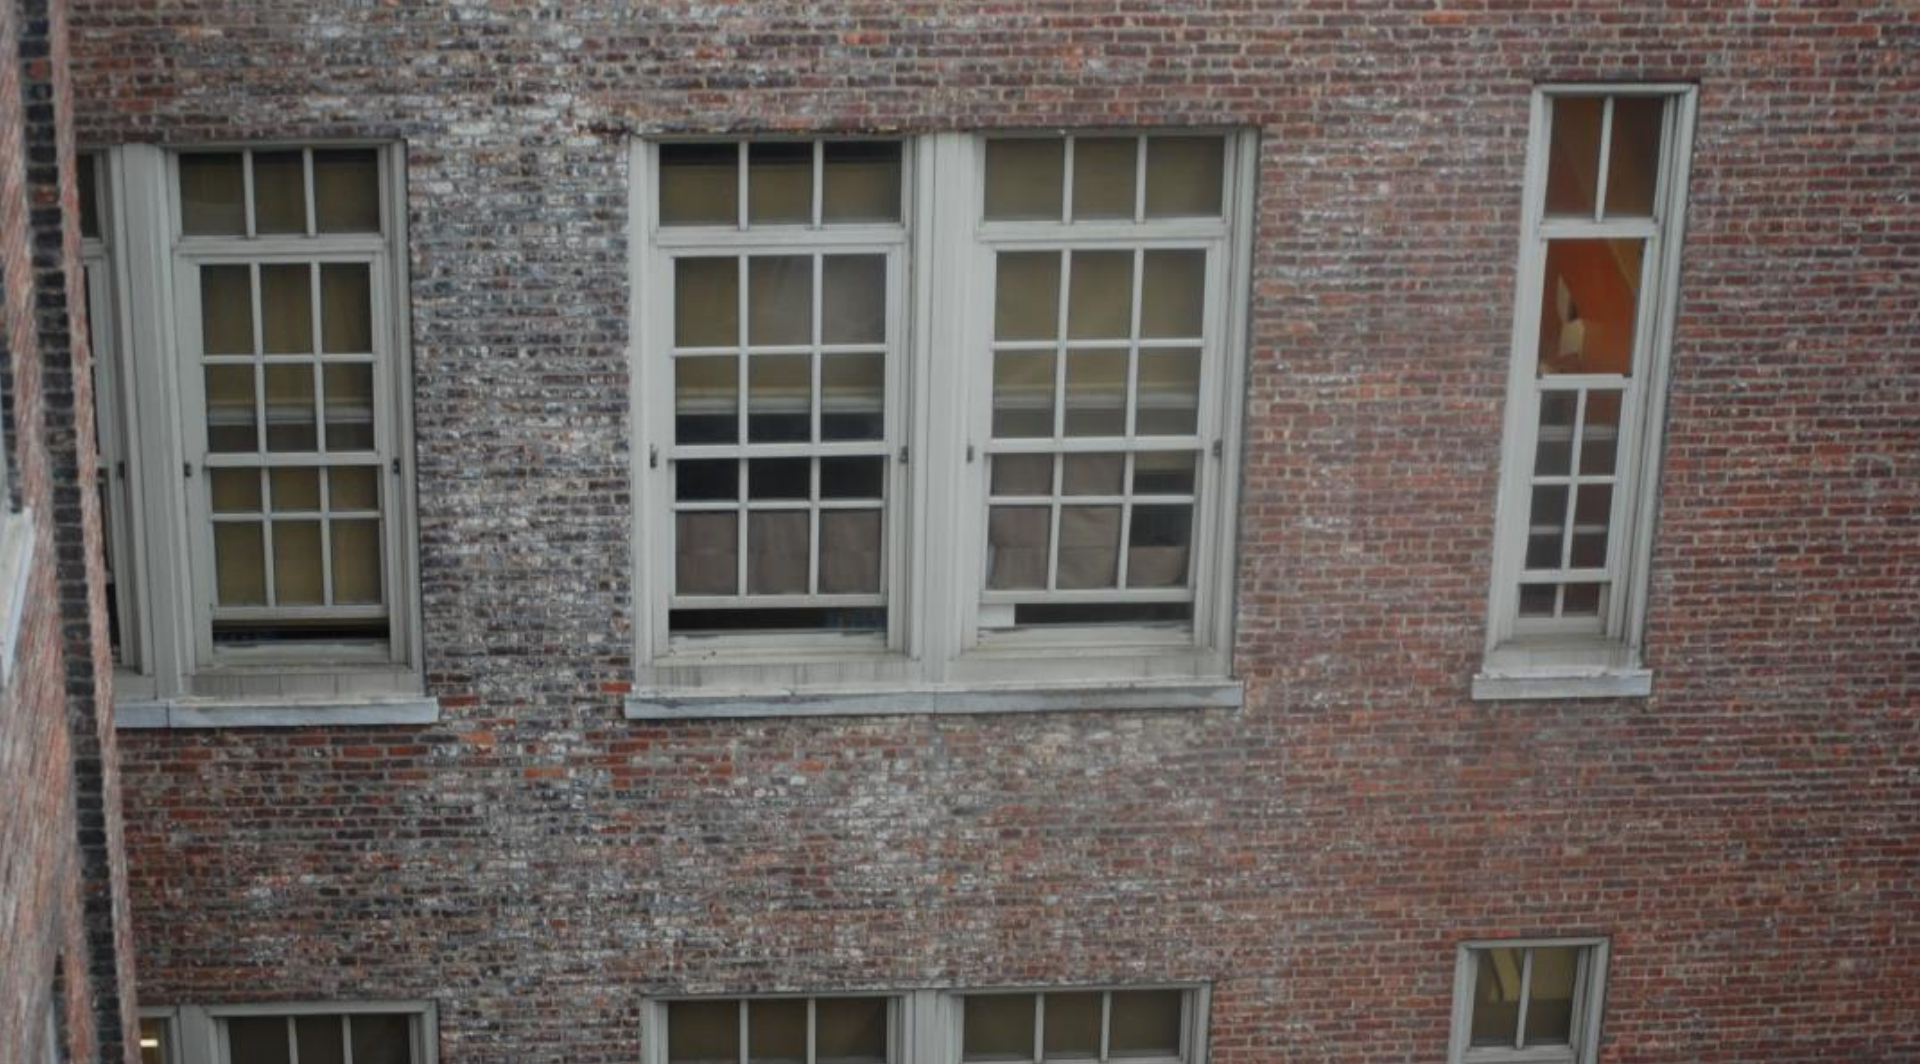
Photo 377: Original Building, North Court Elevation

WORN MASONRY
