Washington Irving Campus Building Rehabilitation

Informational Meeting with NYC Council Member Rosie Mendez and the NYC SCA.

April 24, 2017

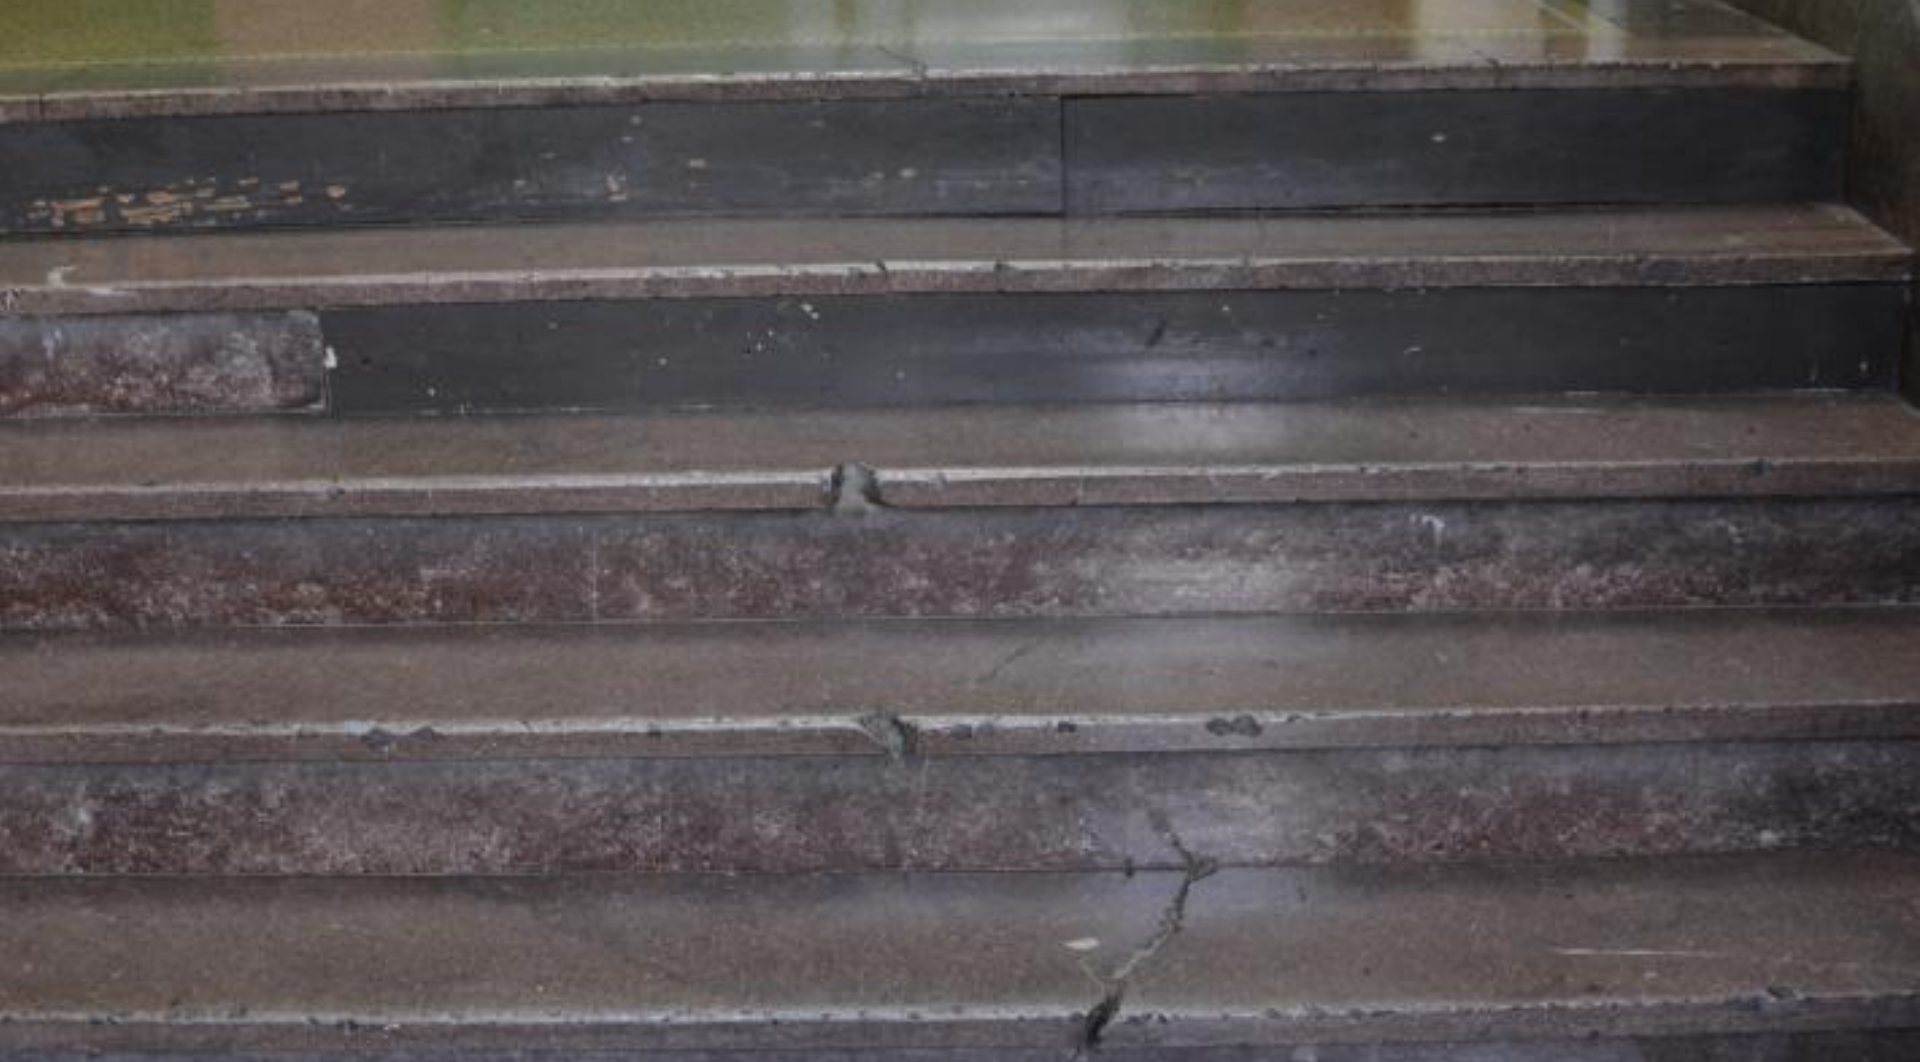
Photo 70: Interior stair

CRACKED STONE AT ENTRY STEPS

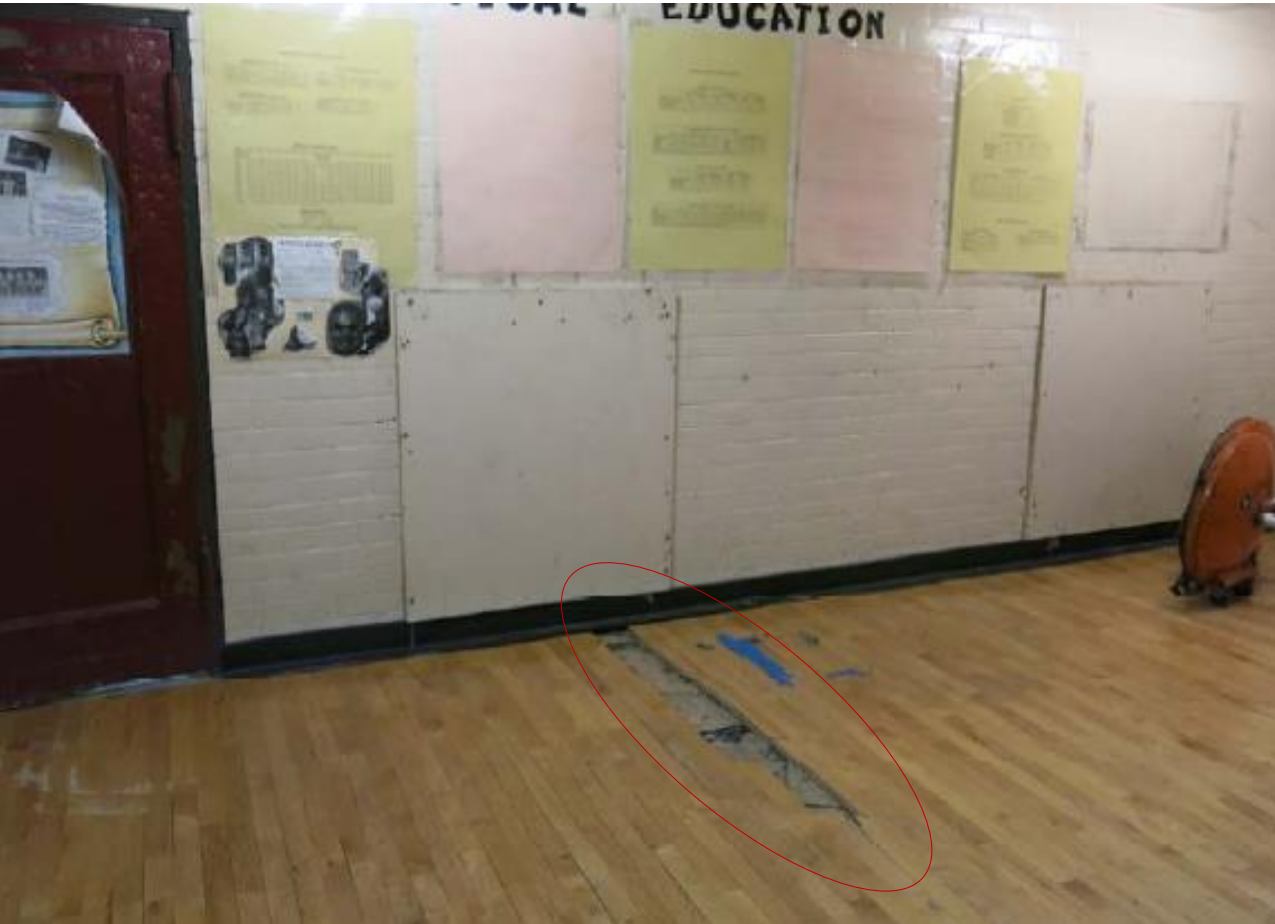
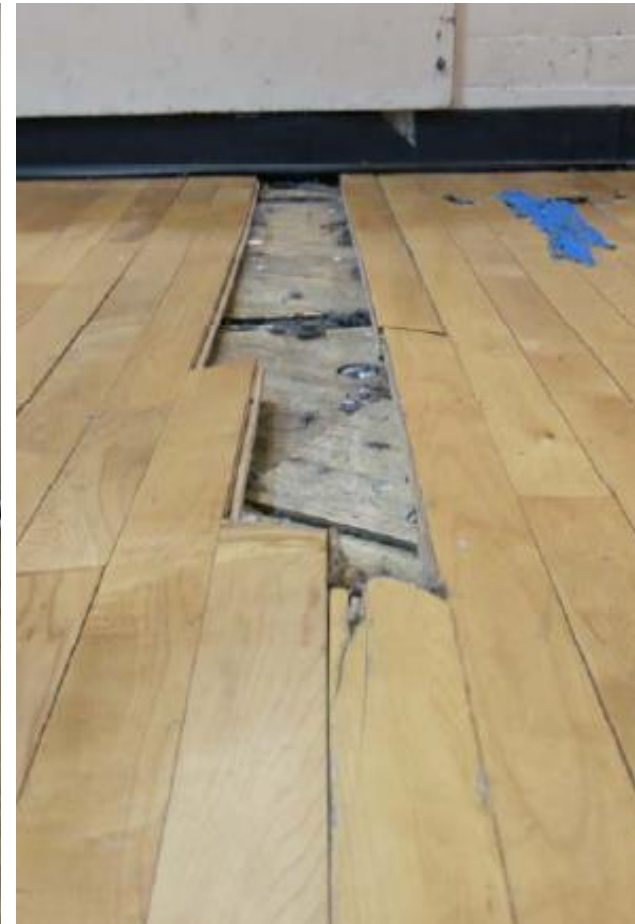
Gymnasium southwest corner

DAMAGED FLOOR AT GYMNASIUM

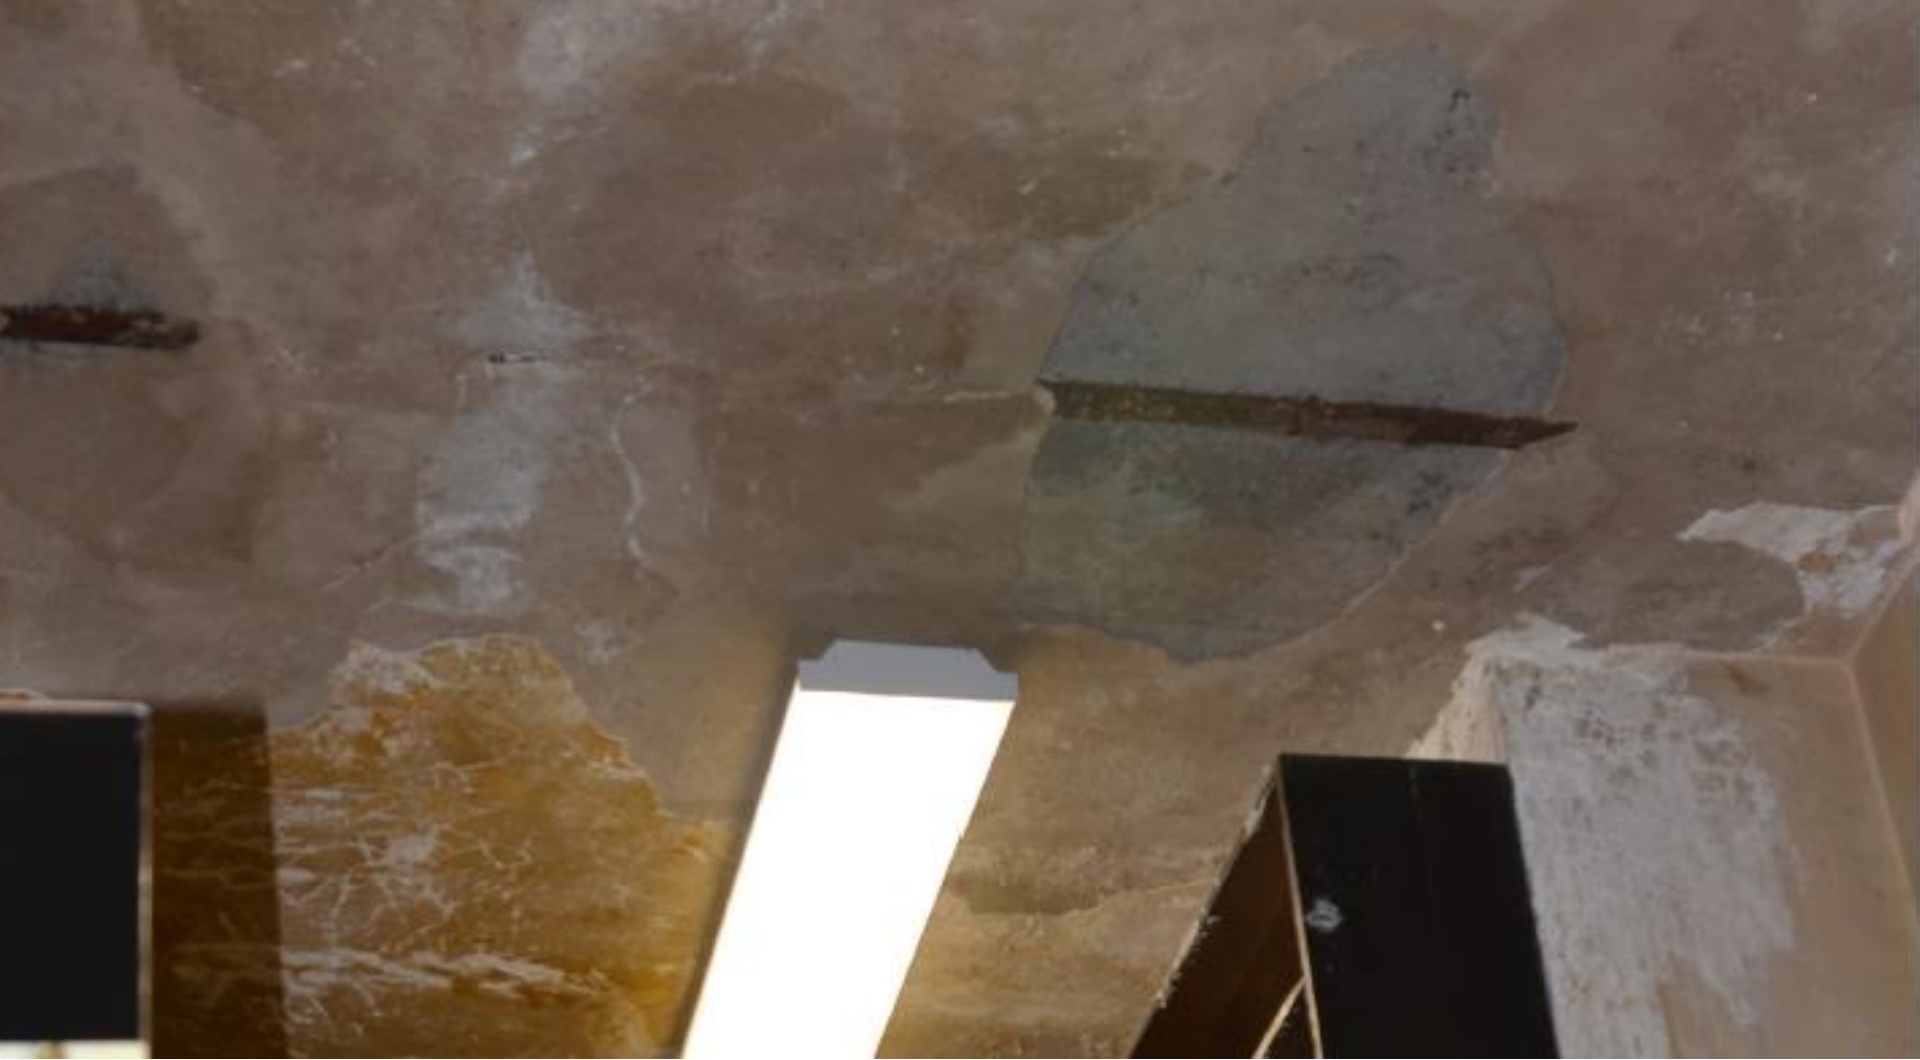
Photo 247: Room 811

WATER DAMAGE AT CEILING

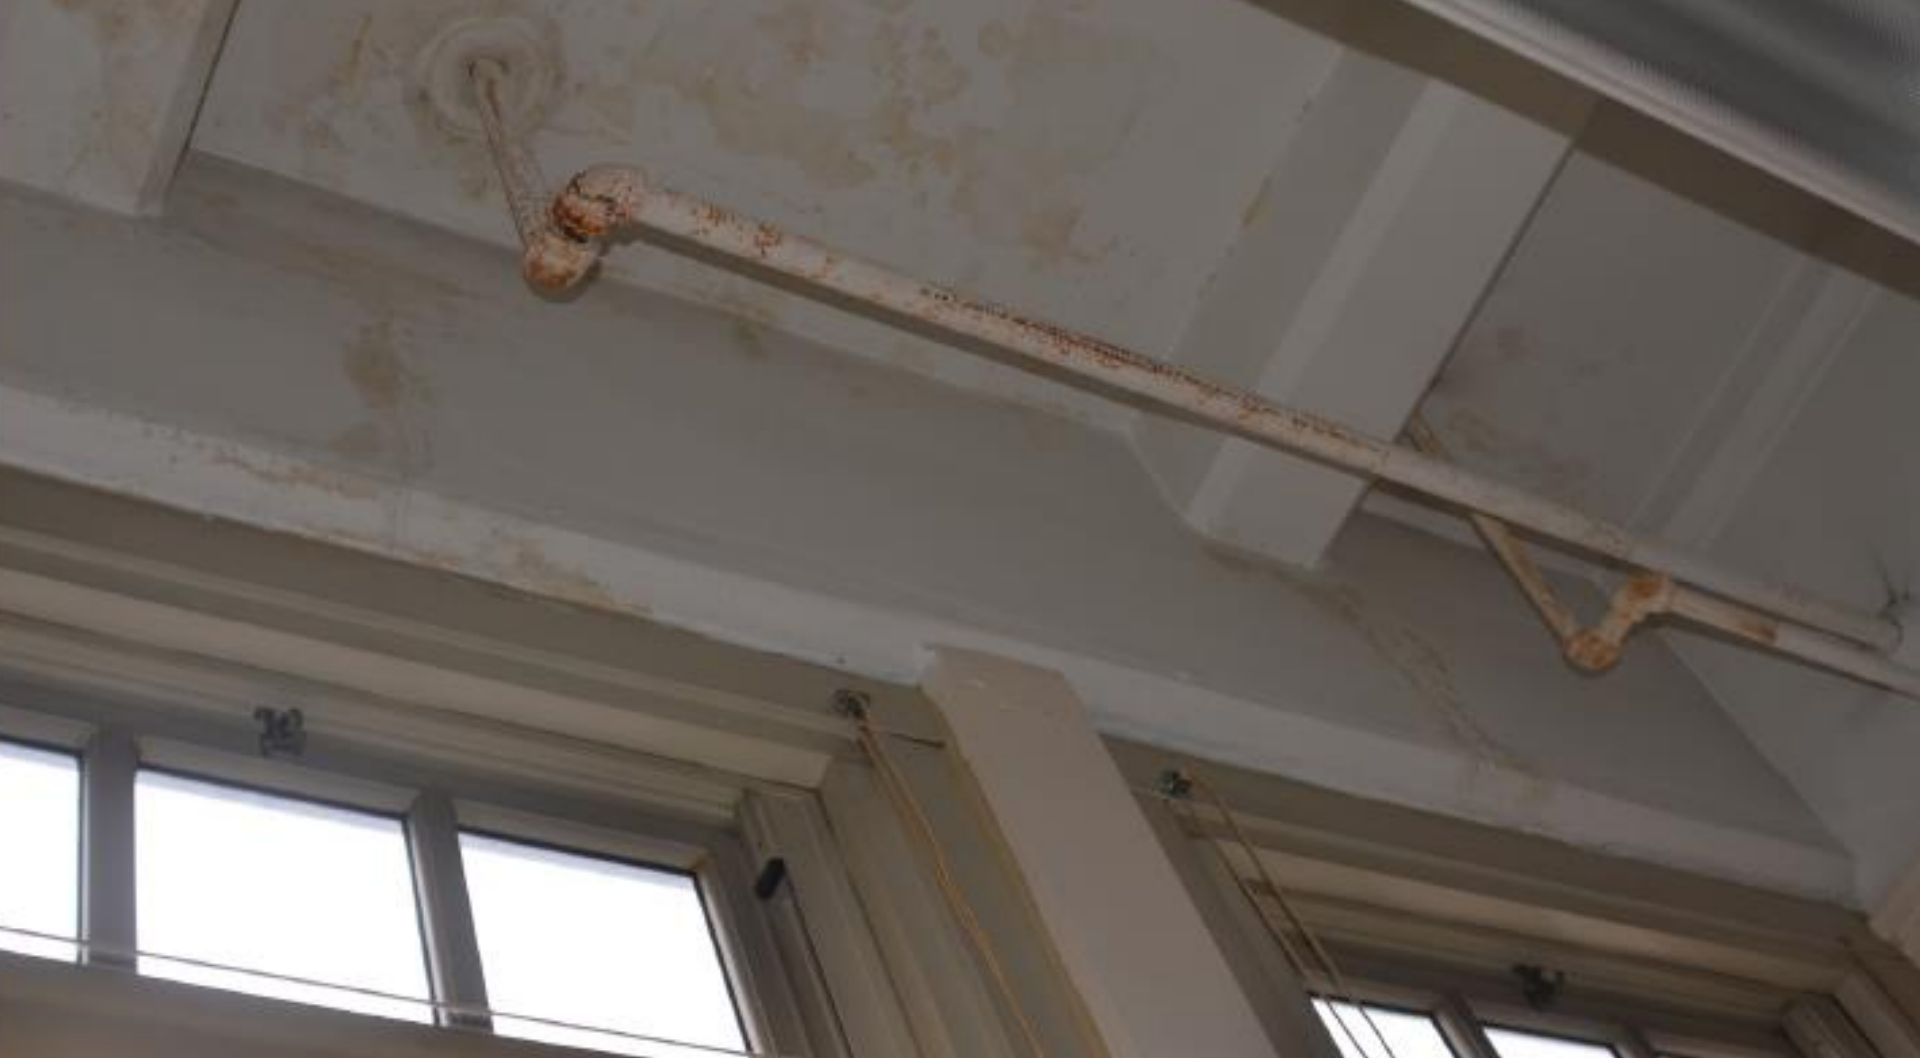
Room 1147

STAINING ON WALLS, AT CEILING AND PIPING

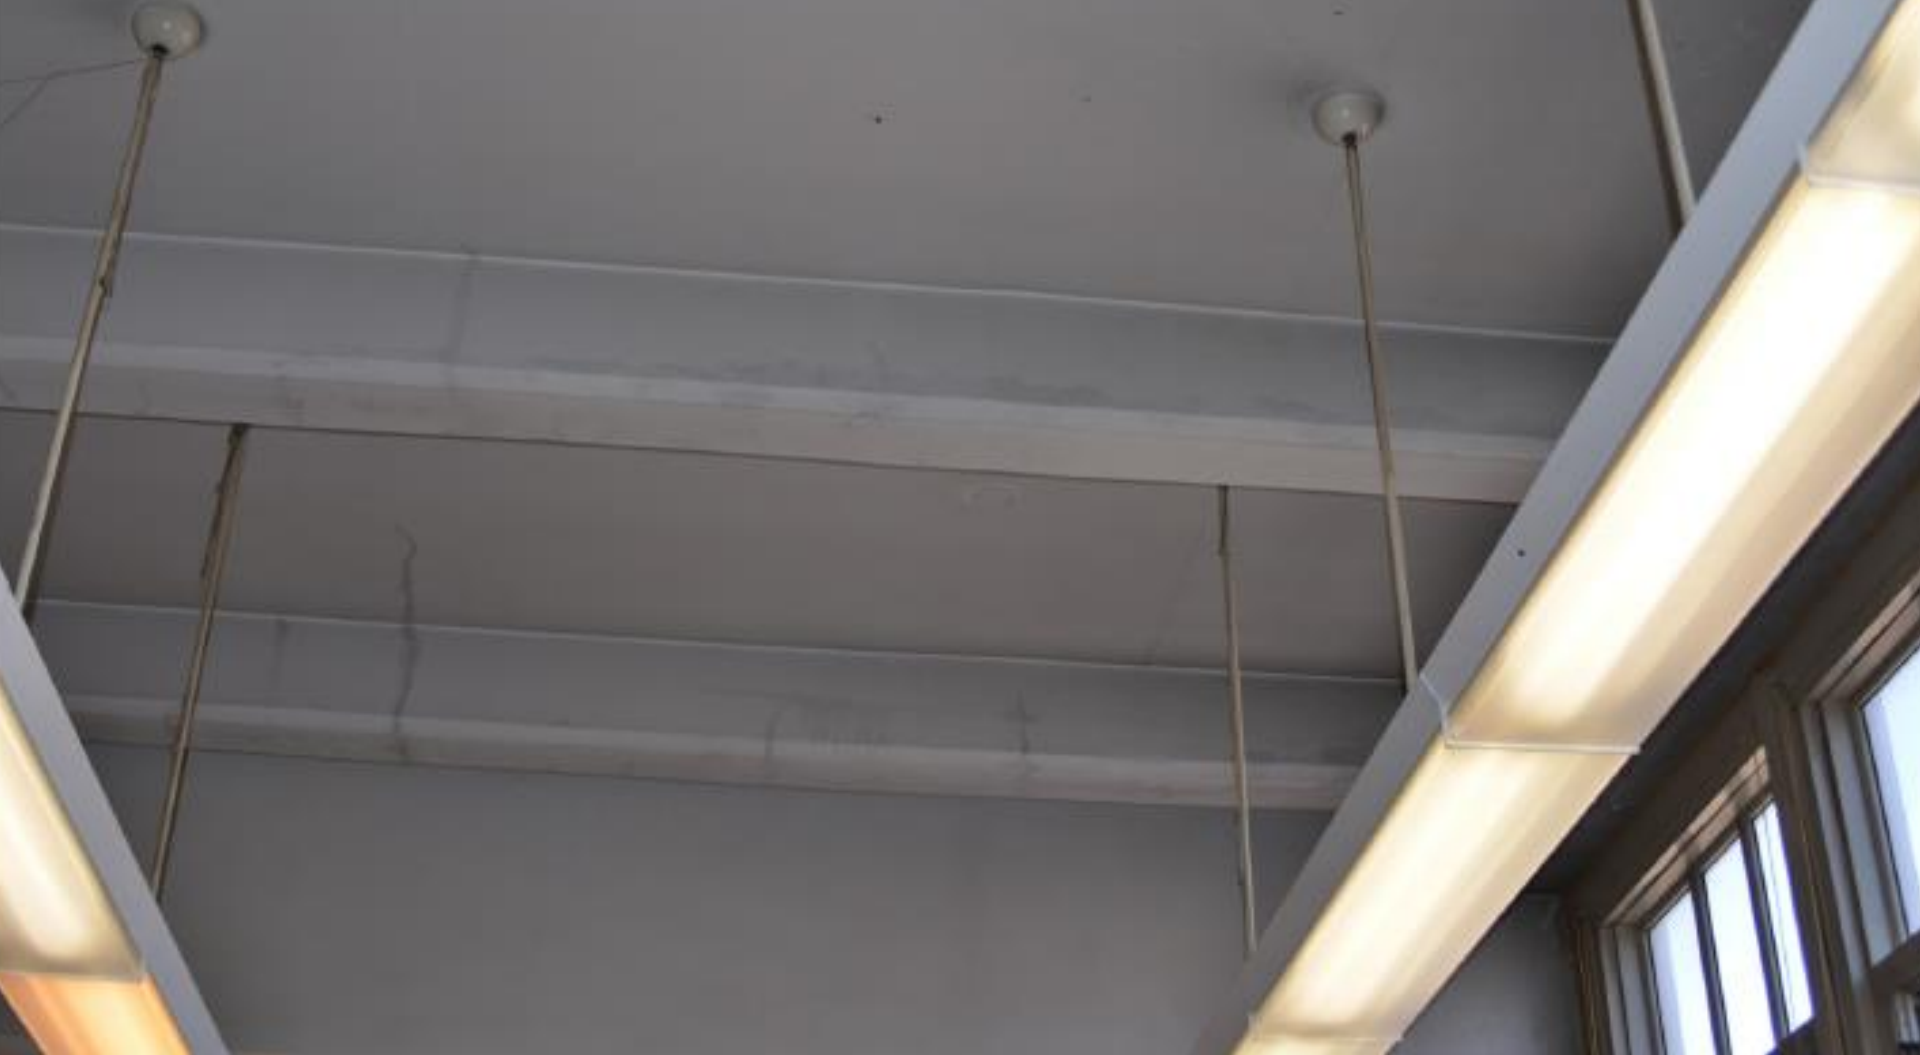
Room 746

CRACKS AT PLASTER'S IN-CASE STEEL BEAMS

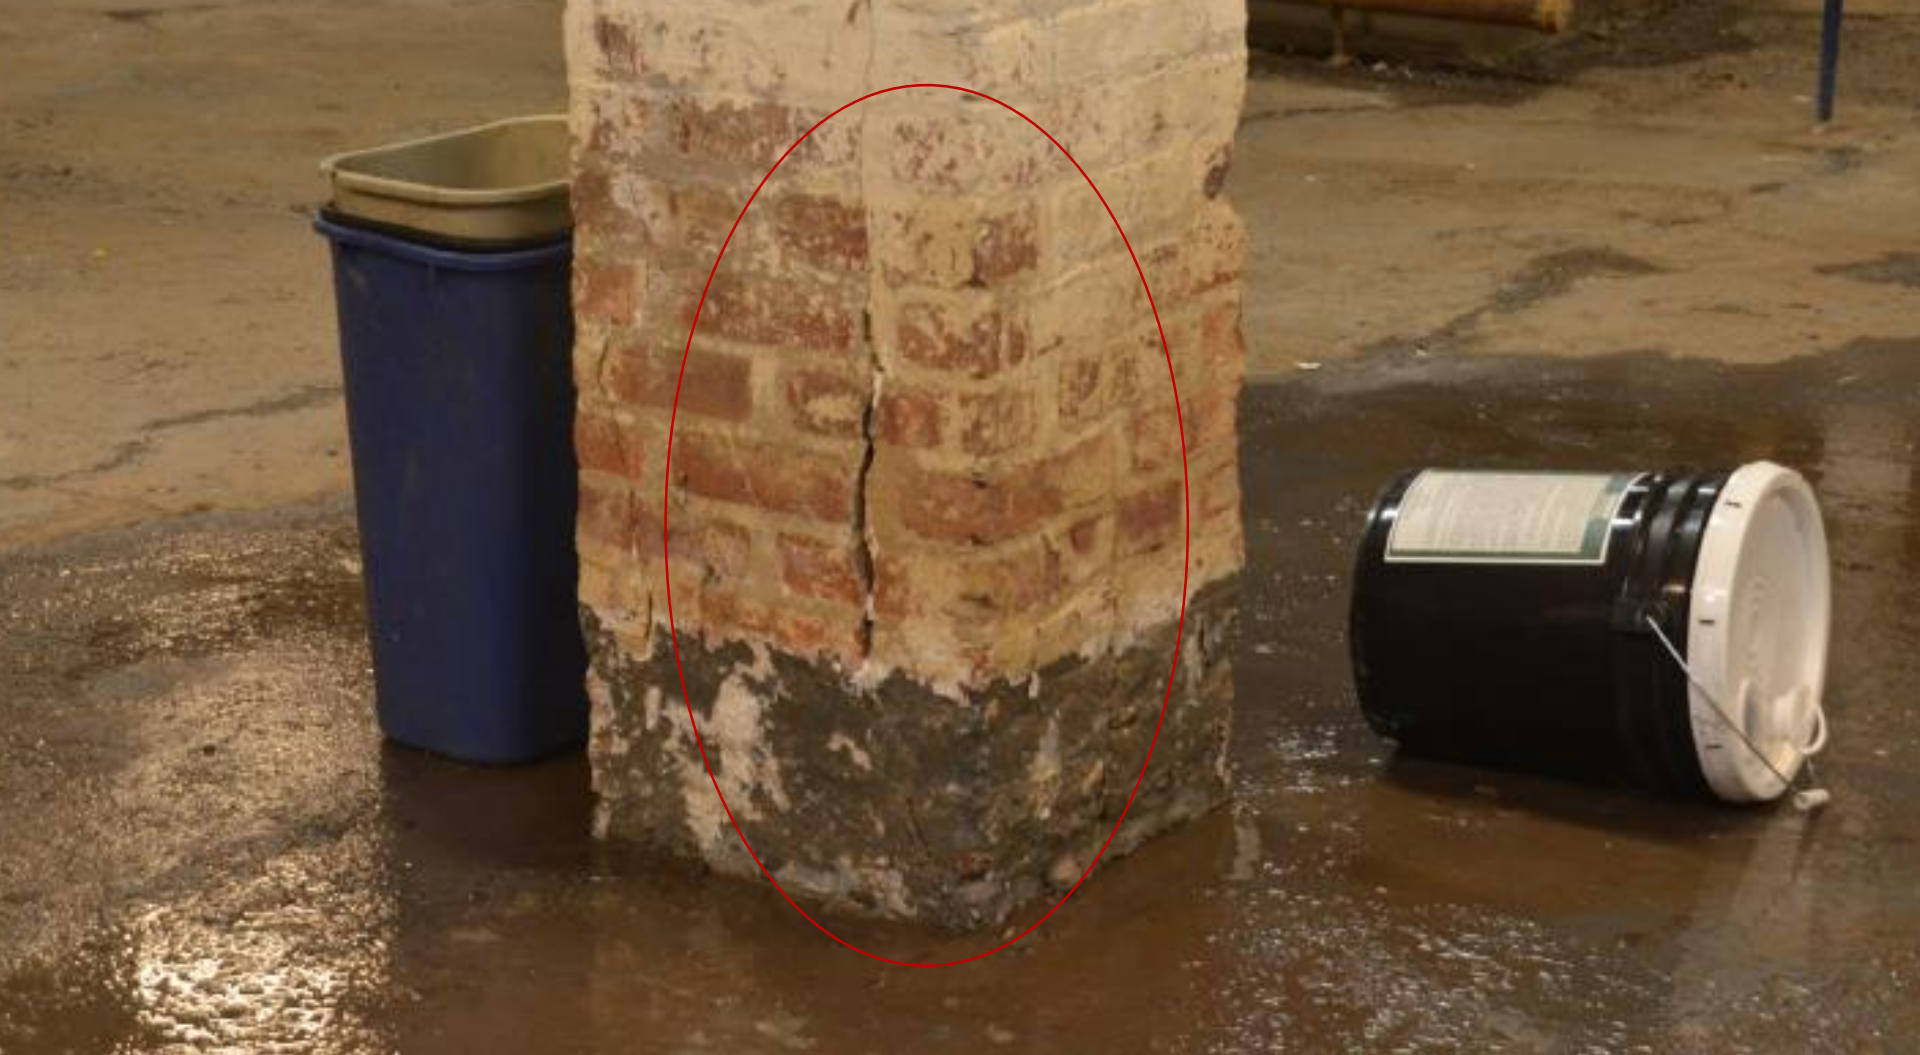
Boiler Pit

WATER PONDING AND CRACK AT BRICK'S IN-CASE STEEL COLUMN

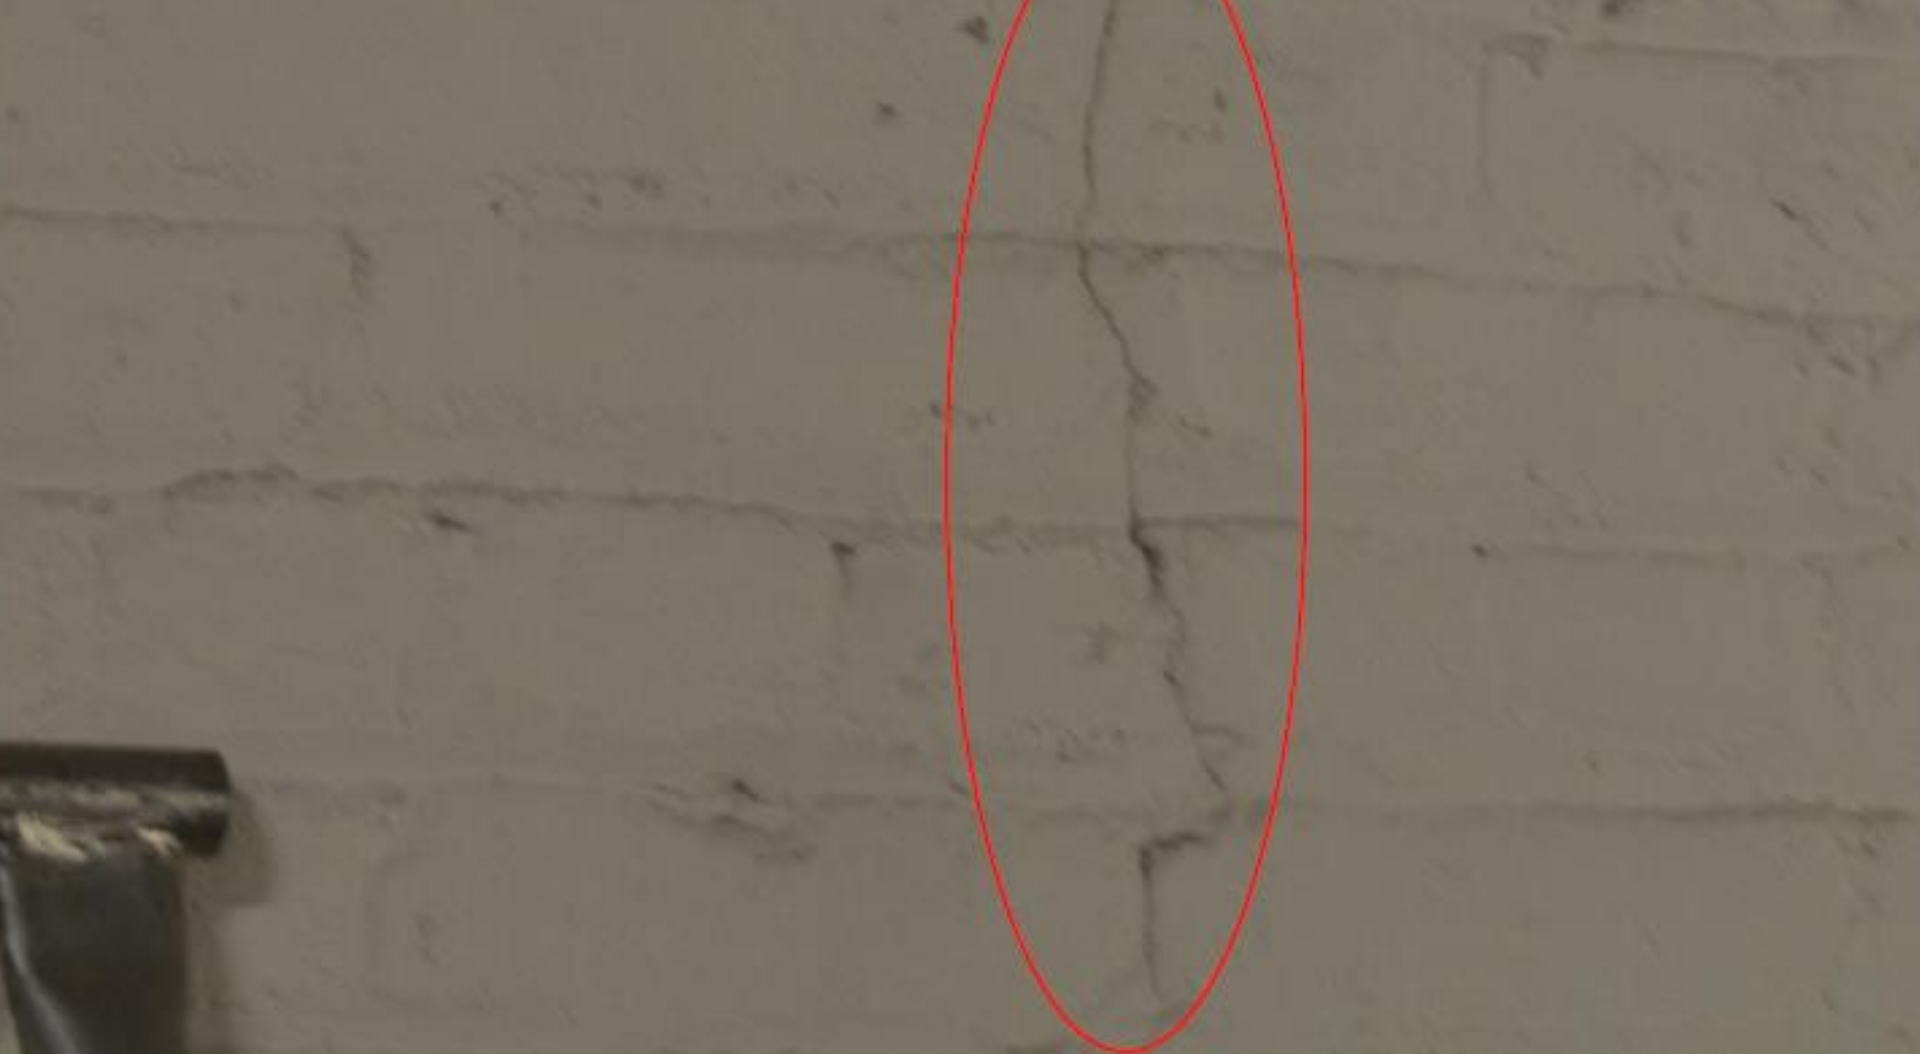
Boiler Room

CRACK AT INTERIOR BRICK MASONRY

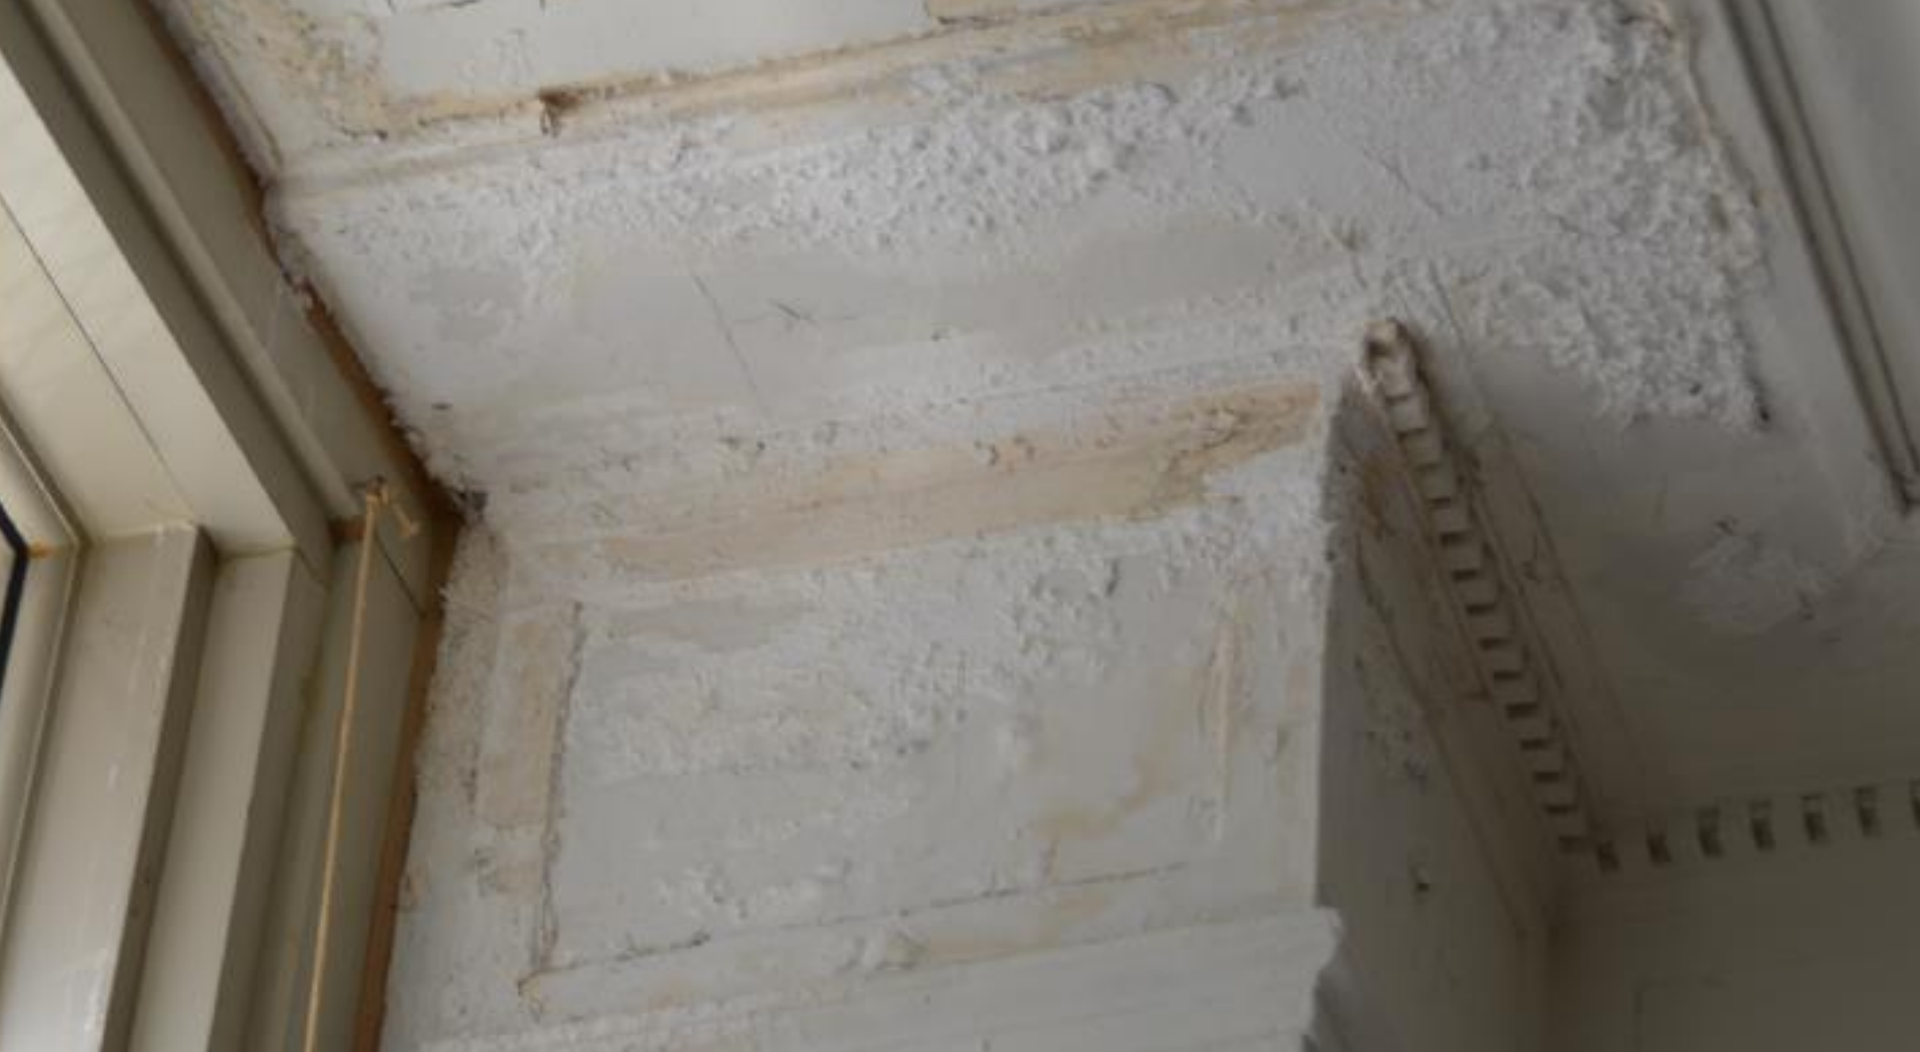
Library

WATER DAMAGE AT INTERIOR PLASTER
