Washington Irving Campus Building Rehabilitation

Informational Meeting with NYC Council Member Rosie Mendez and the NYC SCA.

April 24, 2017

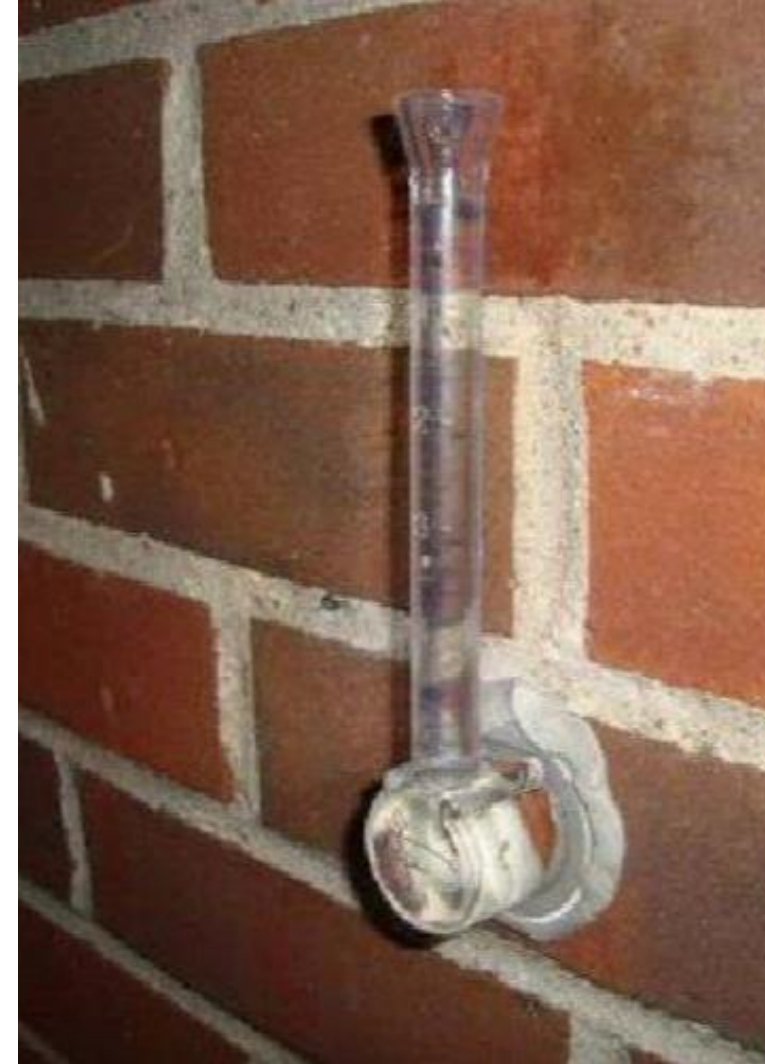
Area B – RILEM test results indicate limited absorption through the brickwork and increased absorption through the mortar joints

Example of Rilem test in progress
