# New York City's Historic Schools

A History and Guide to Rehabilitation

NYC SCHOOL CONSTRUCTION AUTHORITY

This Guide has been developed as a practical and technical resource to assist in the evaluation and design for the restoration of historic school buildings (more than 45 years old). It is worth noting that over half of our public school buildings are more than 60 years old! It is our intention to facilitate strategies for these projects that will target cost effective solutions while at the same time respecting their historic standing as landmarks in the community.

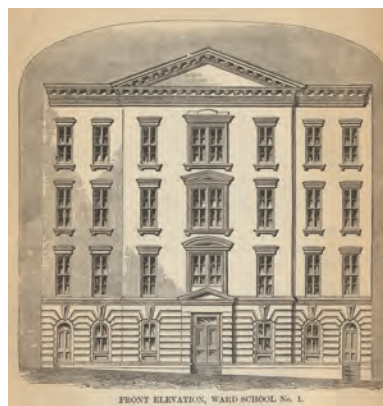
**Fig. 2.1.2**  
Ward school No. 1, front elevation. Courtesy:  
NYC Municipal Archives

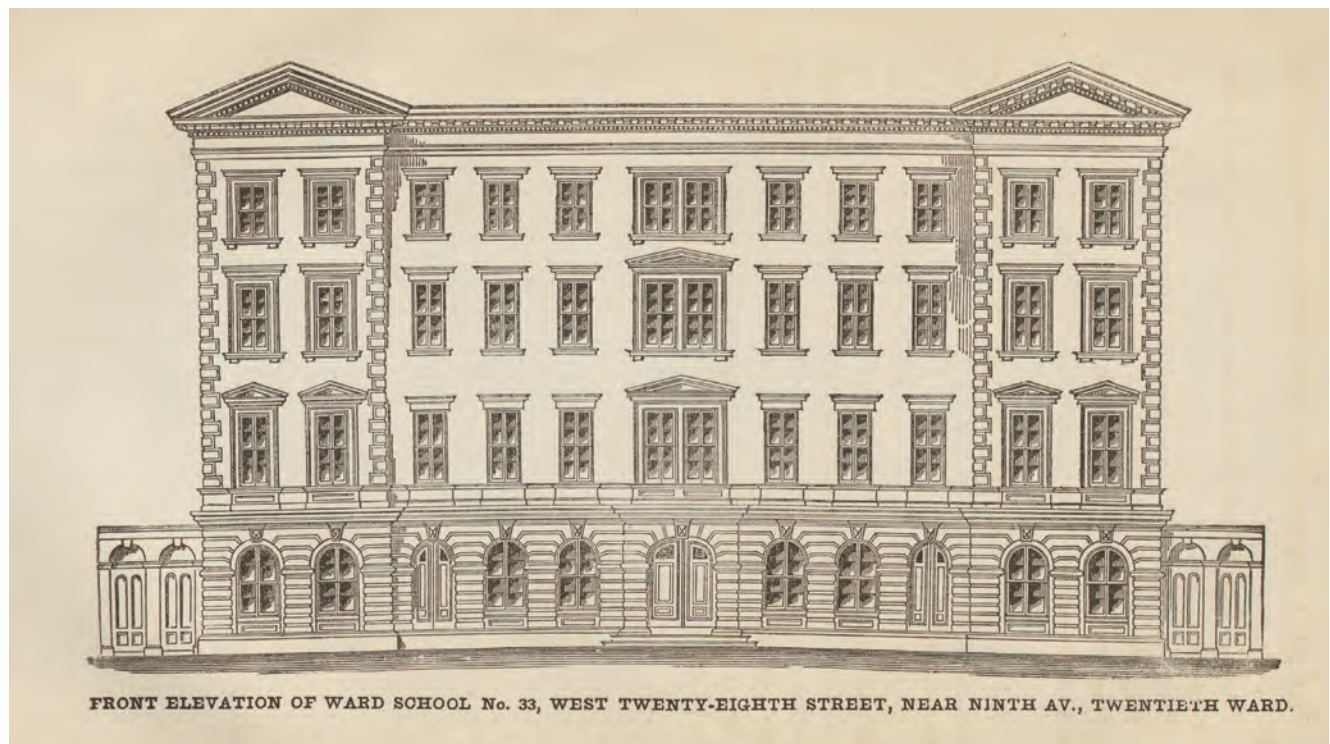
FRONT ELEVATION OF WARD SCHOOL No. 33, WEST TWENTY-EIGHTH STREET, NEAR NINTH AV., TWENTIETH WARD.

**Fig. 2.1.3 (above)**  
Ward school No. 22, located at West 28<sup>th</sup> street near 9<sup>th</sup> Avenue. Courtesy: NYC Municipal Archives

During this period, Leonard's and Naughton's counterpart in New York was David Stagg, former assistant of Macvey from 1870 to 1886. Stagg remained as the Superintendent of Buildings and Repairs until his death in 1886. Six buildings constructed during Stagg's tenure still survive; PS 6, PS 107, PS 79, PS 72, PS 36 and PS 48, all of which is located in Manhattan. PS 72 was closed in 1975, and was converted into the Julia de Burgos Cultural Center in 1994 (Fig. 2.1.3).

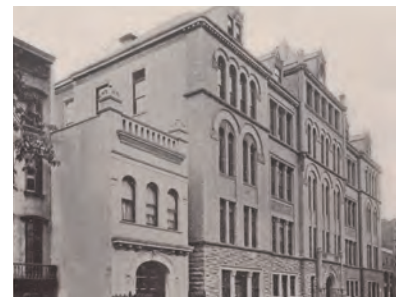
**Fig. 2.2.1 (above) & 2.2.2 (below)**  
Romanesque revival detailing at Jacqueline Kennedy Onassis High School, formerly the High School of Performing Arts on West 47<sup>th</sup> street near Times Square, Completed in 1894. Courtesy: NYC Municipal Archives (Fig.2.2.1), Nelligan White Architects (Fig. 2.2.2)

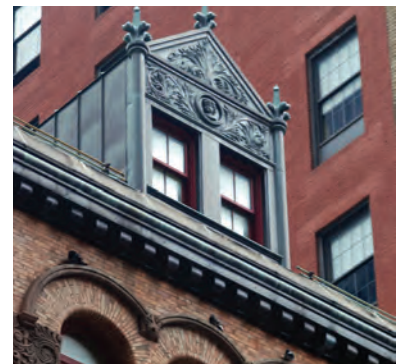
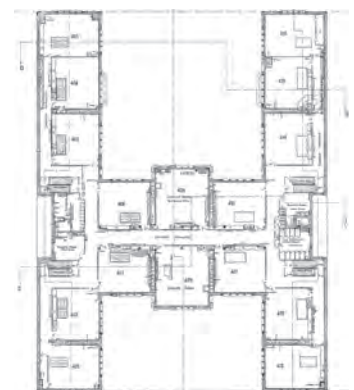
**Fig. 2.2.3**  
PS 150 K, fourth floor plan, completed in 1907 in the East New York neighborhood of Brooklyn. Courtesy: SCA Alchemy

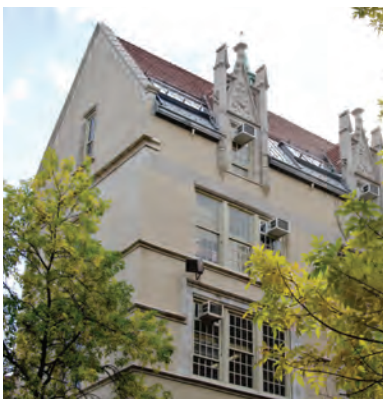
**Fig. 2.2.4**  
French Renaissance/Gothic Composite detailing at PS 171 M, completed in 1900 in the East Harlem neighborhood of Manhattan. Courtesy: Sylvia Hardy

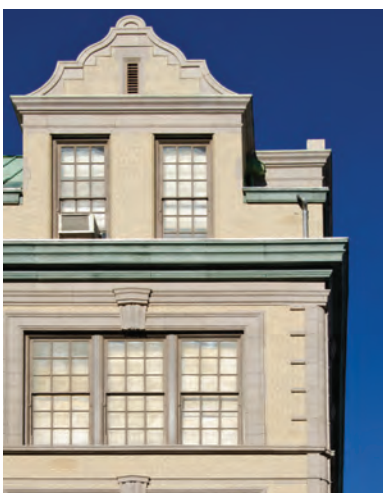
**Fig. 2.2.5**  
Renaissance Revival detailing at PS 277 X, completed in 1897 in the Mott Haven neighborhood in the southern Bronx. Courtesy: Sylvia Hardy

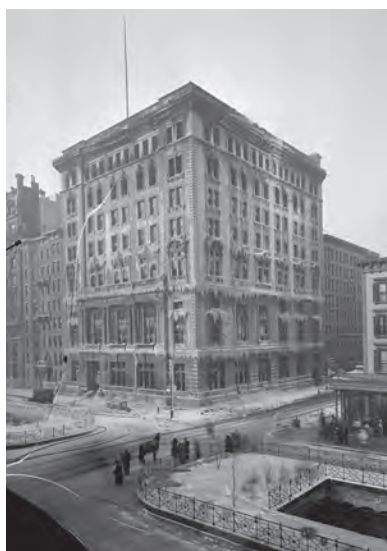
**Fig. 2.2.10**

February 2, 1918 - The morning after a fire ravaged the top three floors of the Hall of the Board of Education. Courtesy: NYC Municipal Archives

On February 1, 1918, less than a year into this new planning initiative, a fire broke out in the Board of Education building (located at 57<sup>th</sup> Street and Park Avenue), which gutted the top three floors (Fig. 2.2.10 & 2.2.11). Unfortunately, the fire destroyed most of the plans that were then being prepared and, also destroyed many other drawings of the Snyder and Pre-Snyder era. This devastating event explains why many of the older drawings are missing from the SCA archives today.

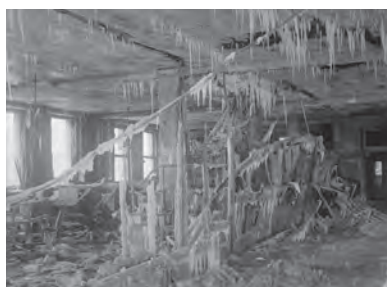
**Fig. 2.2.11**

February 2, 1918 - Icicles hang from the Interior of the Hall of the Board of Education the morning after fire ravaged its top three floors. Drawings of most of the schools existing, in planning and construction were destroyed either from fire directly or water damage. Courtesy: NYC Municipal Archives

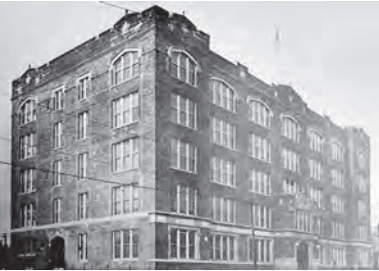
Fig. 2.2.14  
Typical Type-A school. Courtesy: NYC Municipal Archives

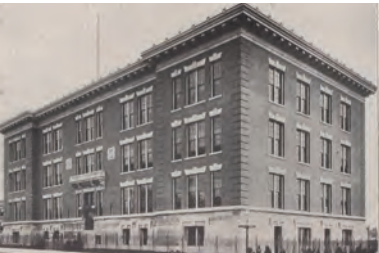
Fig. 2.2.15  
Typical smaller sized Type-A school Courtesy: NYC Municipal Archives

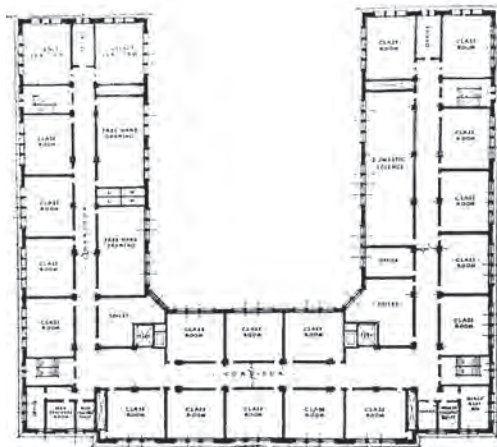
Fig. 2.2.17

Sketches during the early planning of Thomas Jefferson High School in Brooklyn, a U-shaped plan. Courtesy: Board of Education Journal

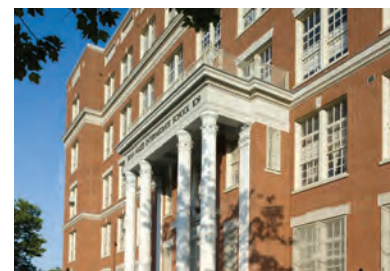
**Fig. 2.3.3**  
PS 121 Q, a prime example of the Type-E school. Courtesy: Sylvia Hardy

As with the interior, the exterior of the building was also redesigned to further meet the objective of standardization, again, continuing the work of Snyder (Fig. 2.3.3). Redesigning the facades also meant rejuvenating the look of the school, which, after years of repetition, had become monotonous to the public eye.

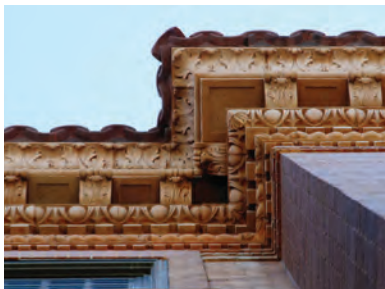
**Fig. 2.4.2**  
PS 89 X. Courtesy: Sylvia Hardy

Another important change that prevailed was the elimination of windows and creation of blank walls at the end pavilions of the principal elevation. This change, combined with the decision to move the cornice (which now included a frieze) up to the roof-line (Fig. 2.4.2, 2.4.3 & 2.4.4), and to rusticate the entire first floor, had a beneficial effect on the overall design of the building. The composition of the main street facade in particular, was rendered more balanced as a result of the solid end-walls that now acted as anchoring devices, and the cornice, which now properly terminates the facade. Thus, while the exterior was simplified, partially to achieve cost savings, the overall design now has a clear look which appeared more coherent.

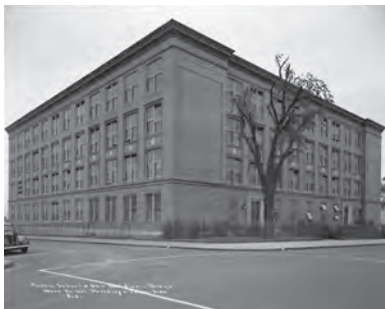
**Fig. 2.4.3**  
PS 89 X. Courtesy: NYC Municipal Archives

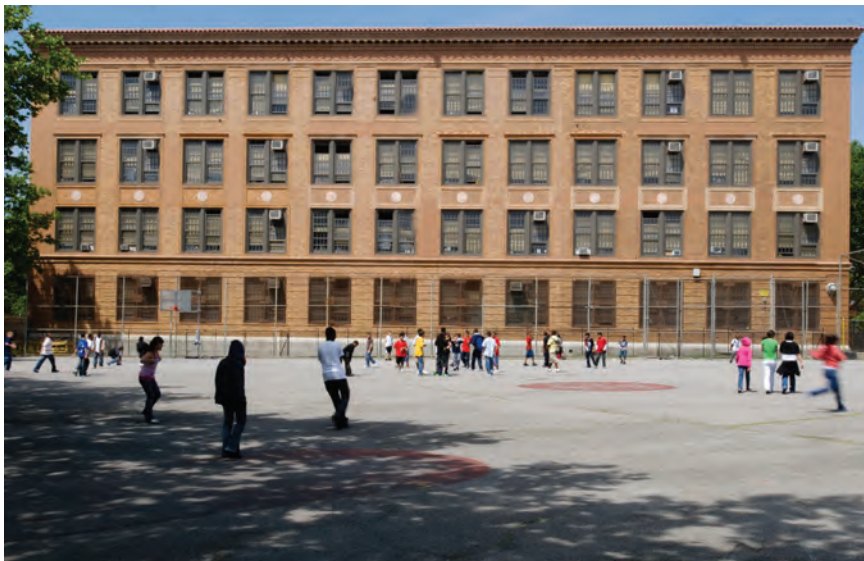
Fig. 2.4.4

**Fig. 2.4.4 (left)**  
PS 89 X. Courtesy: Sylvia Hardy

During this time, the standard Type-E school, which had only recently been introduced by Gompert, underwent further modifications<sup>48</sup>. The new Type-M building that resulted, like its predecessor, was repeatedly erected throughout the city with very slight variation (Fig. 2.4.1 & 2.4.4). Despite the notable differences between the two types, the overall impression is a factory system that emphasizes the need to accommodate as many students as possible, at the expense of variety in design. The sheer number of these schools erected in the 1920s and 1930s, renders them monotonous in their ubiquity, even though the quality of design and construction in these years is not without merit.

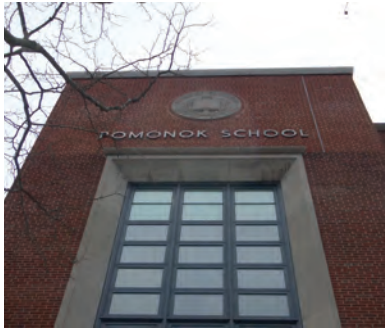
**Fig. 2.5.1**

PS 200 Q, a redbrick mid-century modern type found in the outer boroughs, used early curtain window-wall systems at its entry facades. Courtesy: Nelligan White Architects

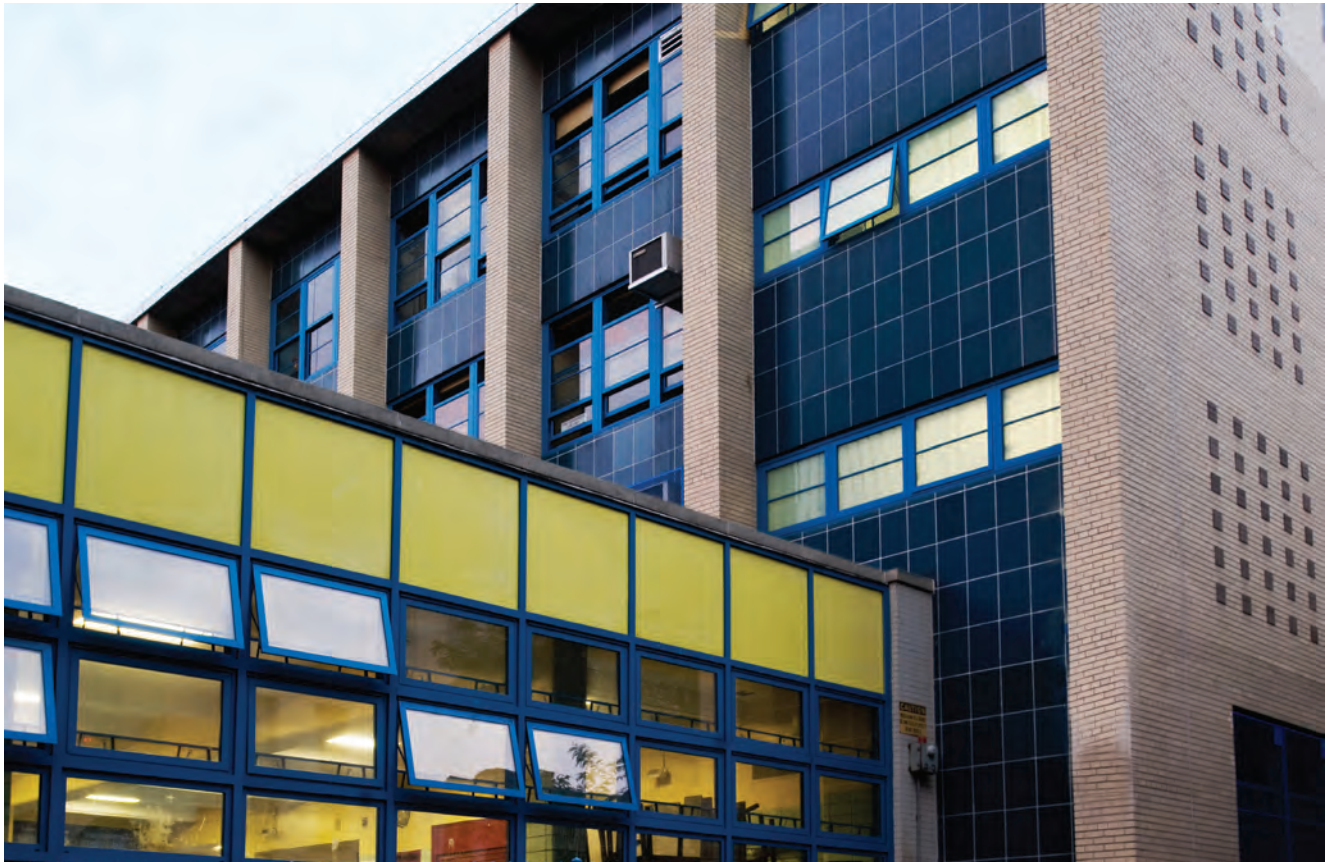
**Fig. 2.7.2**  
PS 111 M from the mid 1950s incorporates metal-panel window wall systems at the lunchrooms, as well as architectural terracotta at a window infill system in the main classroom block. Courtesy: Nelligan White Architects

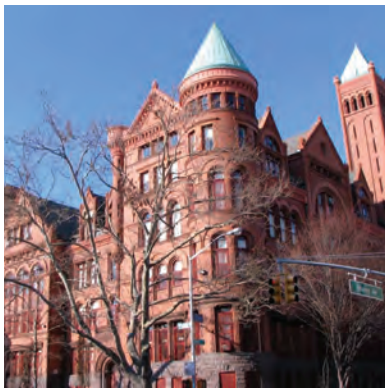
Fig. 3.1.1

Widely considered as one of the premiere Richardsonian Romanesque buildings in New York City, Boys' High School features an abundance of picturesque elements including rounded bays, towers, cupolas, embellished dormers and ornate reliefs around windows and doorways.

Designed by James Naughton and erected in 1891, the Boys' High School in Brooklyn is a prime example of the picturesque schools that still remain in use today (Figs. 3.1.1 & 3.1.2). Boys' High is recognized as a particularly good example of the Richardsonian-Romanesque style, characterized by prominent massing of elements, including rounded bays, towers, a steeply pitched conical roofs, round-arched openings, and contrasting smooth and rough-faced stonework. Technically, Boys' High School was the second school building that was erected as a high school in Brooklyn as the City of New York at this time did not have a high school. The first high school building was built on Nostrand Avenue, between Macon and Halsey Streets in 1886. It accommodated both boys and girls, though the boys division moved to a new building in 1891, while the girls remained in the older building. Thereafter, that building was called Girls' High and still today remains in use as an adult education center.

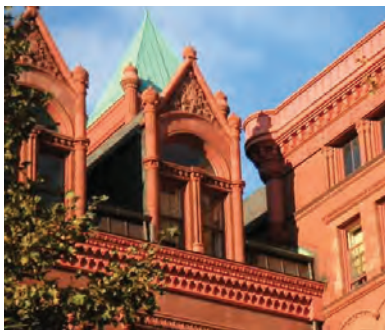
Fig. 3.1.2

Boys' High School in Brooklyn.

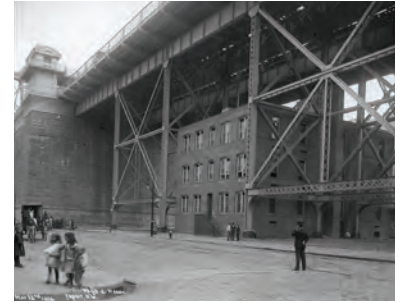
**Fig. 3.1.3**

While many late-19<sup>th</sup> century schools featured ornate designs, not all were so spectacular. This temporary school building dating from the turn of the century, located beneath the Williamsburg Bridge, resembles a tenement rather than a place of higher learning. Courtesy: NYC Municipal Archives

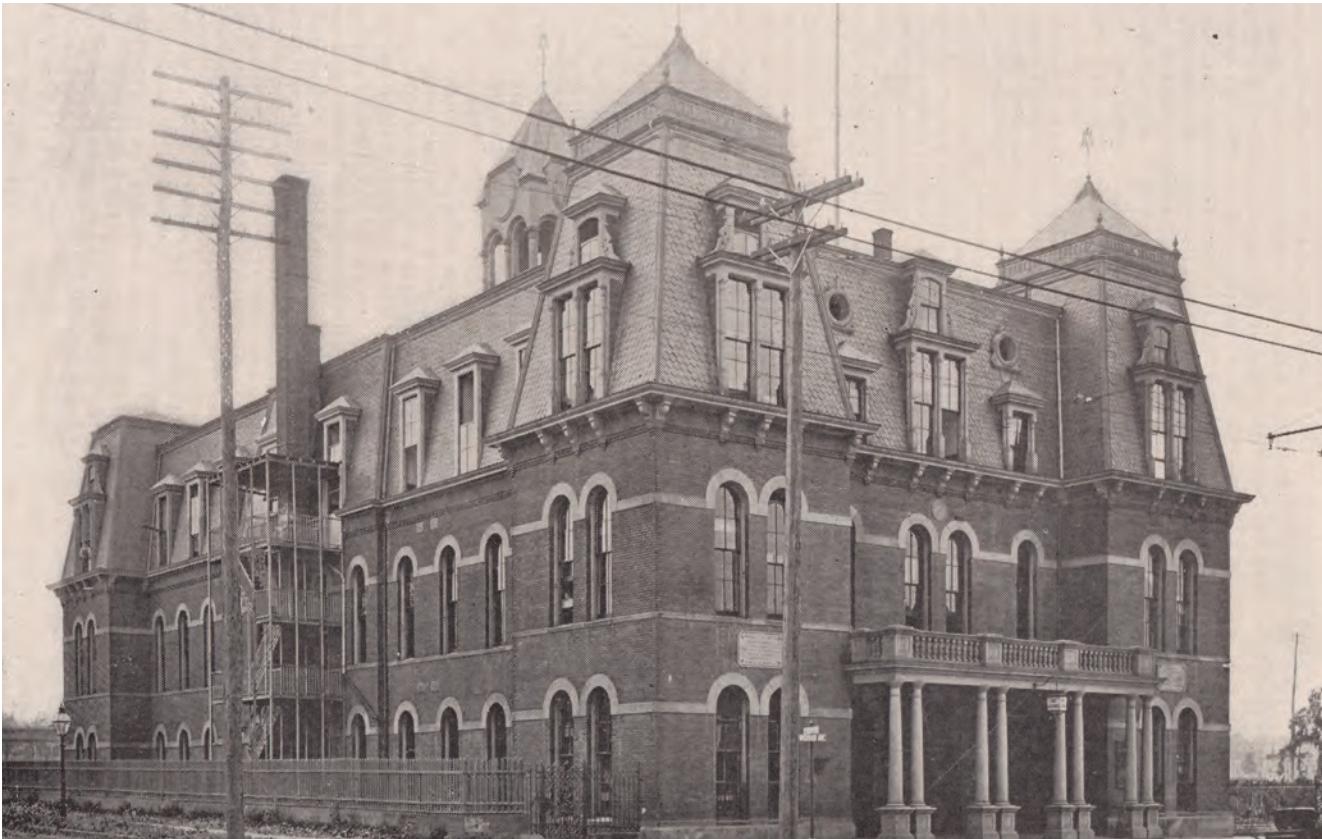
**Fig. 3.2.1**  
PS 5 X, located in the West Bronx, directly adjacent to what is now Fordham Plaza, features Mansard roofs on all sides and corners emphasized by piers capped with spires. There is also a porch at the front as well as a cupola at its center. Courtesy: NYC Municipal Archives

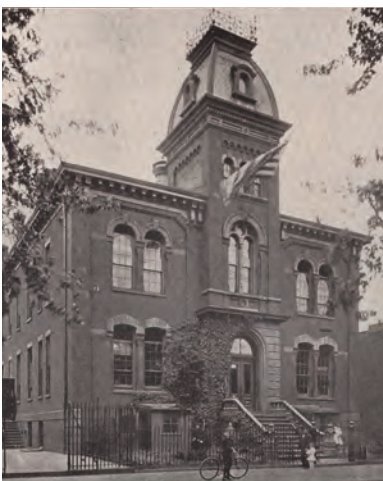
**Fig. 3.2.2 (below)**  
PS 25 K, located in the Williamsburg neighborhood of Brooklyn, features a high central tower along with a Mansard cap. Courtesy: NYC Municipal Archives

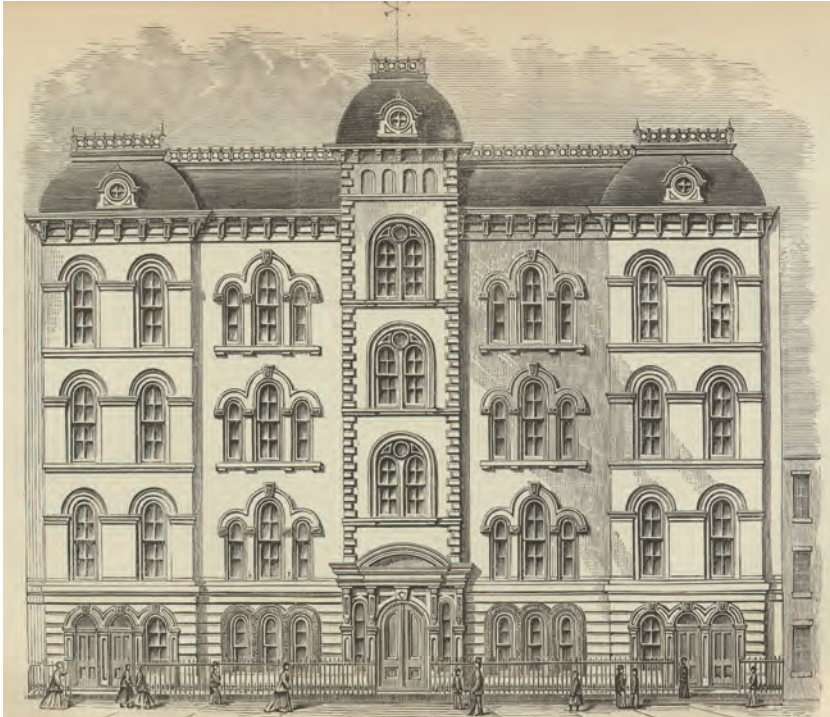
Fig. 3.2.4

**Fig. 3.2.3 (above), 3.2.4 (left) & 3.2.5 (below)**  
 PS 116 M (above), Ward School 26 (left), and PS 117 K (below) feature central towers with Mansard caps, dormers and string courses separating the facade horizontally. Courtesy: NYC Municipal Archives

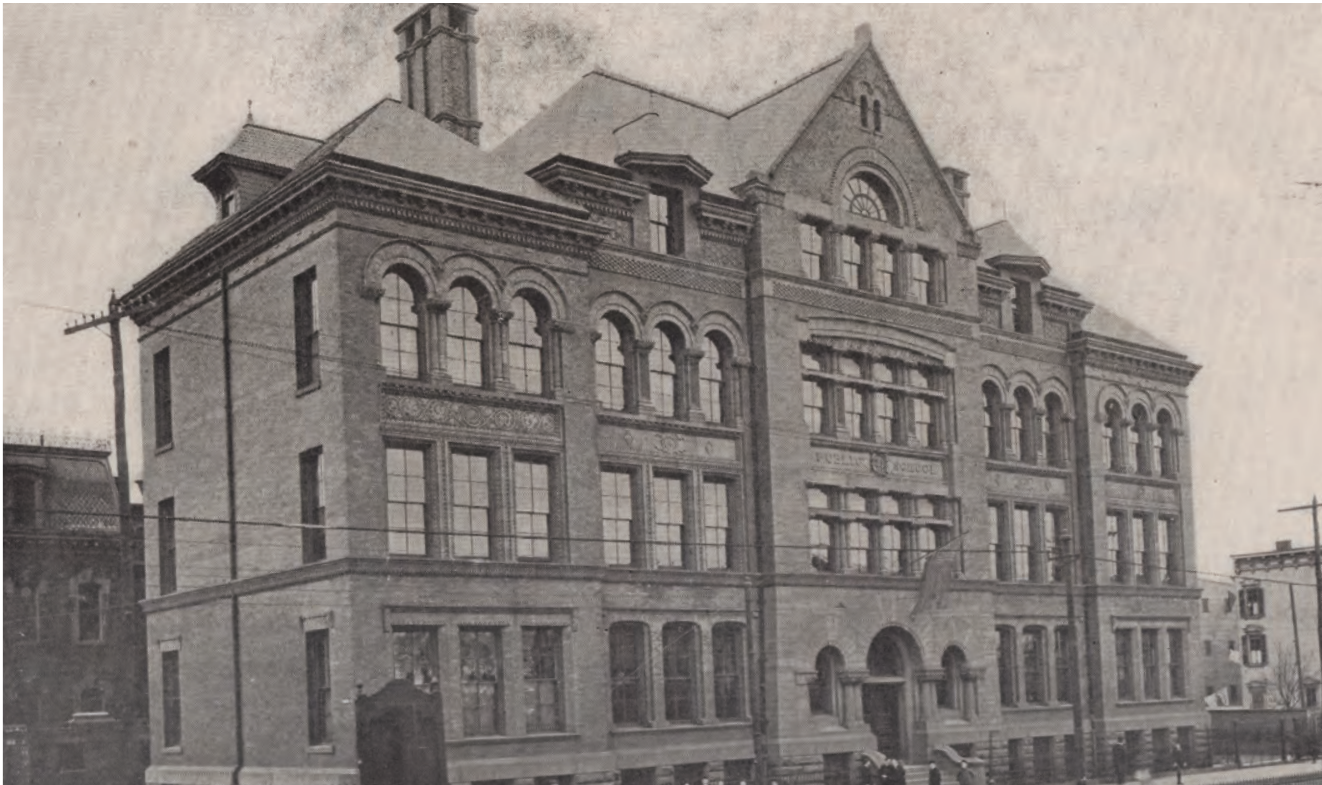
**Fig. 3.3.1**  
Former PS 23 K (demolished), located in the East-Williamsburg neighborhood of Brooklyn features arched windows at the top of each bay, and tall, ornamental chimneys. The roof is complex and steeply sloped, terminating at the front-central bay in a pediment. Courtesy: NYC Municipal Archives

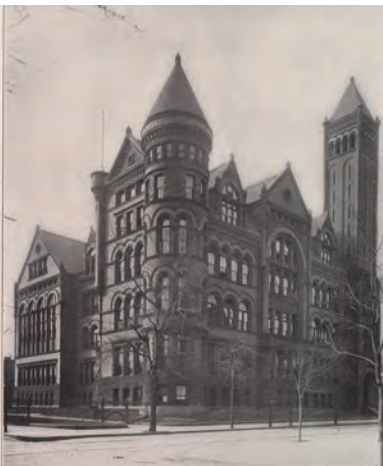
**Fig. 3.3.2 (below)**  
The old Boys' High School (now Brooklyn Academy High School), located in the Bedford-Stuyvesant neighborhood of Brooklyn, is considered one of the most important examples of Romanesque Revival architecture in New York City. Courtesy: NYC Municipal Archives

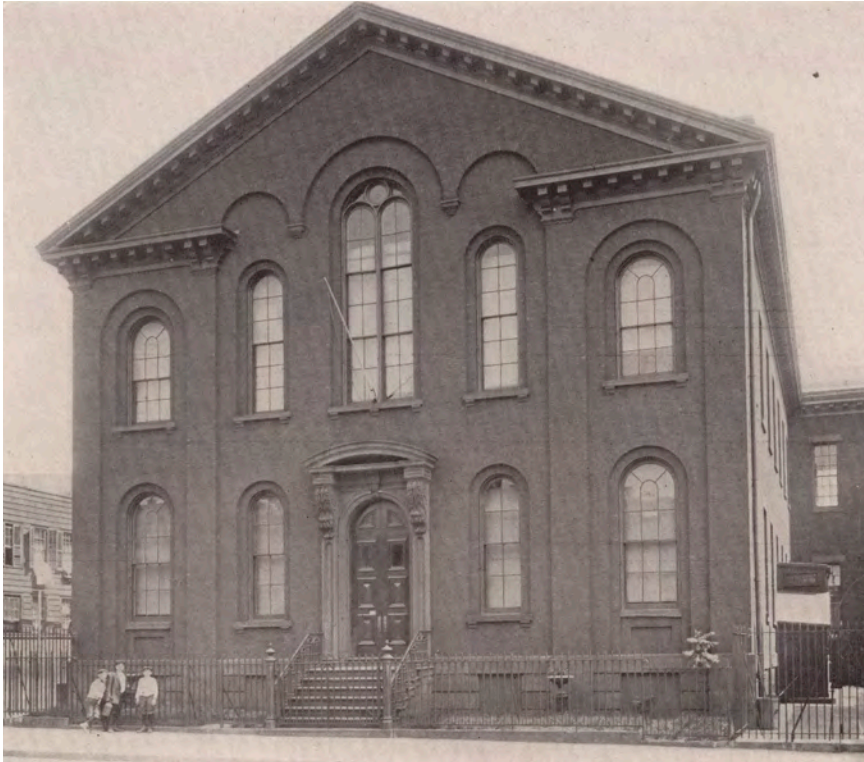
Fig. 3.3.4

**Fig. 3.3.3 (above), 3.3.4 (left) & 3.3.5 (below)**  
Jacqueline Kennedy Onassis High School near Times Square in Manhattan (above), P.S. 38 K (left), and P.S. 116 K in Bushwick, Brooklyn (below) are both typically Romanesque Revival, with rounded windows at the top of bays as well as complex, steeply pitched roofs. Courtesy: Nelligan White Architects (Fig. 3.3.3), NYC Municipal Archives (Fig. 3.3.4 & 3.3.5)

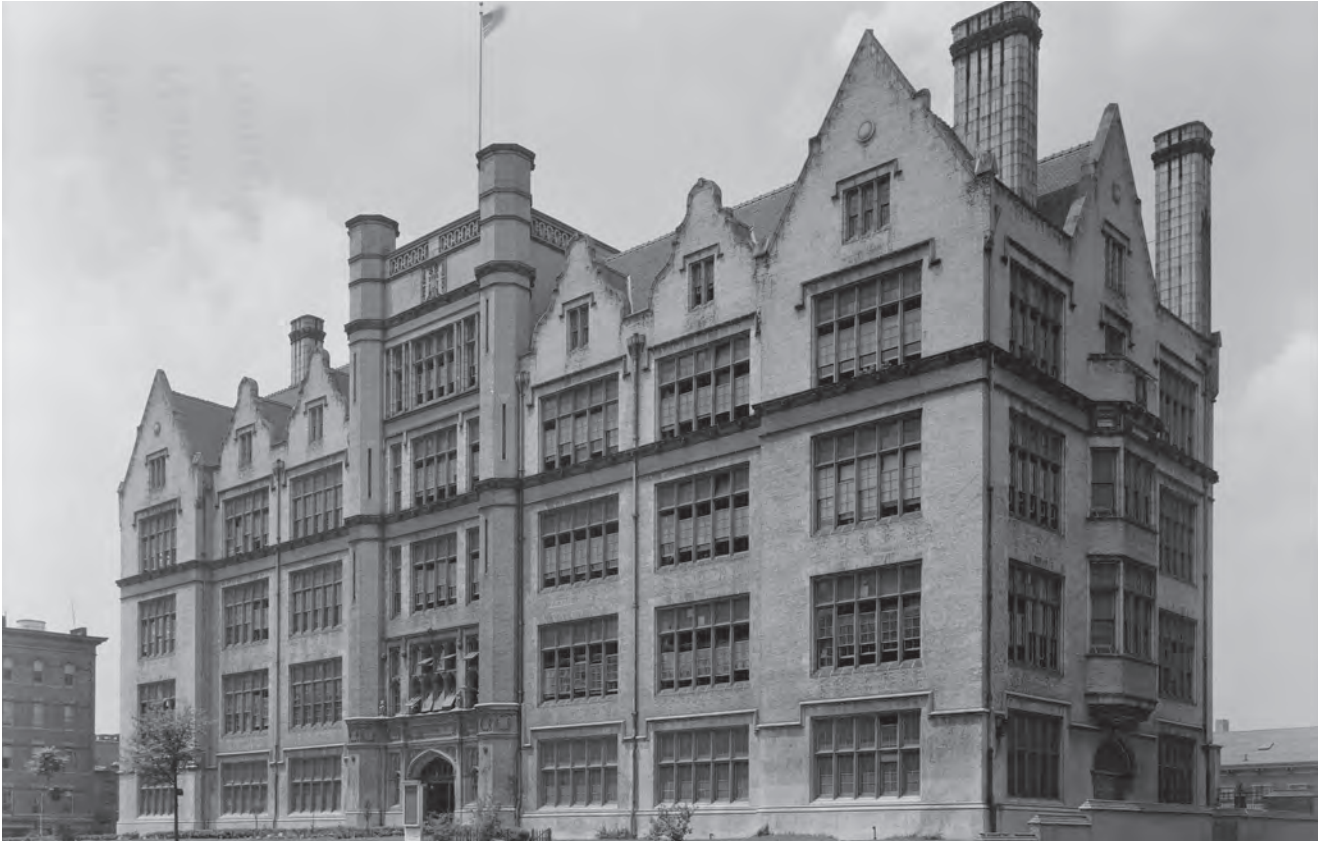
**Fig. 3.4.1**

The innovative Renaissance style of former PS 31 X in the Southern Bronx may be attributed to C.B.J. Snyder's 6 month tour of Europe, funded by the Board of Education, to study successful school design. Snyder visited London, Brussels, Paris, and many cities in Germany. Courtesy: NYC Municipal Archives

The Renaissance Revival styles are best associated with public schools built between the years 1891-1910. By the mid 1890s, C.B.J. Snyder's stylistic schemes began to reflect a popular shift, away from Romanesque and Queen Anne revival towards Classical Revivalism, known as the '*American Renaissance*'. PS 31 X is a strikingly well-composed example of this shift in architectural style. Snyder was especially drawn to renaissance architecture in northern Europe, where he studied school design on a six-month tour, funded by the Board of Education. The characteristic features of the English-Renaissance Revival buildings include Flemish style gables, high chimneys, prominent central tower, and Tudor-Gothic entrances window details.

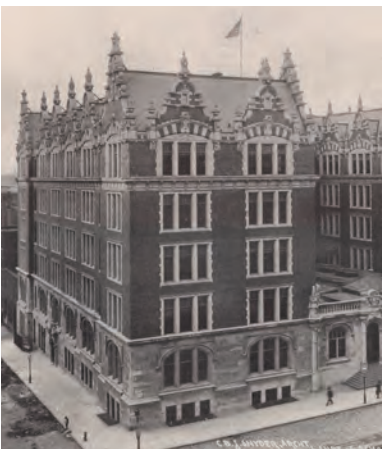
**Fig. 3.4.2 (below)**

The old Dewitt Clinton High School (now the Haaren Hall of the John Jay College of Criminal Justice) in the Hell's Kitchen neighborhood of Manhattan, features high-Flemish Renaissance-style parapets, centered at the head of each window bay. Courtesy: NYC Municipal Archives

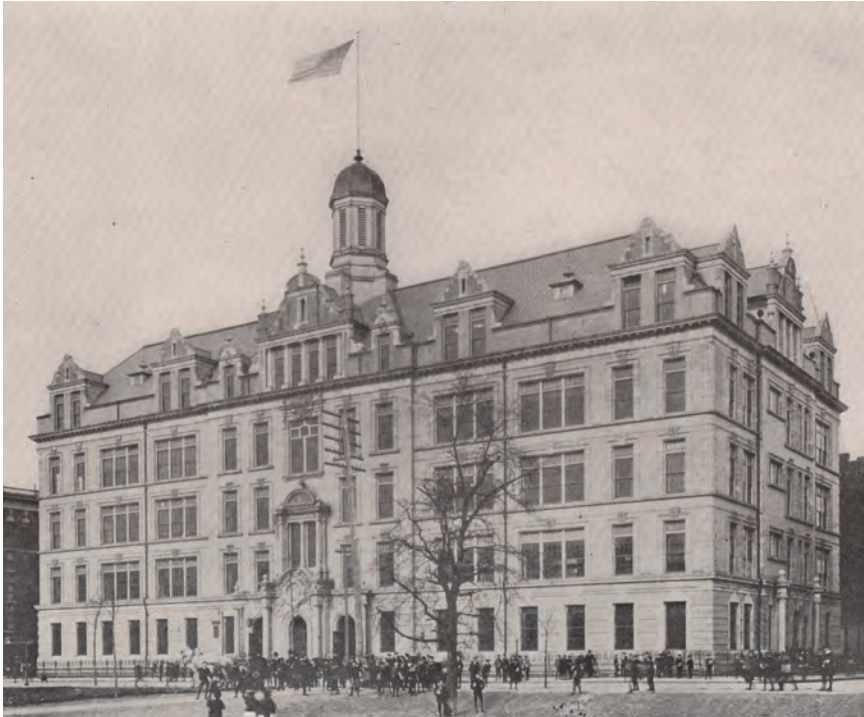
Fig. 3.4.4

**Fig. 3.4.3 (above), 3.4.4 (left) & 3.4.5 (below)**  
 PS 27 X in the Mott Haven neighborhood of the Bronx (above - left) and former PS 150 M (now the Life Sciences Secondary School) (below) on Manhattan's Upper East Side feature Flemish-style gables and parapets, and Renaissance detailing across the facade including cornices, window surrounds and quoins. Courtesy: NYC Municipal Archives (Fig. 3.3.4 & 3.4.5), Sylvia Hardy (Fig. 3.4.3)

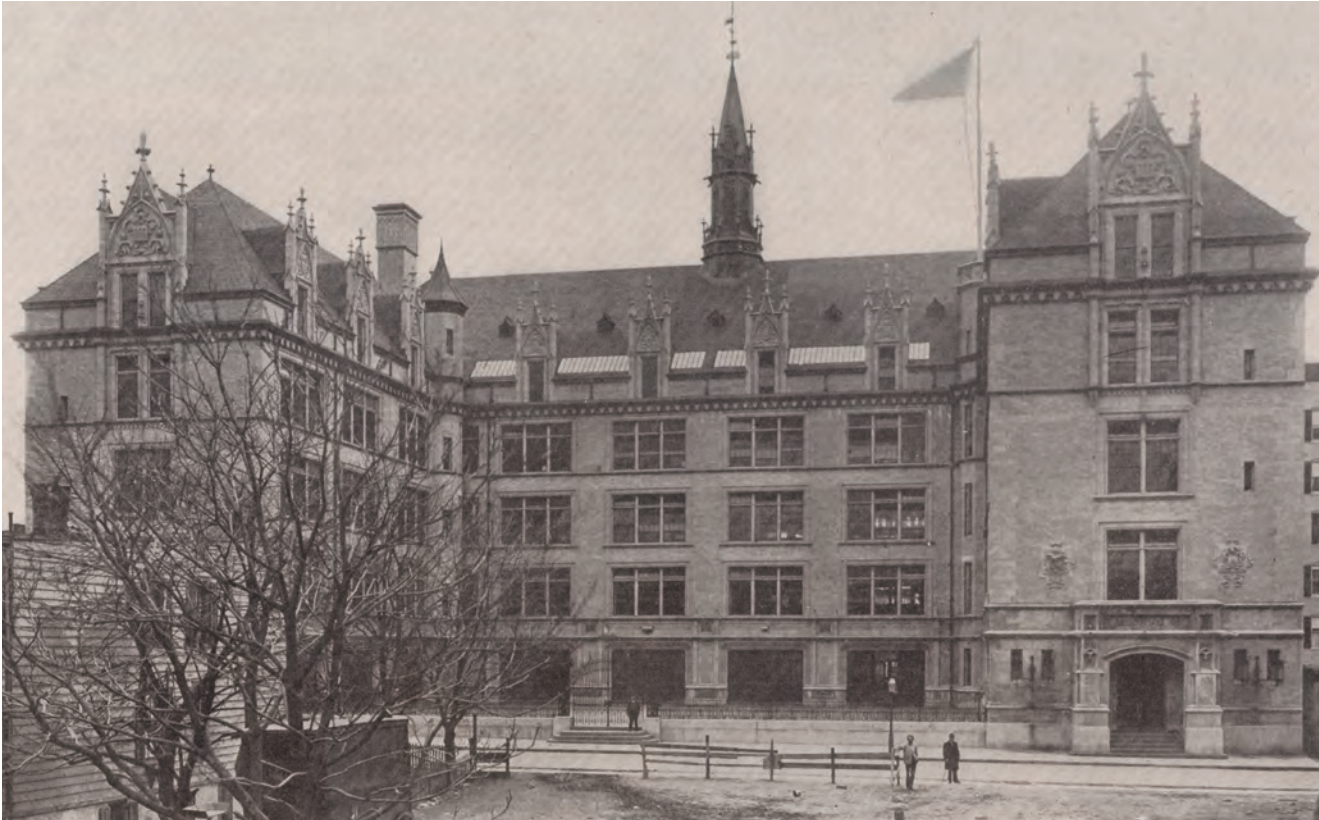
**Fig. 3.5.1**

The innovative Renaissance styles of PS 165 M on Manhattan's Upper West Side may be attributed to C.B.J. Snyder's six-month tour of Europe, funded by the Board of Education, to study successful school design. Snyder visited London, Brussels, Paris, and many cities in Germany. Courtesy: NYC Municipal Archives

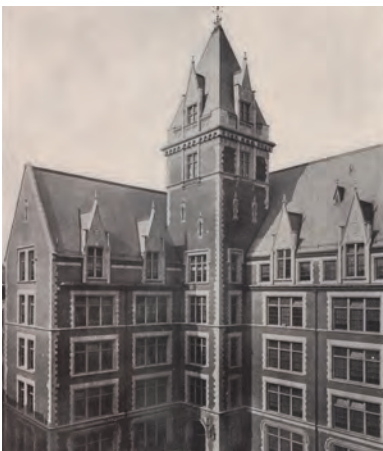
**Fig. 3.5.2 (below)**

The Wadleigh High School (now a secondary school) on Manhattan's Upper West Side, features Gothic inspired dormers, steeply pitched roofs, and spires reminiscent of churches throughout France. Courtesy: NYC Municipal Archives

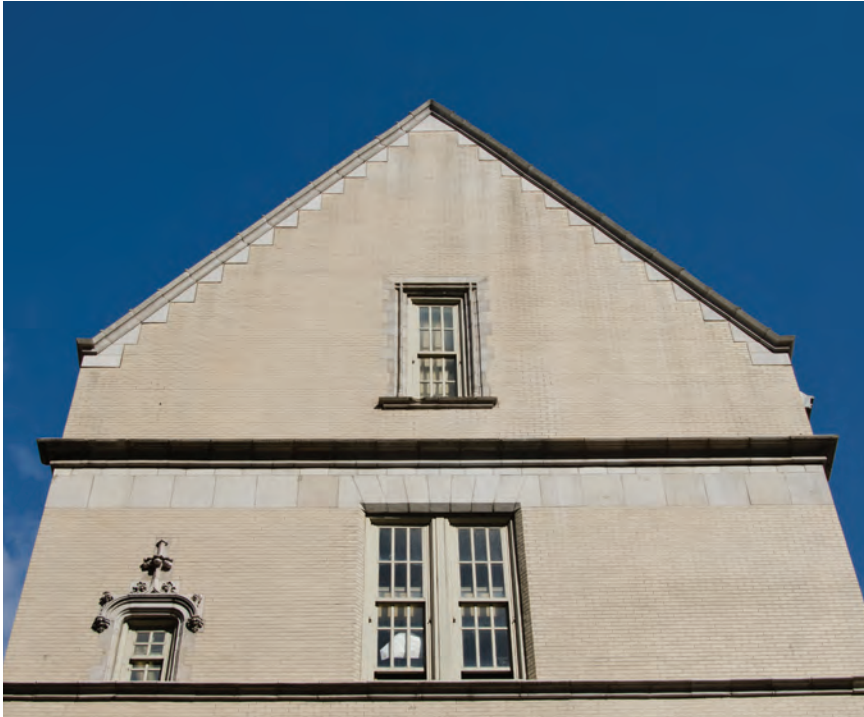
Fig. 3.5.4

**Fig. 3.5.3 (above), 3.5.4 (left) & 3.5.5 (below)**  
 PS 171 M (above - left - below) located in East Harlem in Manhattan features a steeply pitched tile roof and multiple spires which originally served as exhaust for the building's ventilation systems. Courtesy: NYC Municipal Archives (Fig.3.5.5), Sylvia Hardy (Fig. 3.5.4 & 3.5.5)

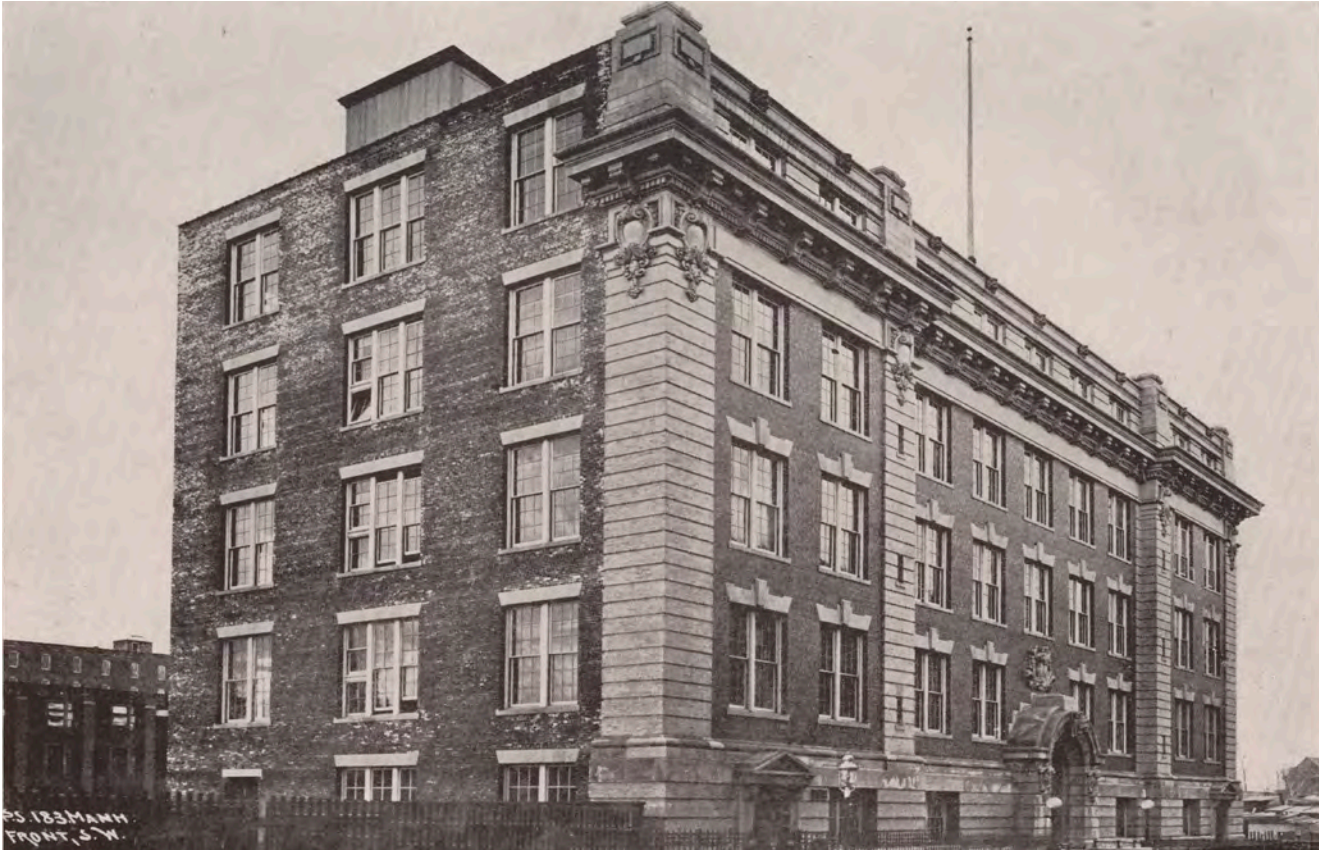
**Fig. 3.6.1**

P.S. 183 M, located on Manhattan's Upper East Side, originally featured a massive cornice across its front, and large pilasters across the front facade. The base uses the same channeled rustication as the pilasters. Courtesy: NYC Municipal Archives

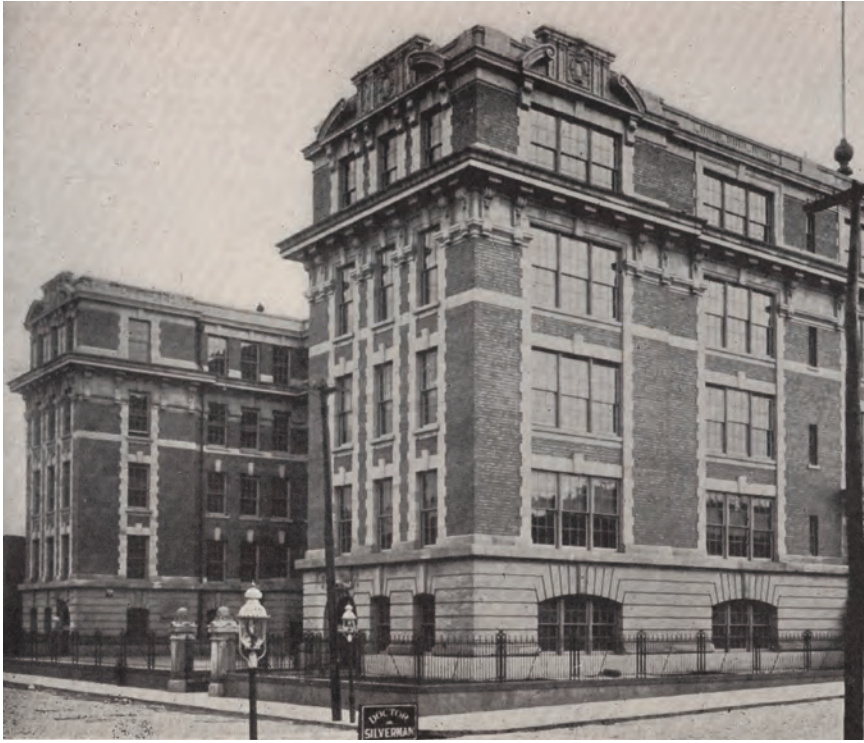
Fig. 3.6.4

**Fig. 3.6.3 (above), 3.6.4 (left) & 3.6.5 (below)**  
PS 84 Q (above) in the Ditmas neighborhood of Queens, PS 149 K (left) in East New York, and PS 158 M (below) in the Yorkville neighborhood of Manhattan, both differ in their appearance, although they feature the channeled rustication, quoins, and intricate sculptural detailing associated with the Beaux-Arts style. Courtesy: NYC Municipal Archives (Fig.3.6.4 & 3.6.5), Nelligan White Architects (Fig. 3.6.3)

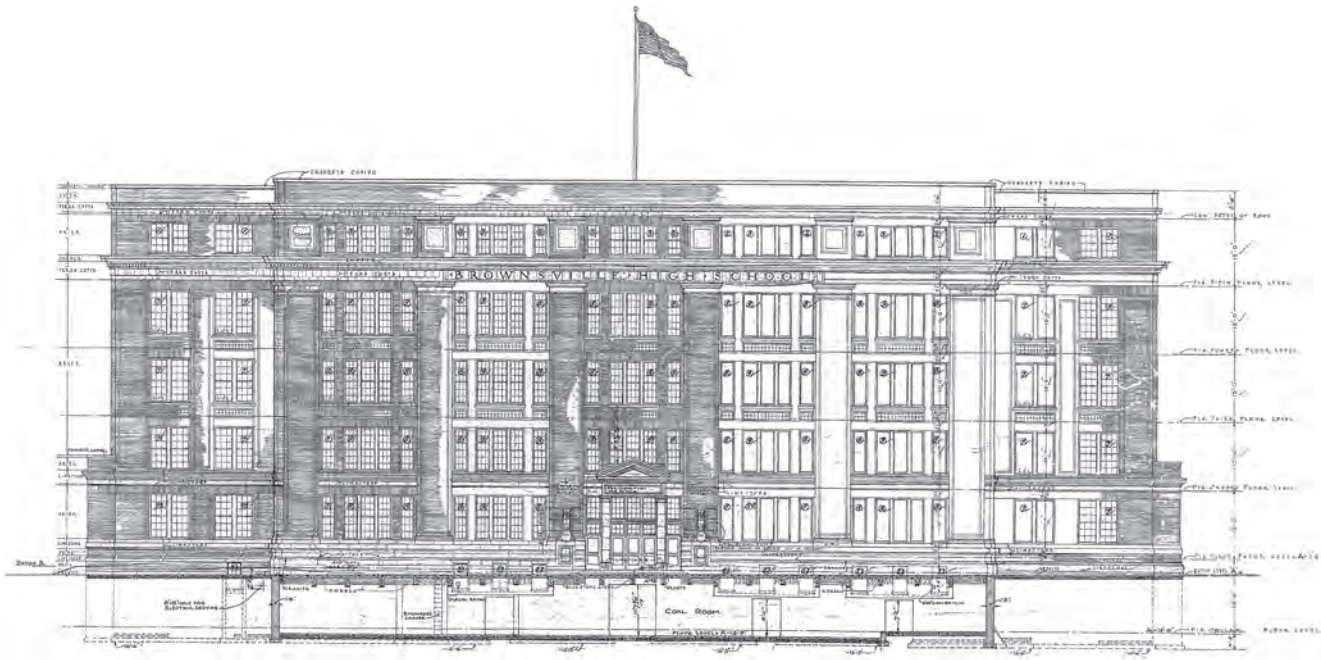
**Fig. 3.8.1**

Originally designed as the Brownsville High School under C. B. J. Snyder, the building was constructed under William H. Gompert. The completed school was renamed Thomas Jefferson High School. This patriotic emphasis is consistent with Gompert's design approach, as his original school designs referenced Colonial-American vernacular architecture. Courtesy: NYC Municipal Archives

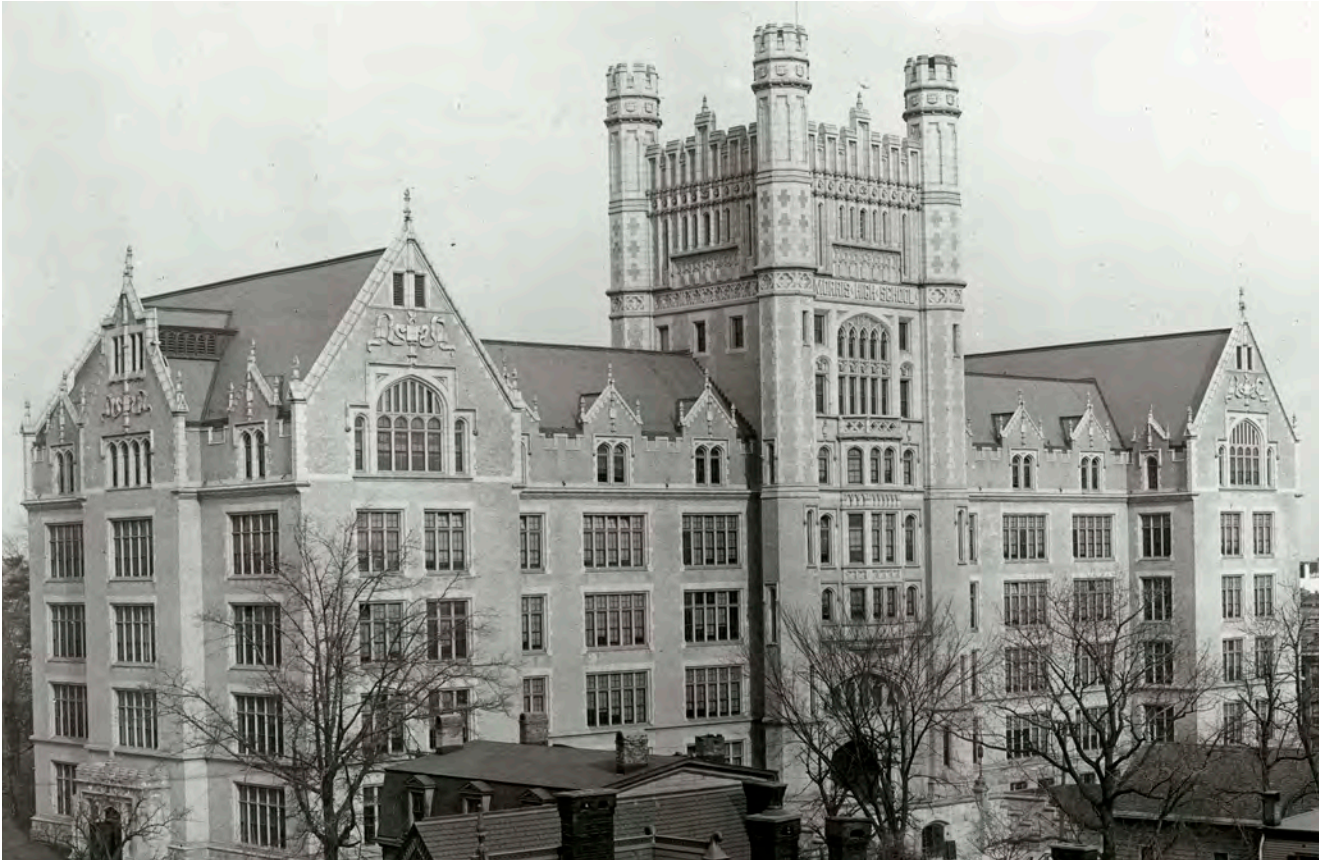
Fig. 3.9.1

Morris High School in the southern Bronx (above) and Flushing High School (below) in Queens, both feature High-Gothic Revival elements and massing. The central tower above the main entrance is reminiscent of the buildings found at many of America's most prestigious universities. This was one of the many styles employed with the intention of inspiring students to continue in their education at a time when most Americans did not attend high school. Courtesy: NYC Municipal Archives

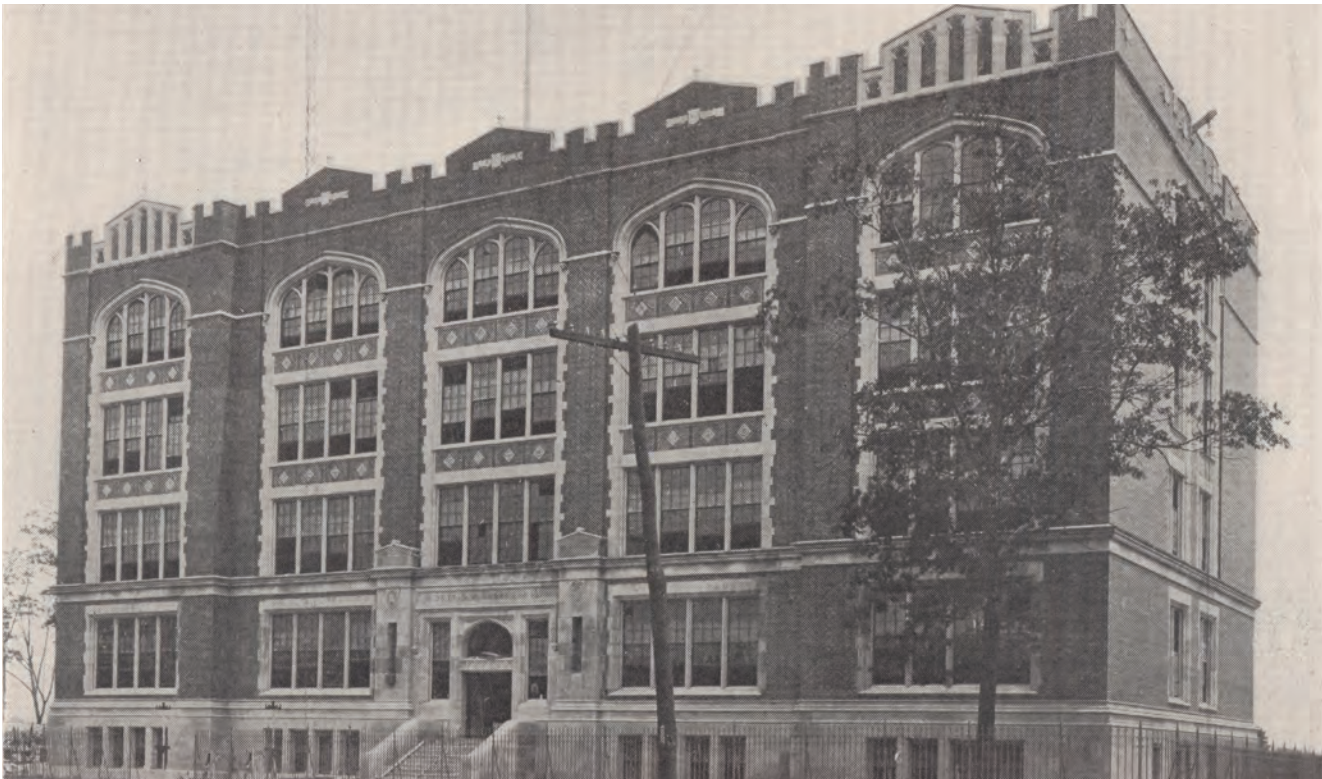
**Fig. 3.10.1**

PS 160 K in the Borough Park neighborhood of Brooklyn features a crenelated parapet and pointed arches at the top of each window bay. The Gothic Revival style was meant to be reminiscent of the buildings found at many of America's most prestigious universities, however the rapid demand of schools meant that ornament at many of these buildings was kept to a minimum. Courtesy: NYC Municipal Archives

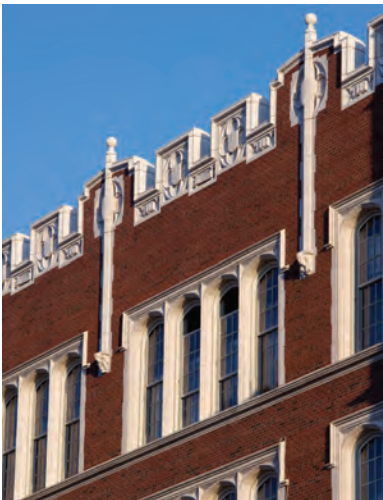
**Fig. 3.10.2 (below)**

PS 48 X in the Hunts Point neighborhood of the Bronx features a red brick facade and limestone/terracotta ornamentation at the crenelations and window surrounds. Courtesy: Sylvia Hardy
