# New York City's Historic Schools

A History and Guide to Rehabilitation

NYC SCHOOL CONSTRUCTION AUTHORITY

This Guide has been developed as a practical and technical resource to assist in the evaluation and design for the restoration of historic school buildings (more than 45 years old). It is worth noting that over half of our public school buildings are more than 60 years old! It is our intention to facilitate strategies for these projects that will target cost effective solutions while at the same time respecting their historic standing as landmarks in the community.

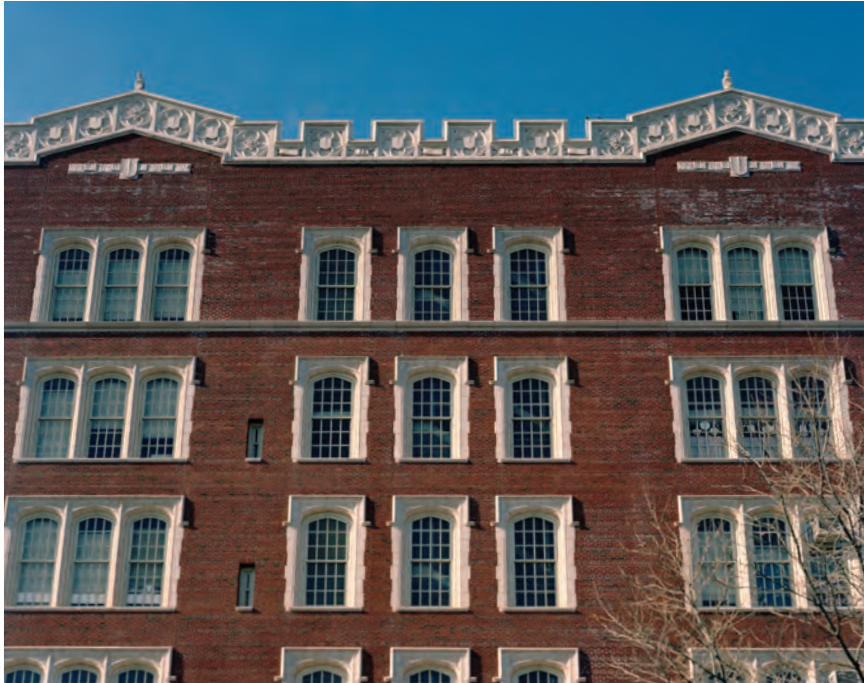
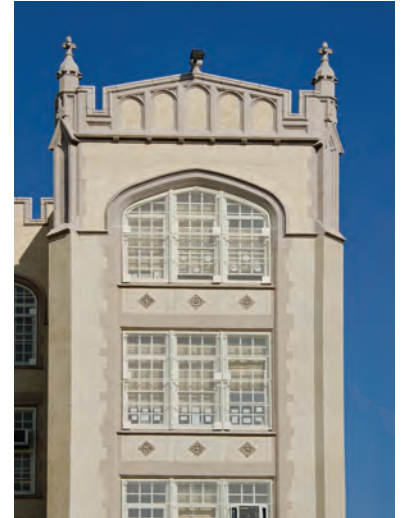
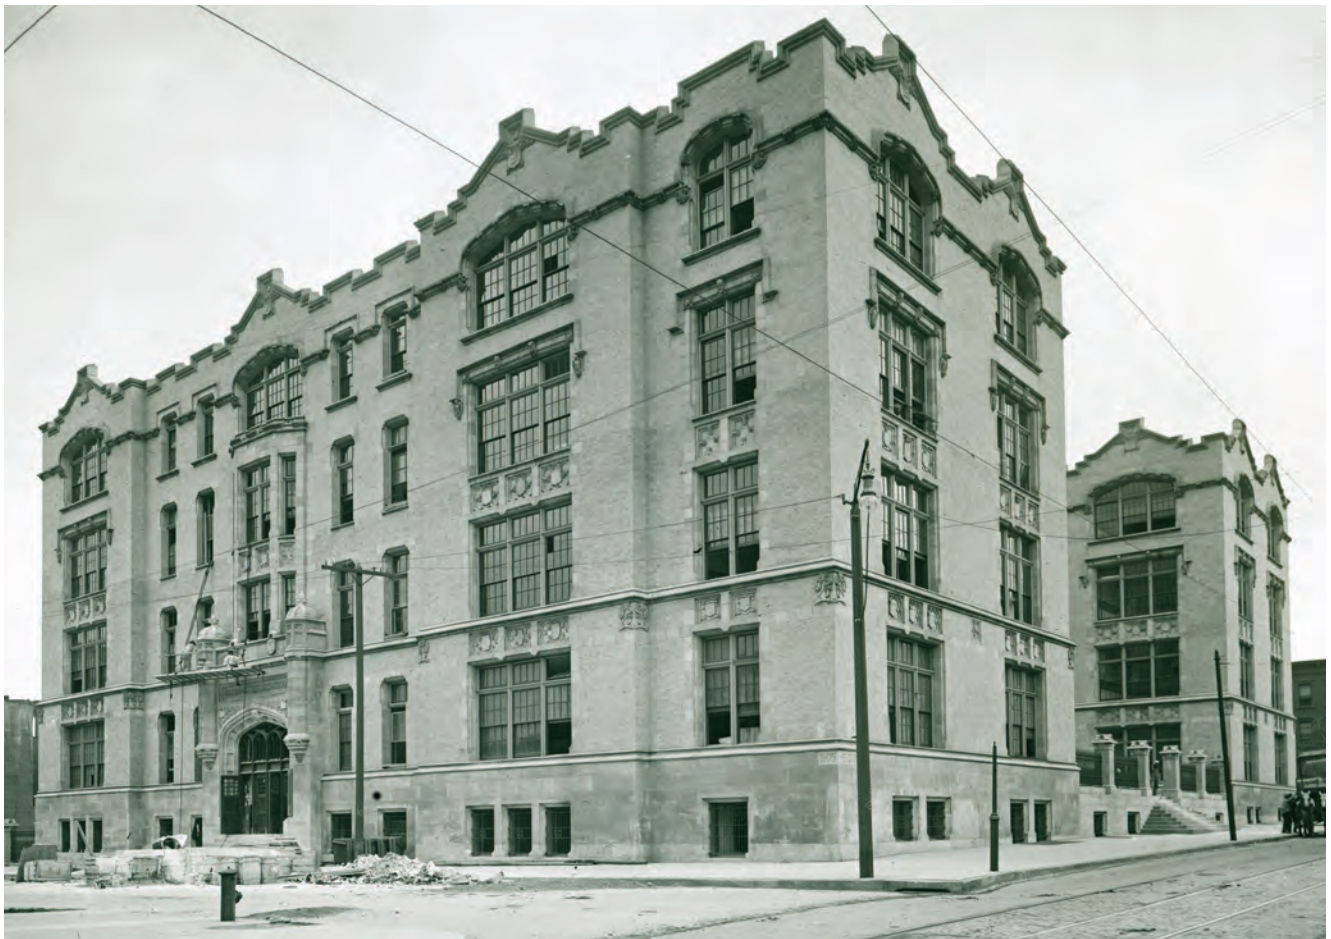
**Fig. 3.10.3 (above), 3.10.4 (left) & 3.10.5 (below)** IS 77 Q in Ridgewood, Queens, PS 48 X in Hunts Point, and the former Eastern District High School in Williamsburg in Brooklyn, both feature pointed arch windows and crenelated parapets. Courtesy: Sylvia Hardy (Fig. 3.10.3 & 3.10.4), NYC Municipal Archives (Fig. 3.10.5)

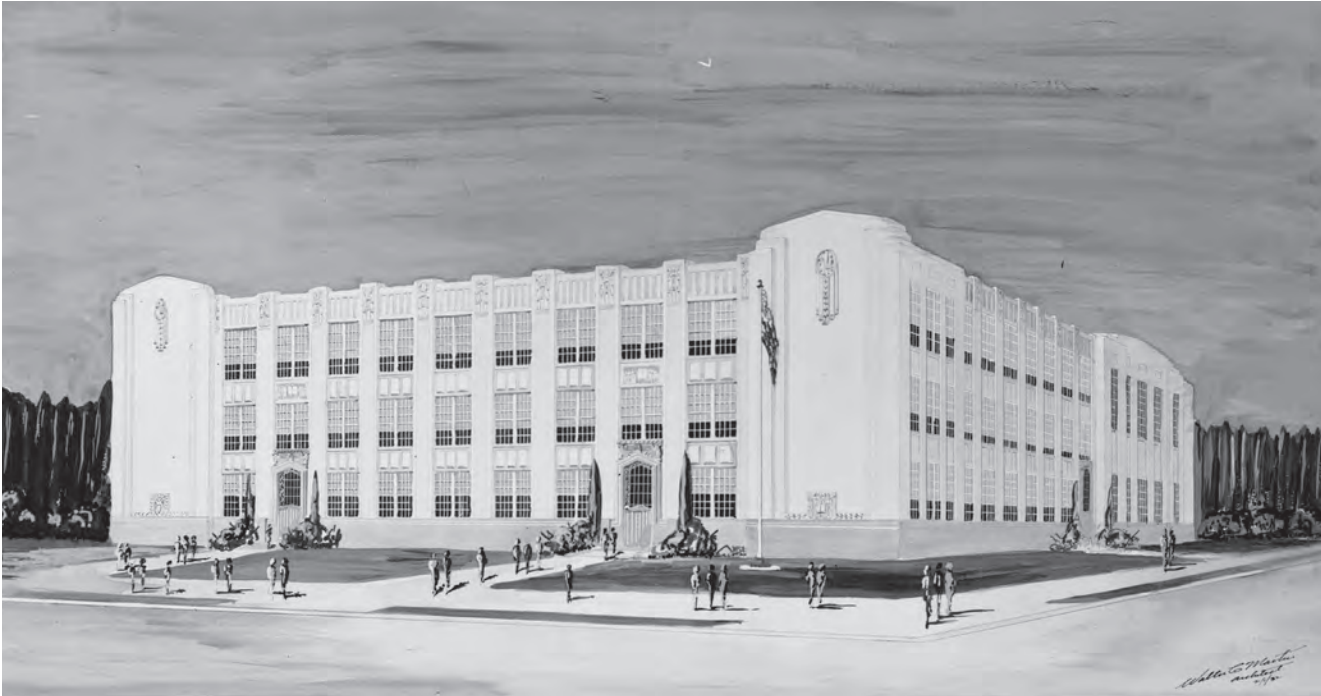
**Fig. 3.11.1**

Rendering of the original design of PS 48 Q, located in Jamaica, Queens. Courtesy: NYC Municipal Archives

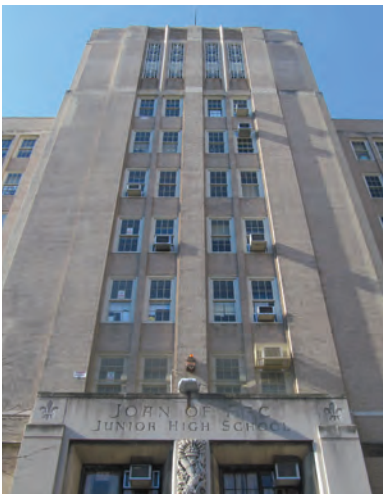
**Fig. 3.11.2 (below)**

Located on Manhattan's Upper West Side, PS 333 M (also known as the Manhattan School for Children, formerly the Joan of Arc Junior High School) is a high-rise Art Deco school building completed in 1940. Designed by Eric Kebbon, its features include emphasis on verticality and abstracted relief work at the entry. Courtesy: Nelligan White Architects

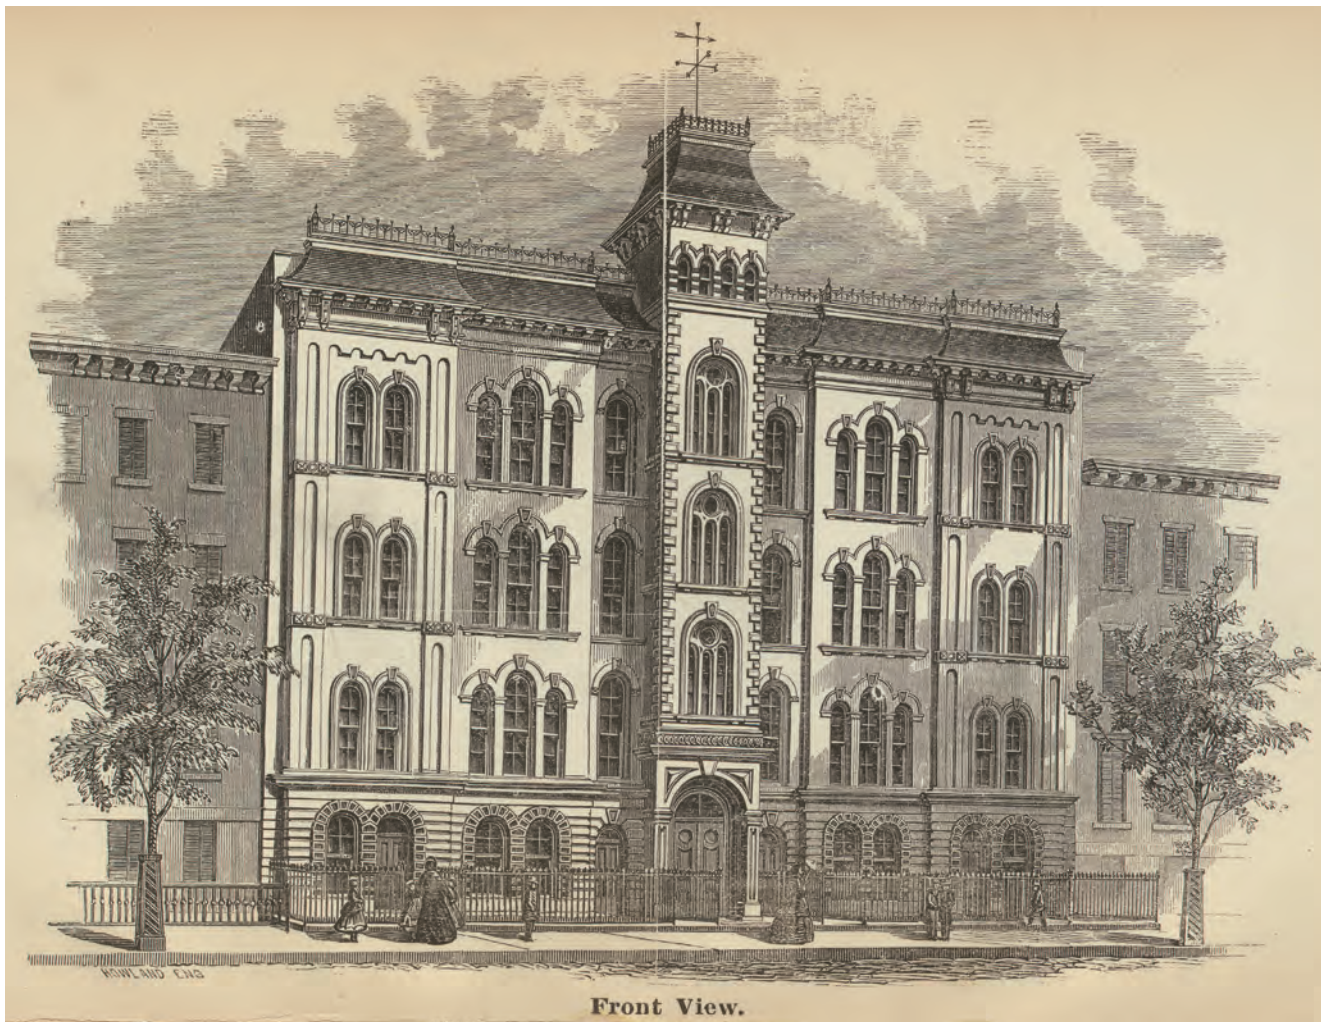
**Fig. 4.2.2 (overleaf-above), 4.2.3 (overleaf-bottom left) & 4.2.4 (overleaf-bottom right)**  
Grammar School 56 - 1869  
West 18<sup>th</sup> Street between 8<sup>th</sup> and 9<sup>th</sup>  
Courtesy: NYC Municipal Archives

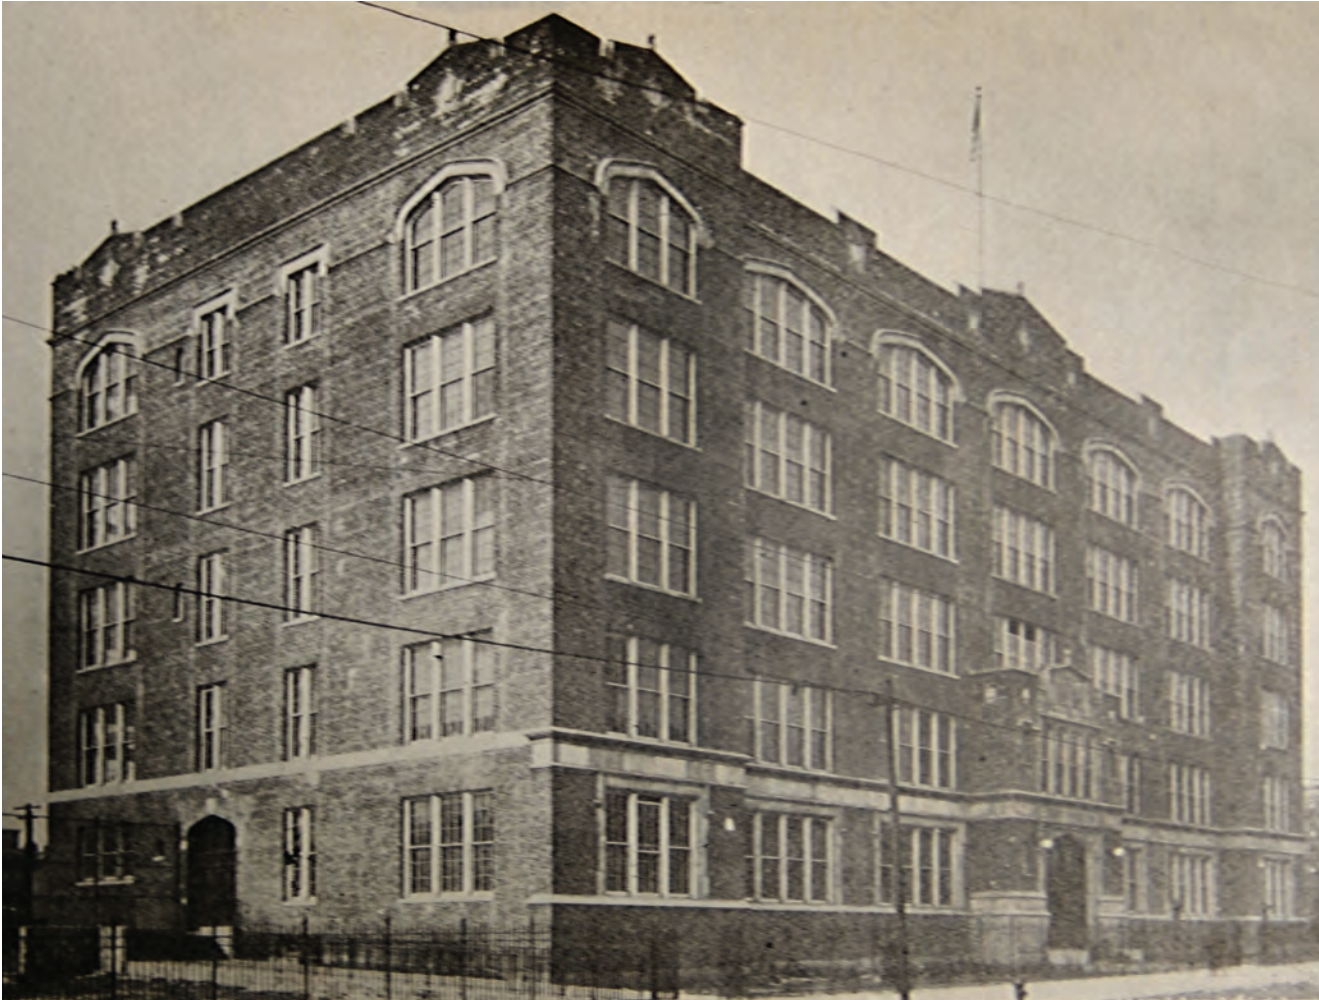
**Fig. 4.4.1 (above)**  
A typical 48 classroom Type-A school in Simplified Gothic styling. Courtesy: Board of Education Journal

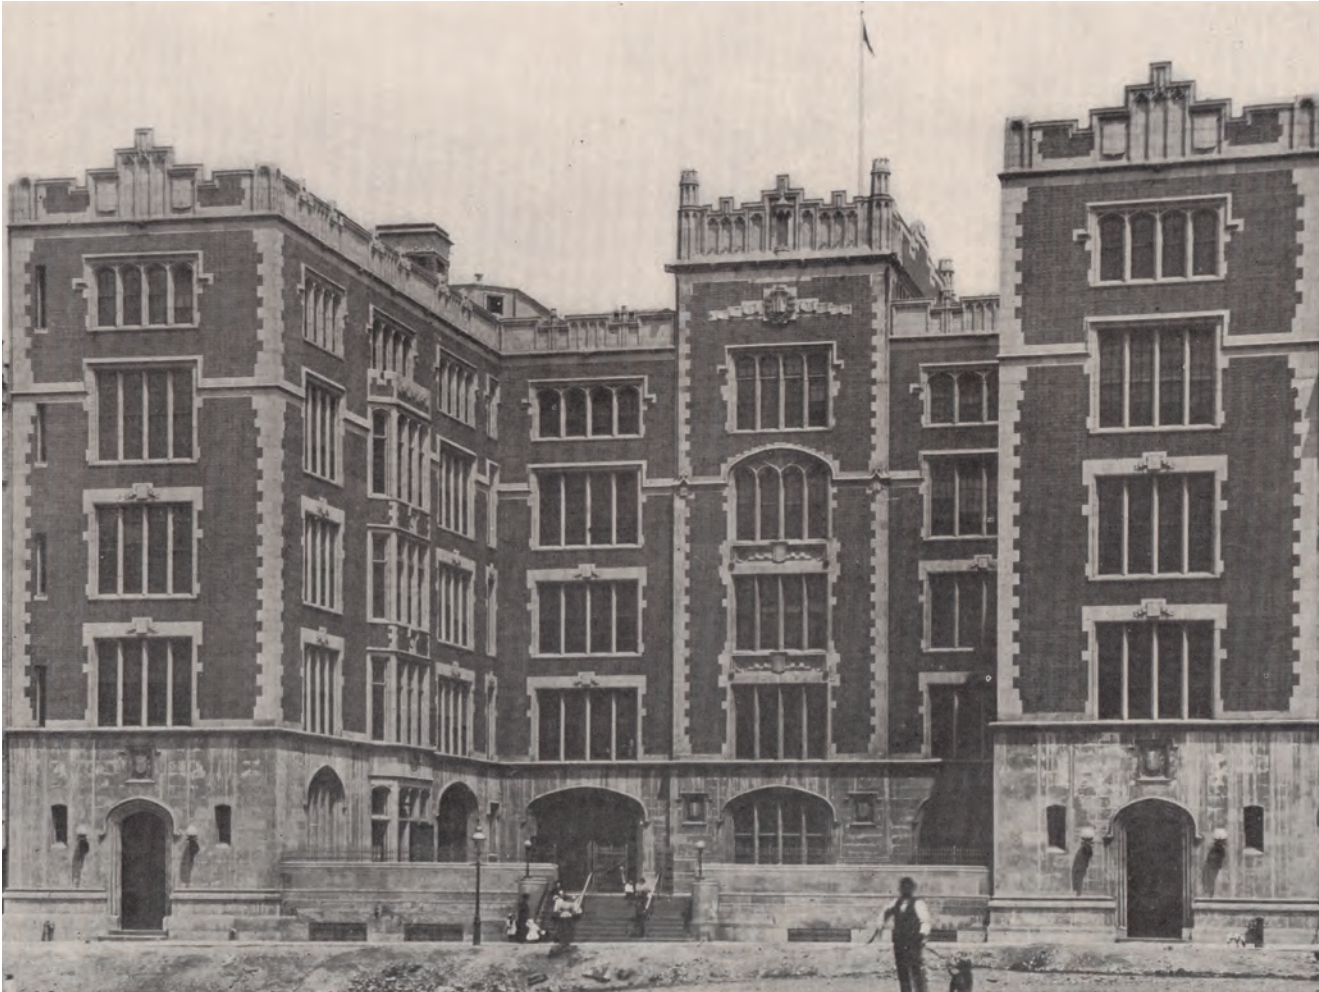
**Fig 4.5.1 (above)**

PS 90 M located in Upper Manhattan, is no longer a public school building, but is a prime example of the H-Plan configured with the English-Flemish Renaissance Revival style. Courtesy: NYC Municipal Archives

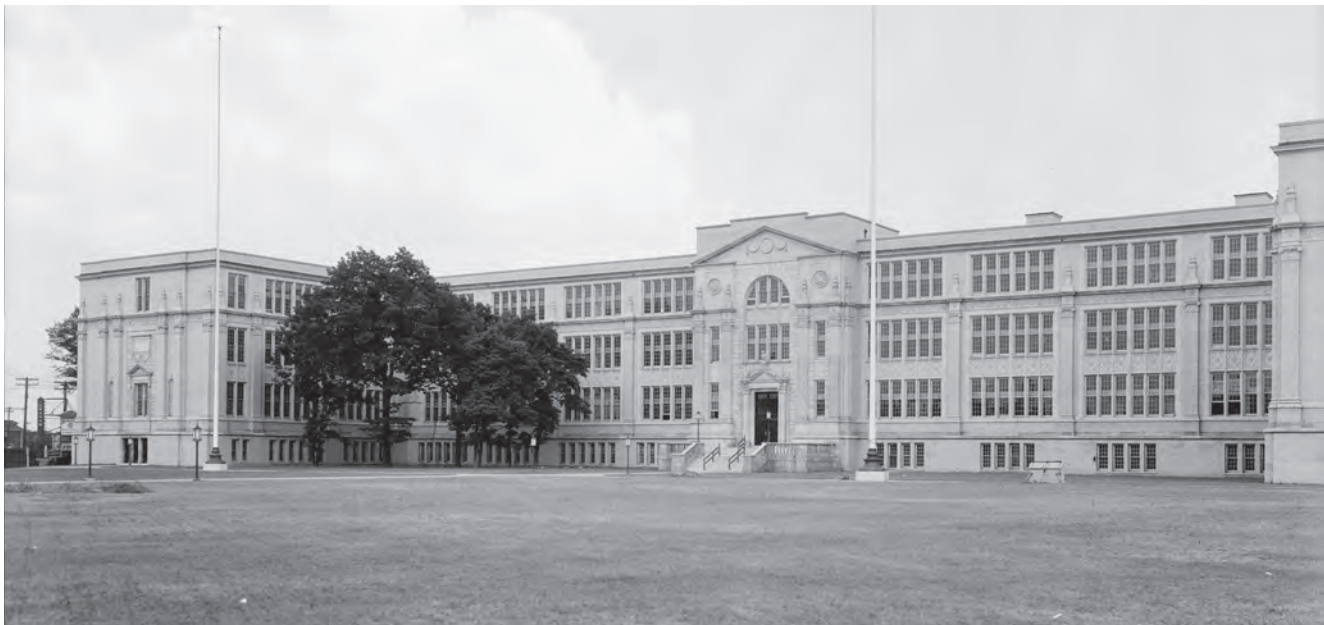
Fig. 4.9.1

**Fig. 4.9.1 (far above) & 4.9.2 (above)**  
Far Rockaway and John Adams High School utilized the same plans. Courtesy: NYC Municipal Archives

Found only in the outer boroughs where people were moving, land was cheap, and more space was available, this plan type resembles a sprawling campus, rather than a single building. These high schools were built from one set of plans, a cost saving measure devised during the depression of the 1930s. This accounts for the startling similarity between all schools of this type.

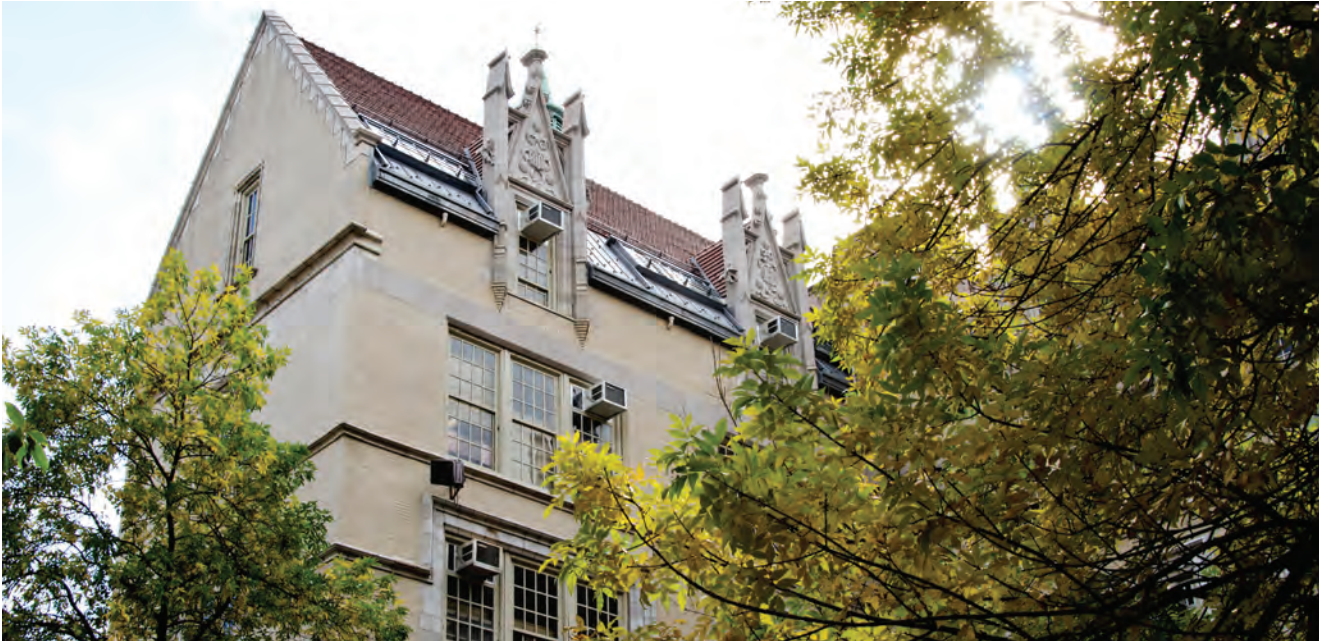
**Fig. 5.1.1**

PS 171 M located in East Harlem is an H Plan building with a French Renaissance Revival Style. The structural system incorporates an iron and steel frame clad with brick masonry. Courtesy: Sylvia Hardy

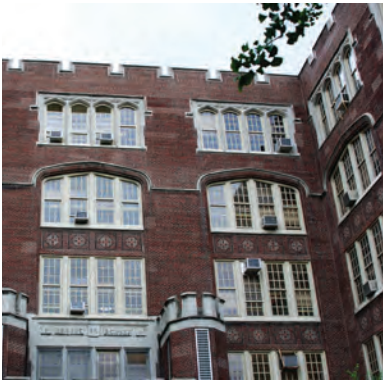
**Fig. 5.1.2**

PS 721 M located in the Hudson Square neighborhood of Manhattan is an H Plan building with a Simplified Gothic Style. The structural system incorporates load bearing brick piers as its main compressive element. Courtesy: Nelligan White Architects

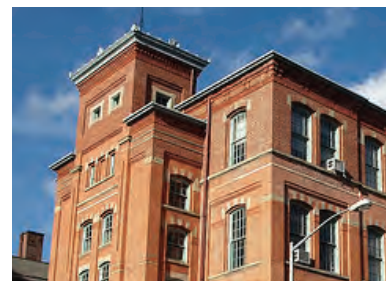
**Fig. 5.1.4**  
Old PS 72 M (now the Julia de Burgos Cultural Center) located in East Harlem is a load bearing structure which incorporates shallow jack arches to form window openings. Courtesy: Sylvia Hardy

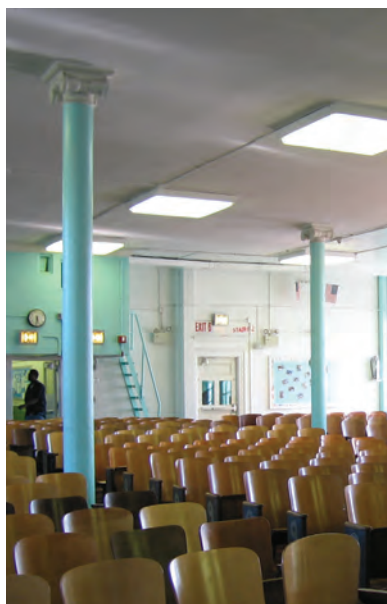
**Fig. 5.1.12**  
Cast Iron columns commonly found at the interior of schools which use load-bearing brick masonry exterior walls support the beams on which the floors span. Courtesy: Nelligan White Architects

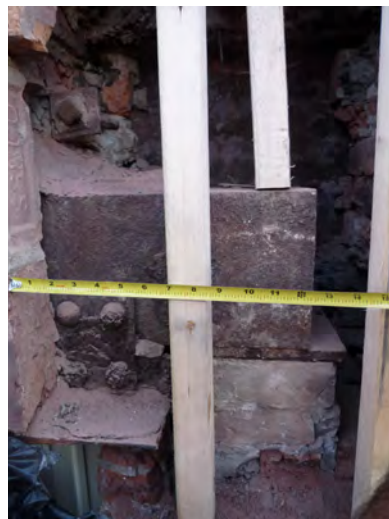
**Fig. 5.1.16**  
Probes performed at PS 19 Q revealed conditions contrary to the original design drawings. Probes identified a steel columns and spandrels just beneath the facade, however the original drawings depict a structure of pure load bearing masonry. Courtesy: Nelligan White Architects

One example of this is at PS 19 Queens, a late 1922 design by C.B.J Snyder. The drawings for this building show load bearing masonry construction similar to many Snyder designs, yet probes and construction show a steel frame that includes columns and spandrels at the facade. As constructed, the load bearing masonry facade carries only itself – all the floor loading is carried by the steel frame. At Washington Irving High School, the 1910 Snyder design for the original portion of the building has steel columns at the perimeter, but the exterior walls of this tall building are self supporting, perhaps due to the atypical height of this building.

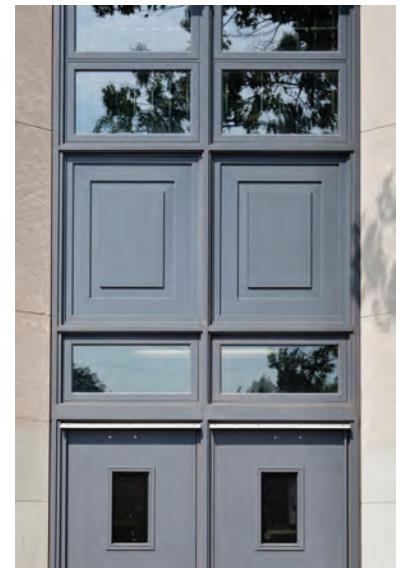
Fig. 5.1.23

PS 200 Q, a 1950's design, features a steel window wall system at its entry bays. Courtesy: Nelligan White Architects

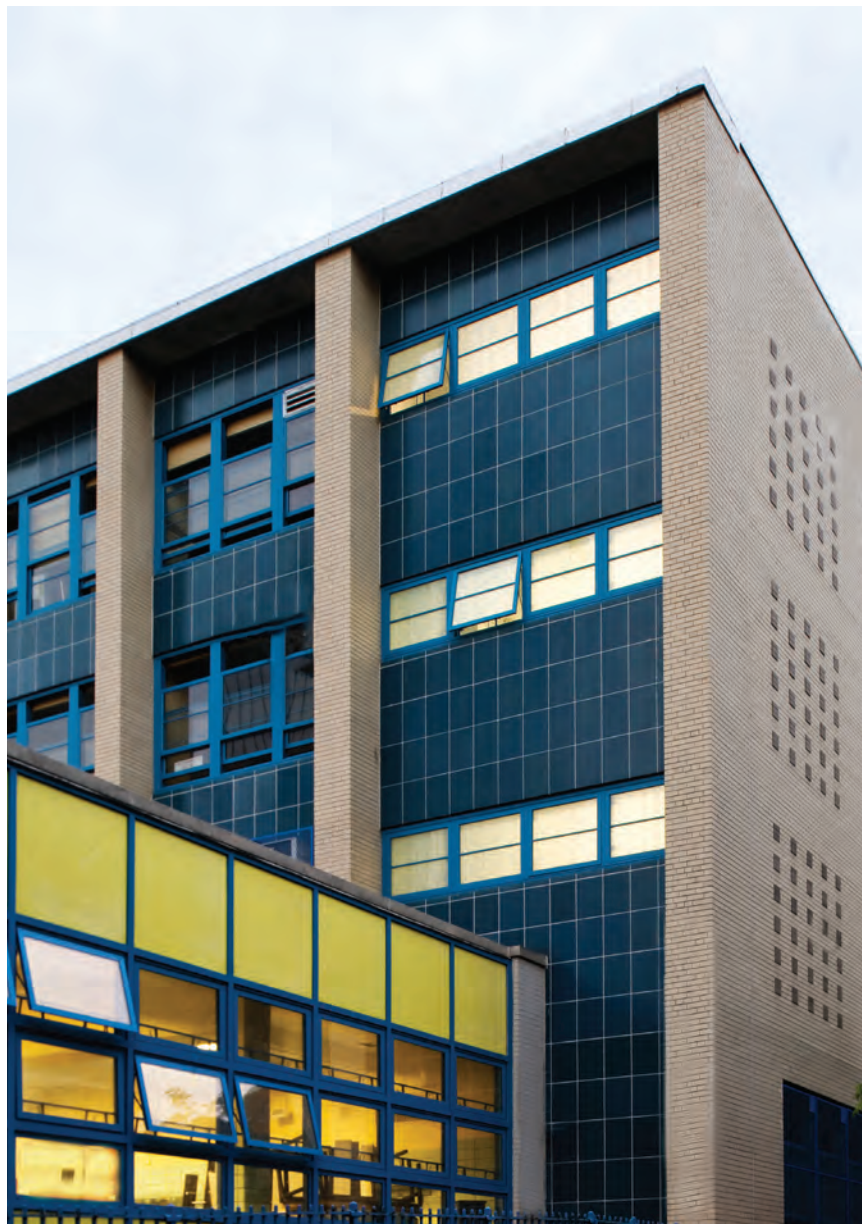
Fig. 5.1.27

**Fig. 5.1.27 (right)**  
Multiple window types present at PS 111 M represent the changes in design from previous standard school types. Punched, double hung windows were replaced with curtain wall/window wall systems, and window infill systems. By the 1950's wooden windows had been abandoned in favor of rolled steel windows. Courtesy: Sylvia Hardy

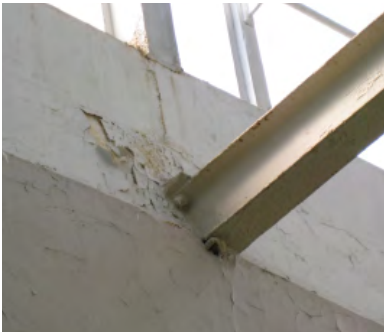
**Fig. 5.3.1**  
Water damage below a skylight at PS 277 X has caused plaster to spall, paint to crack, and metal to rust, staining the finishes below. Courtesy: Nelligan White Architects

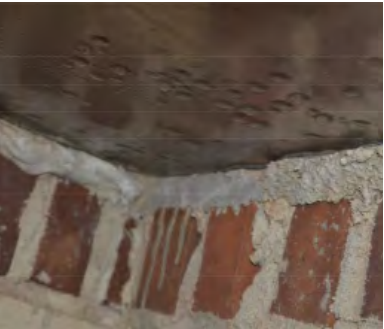
**Fig. 5.3.2**  
Moisture present on the underside of a bastion cap along the parapet at PS 183 M. Observed during a routine probe examination, the moisture indicates that water is able to infiltrate the building enclosure with ease. Courtesy: Nelligan White Architects

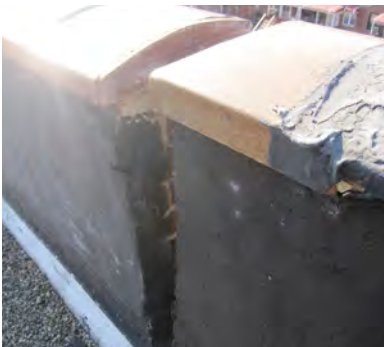
**Fig. 5.3.3**  
An out of plumb parapet, deformed as a result of brick expansion. New brick at the face was installed with no joints, resulting in expansion and deformation. Courtesy: Nelligan White Architects

The second most commonly observed failure is a result of thermal and moisture induced expansion of brick, and for the failure of the design or construction to accommodate this movement. Bricks expand through their lifetime, though the majority of this expansion occurs in the first six months after placement, expanding up to  $\frac{1}{10}^{\text{th}}$  of 1% of their original size. While this may seem insignificant, over the length of a wall this expansion can be readily visible. Most of these buildings, especially the oldest of the stock, were not built with expansion in mind. This expansion is, especially, noticeable when new repairs have not taken expansion into account, resulting in cracking of the surrounding masonry.

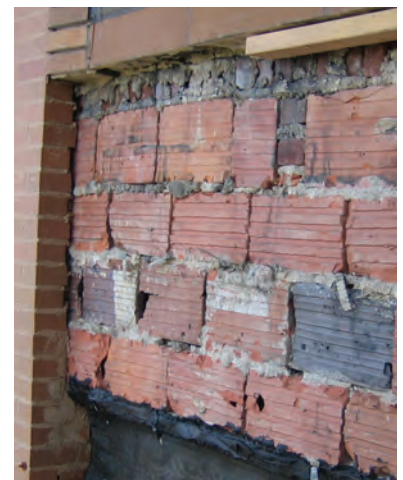
**Fig. 5.3.5**

Joints at terracotta backup is often not fully mortared on all edges, and it is sometimes left to the shear weight of the backup to keep itself in place. Strong winds can cause deflection of these backup walls when there is insufficient lateral support. While this rarely results in a catastrophic failure, it can cause cracking over time, increasing the wall's susceptibility to moisture infiltration. Courtesy: Nelligan White Architects

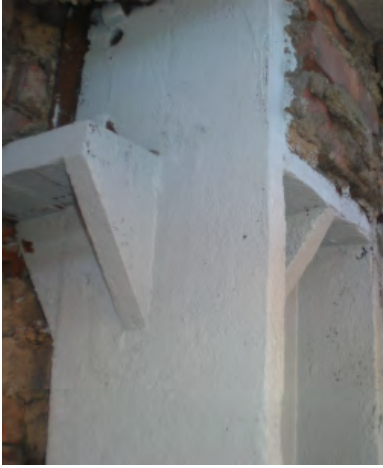
**Fig. 5.4.1 (above) & 5.4.3 (overleaf-bottom)**

Cast iron columns at PS 277 X were mostly in good condition, and showed little corrosion, especially compared to thinner steel members in the assembly. Courtesy: Nelligan White Architects

It is worth noting that large cast iron sections, though brittle and prone to cracking in tension, have weathered remarkably well, often showing less corrosion than steel sections in the same conditions.

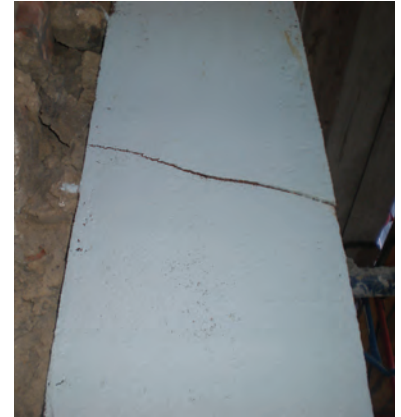
**Fig. 5.4.2 (above)**

One of the cast iron columns as PS 277 X was found to be cracked across its section. It was determined that this crack occurred during or just after original construction, and that its condition was stable. Regardless, a remediation effort was undertaken which included drilling holes through the webs with a low-RPM drill, and plates were bolted to the crack to splice the column. Courtesy: Nelligan White Architects

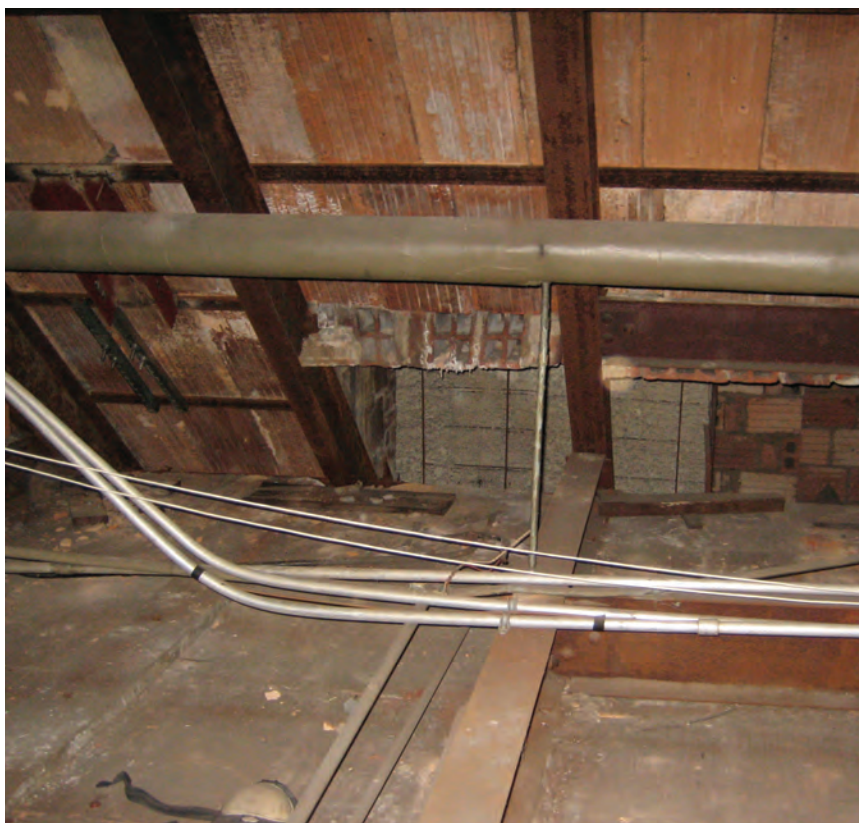
**Fig. 5.4.4 (right)**

Steel framing at the pitched roofs of PS 171 M. The 110-year old roof was under-designed by today's standards. Deflection saw compounded by the insufficient knee-joint connection to the main wall structures. Courtesy: Nelligan White Architects

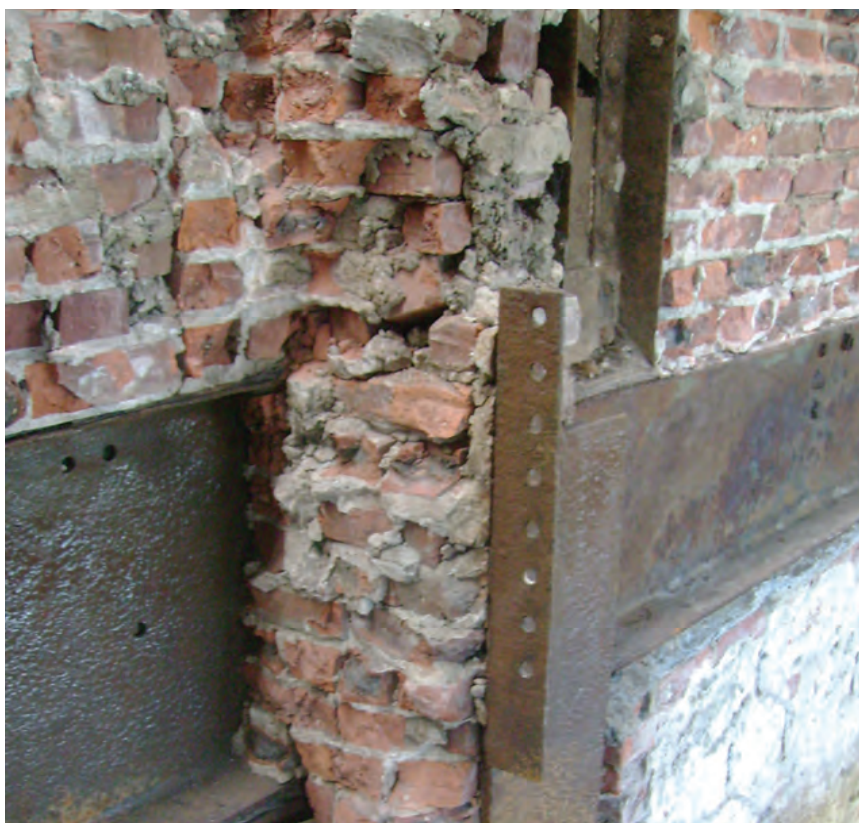
**Fig. 5.4.5 (right)**

Most steel members in early school buildings were encased in either brick or concrete. Encasement of the steel was not only a fire protection measure, but also provided lateral stability to the members as they were designed primarily as compressive elements. Courtesy: Nelligan White Architects

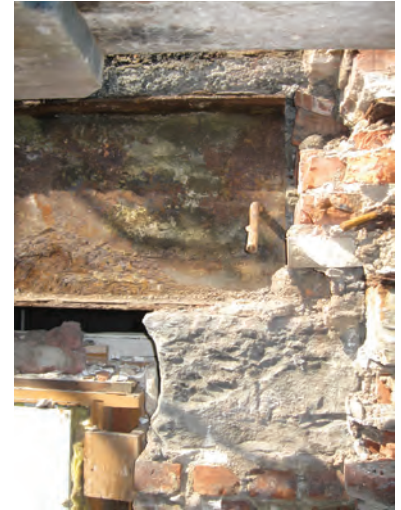
**Fig. 5.4.6**

A corroded steel lintel at IS 77 Q. During inspection of steel lintels during construction, each was pounded with a hammer to remove excess rust and determine the solidity of the section as well as a rough idea of its sectional loss. Most were deemed sufficient, but several areas were selected for repair. Courtesy: Nelligan White Architects

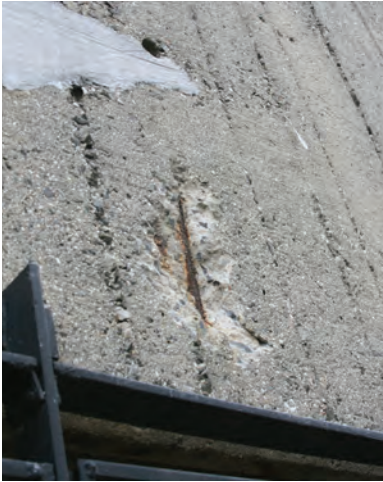
**Fig. 5.4.7**

At PS 36 M, steel reinforcement was exposed in locations over all facades. It was determined that this was a effect of insufficient concrete cover, causing the concrete to spall once the rebar started to rust and expand. Courtesy: Nelligan White Architects

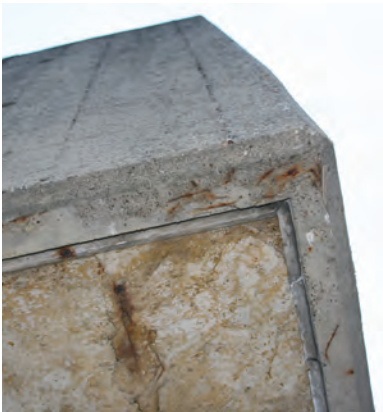
**Fig. 5.4.8**

Rust stains at the surface, an indication of the building-wide problem of insufficient concrete cover at PS 36 M. In remediation of this building included hydro-scrubbing all rebar clean and splicing where rebar was too corroded for safe inclusion. Two inches of concrete were cast over all cleaned concrete components, and a migrating corrosion inhibitor was then applied to protect the existing rebar. Courtesy: Nelligan White Architects

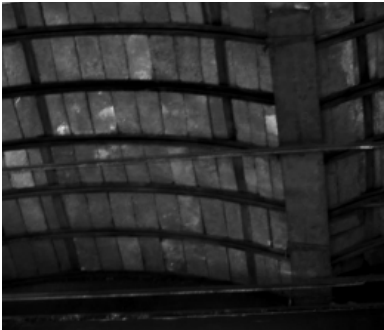
**Fig. 5.4.9**

Arched brick vaults use rolled steel ribs spaced on center at the wide of one brick. Bricks are then vaulted across the span. A cinder concrete slag is poured on top of the vaults to seal them in place and provide a level floor surface. Courtesy: Nelligan White Architects

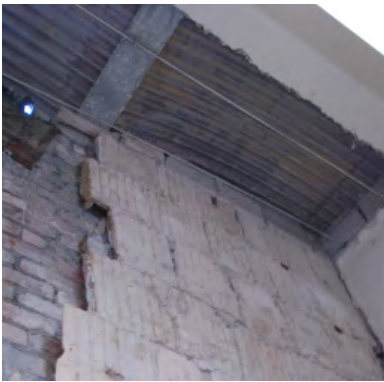
**Fig. 5.4.10**

Corrugated iron vaults use rolled steel ribs spaced on center at the wide of one brick. Bricks are then vaulted across the span. A cinder concrete slag is poured on top of the vaults to seal them in place and provide a level floor surface. Courtesy: Nelligan White Architects

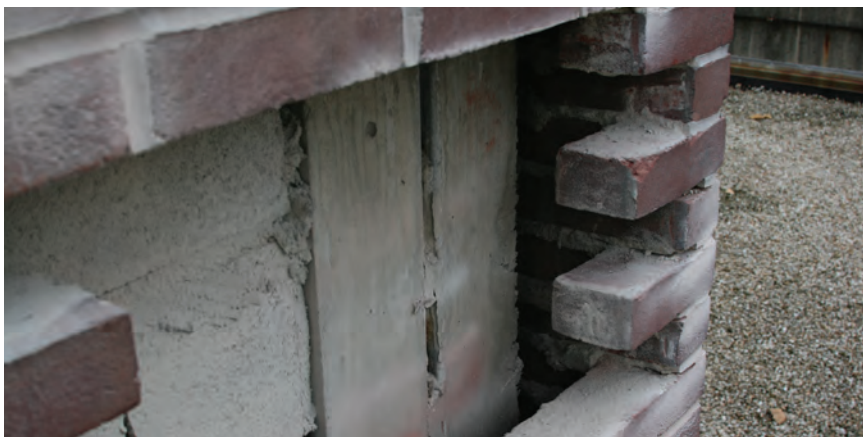
**Fig. 5.4.12**

Load bearing brick pier structural systems use large, thick columns composed of brick masonry as the primary compressive elements. All loads (except those at the center of the building, which may be served by a series of cast iron columns) are brought back to these masonry piers. Courtesy: Nelligan White Architects

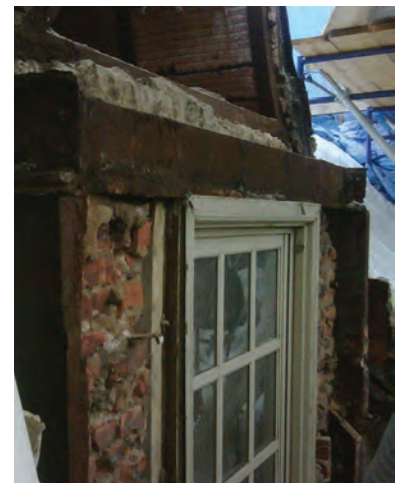
**Fig. 5.4.13**

Composite frame structures often have some type of iron or steel frame which is encased in either concrete or brick masonry. This stiffens and provides extra compressive strength to the frame, while also providing an effective form of proofing. Courtesy: Nelligan White Architects

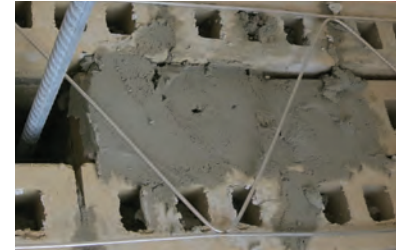
Fig. 5.4.18

Voids in the masonry are filled solid with grout at the parapet wall. Truss reinforcement is incorporated for additional support. Courtesy: Nelligan White Architects

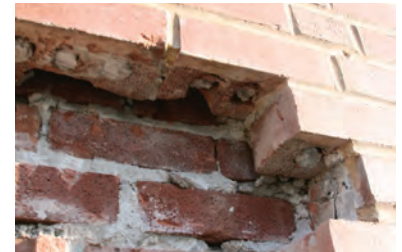
Fig. 5.4.19

Inspection of probes can reveal deficiencies which many of the school types share. Often the collar joint between the face-brick and backup wall is not filled solid with grout, which may augment migration of moisture to the interior. Courtesy: Nelligan White Architects

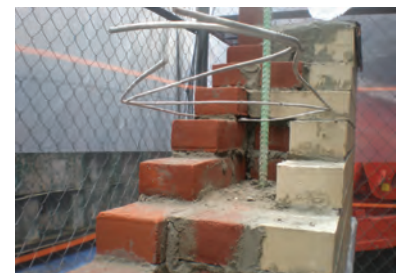
Fig. 5.4.20

Voids in the masonry are filled solid with grout at the parapet wall. Truss reinforcement is incorporated for additional support. Courtesy: Nelligan White Architects

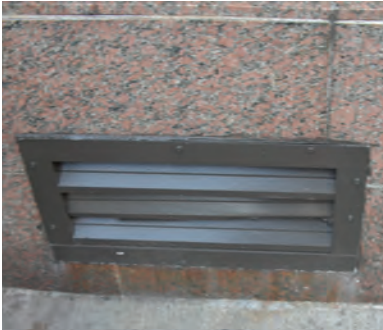
**Fig. 5.4.21**  
Rust stained granite beneath a metal vent.  
Courtesy: Nelligan White Architects

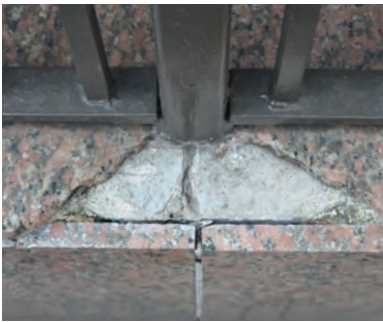
**Fig. 5.4.22**  
Cracked and broken granite veneer at a low curb wall. Granite is known for its extreme resilience, but improper installation will impede its longevity.  
Courtesy: Nelligan White Architects

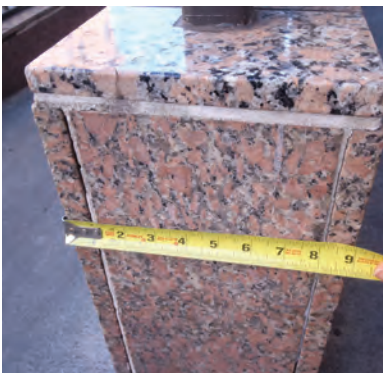
**Fig. 5.4.23**  
Cracked and spalling mortar joints increase the amount of water which gets behind veneer, inciting cracks, efflorescence and other forms of moisture related deterioration. Courtesy: Nelligan White Architects

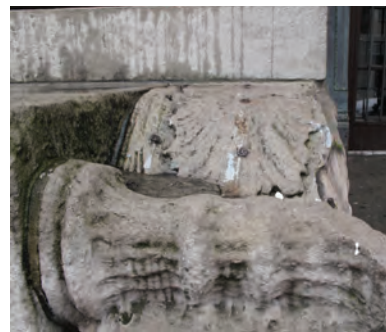
**Fig. 5.4.26**

Limestone is very durable, but can be subject to erosion due to weather, wear, pollution, de-icing salts or exposure to other corrosive environments. Courtesy: Nelligan White Architects

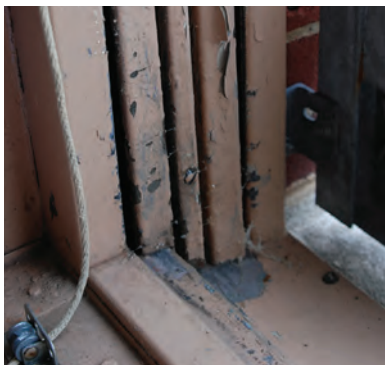
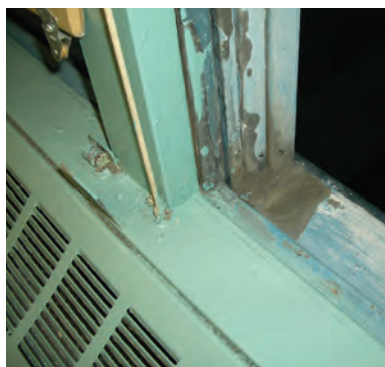
**Fig. 5.4.27 & 5.4.28 (above - below)**

As a form of maintenance, metal windows are often painted over to mitigate rust. Several coats of paint over many years can result in build-up which can leave window jammed in their frames. Courtesy: Nelligan White Architects

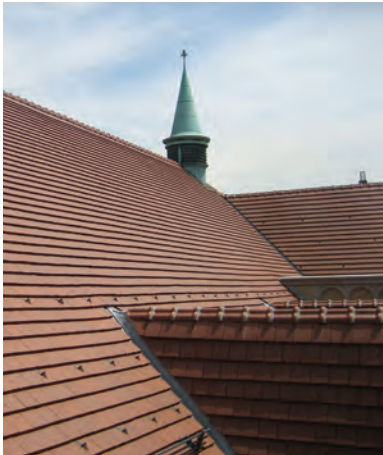
**Fig. 5.4.30**  
Clay tile roofing at PS 171 M. This roofing type is fairly uncommon, even in the oldest schools, where pitched roofs were often clad in slate tile. Courtesy: Nelligan White Architects

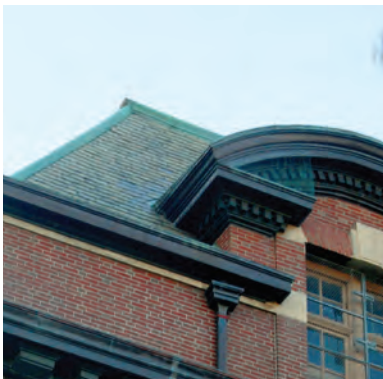
**Fig. 5.4.31**  
Slate roofing is extremely durable and typically holds the longest warranty of roofs used in public schools. Courtesy: Nelligan White Architects

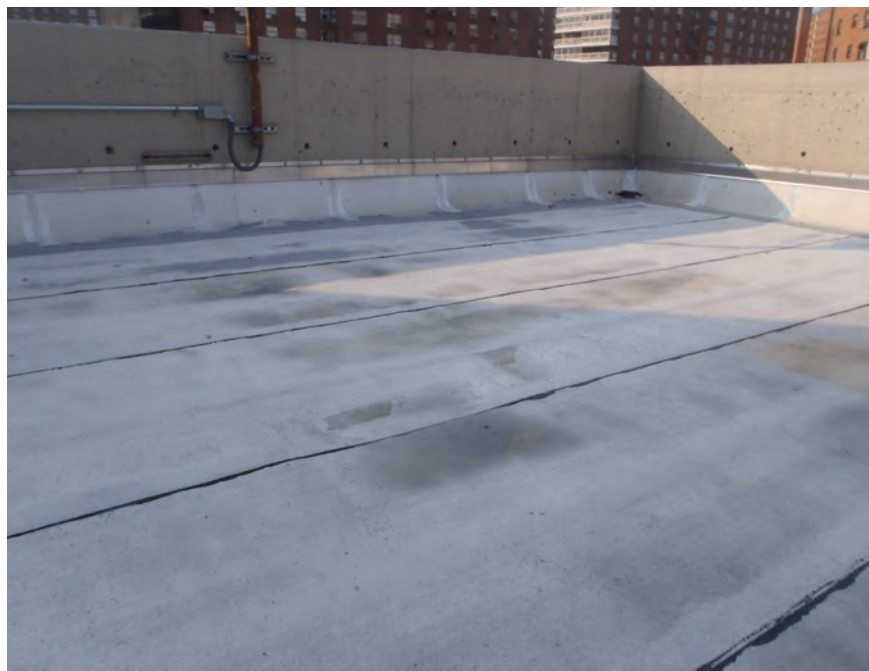
Fig. 5.4.32

**Fig. 5.4.32 (right)**  
Built-up-roof (BUR). Courtesy: Nelligan White Architects

Built-up-roofs are an assembly, typically made up of four components: the structural deck, vapor barrier, insulation and built-up membrane . These are the most common roofing systems, not only in historic public school buildings, but of all buildings in New York City.

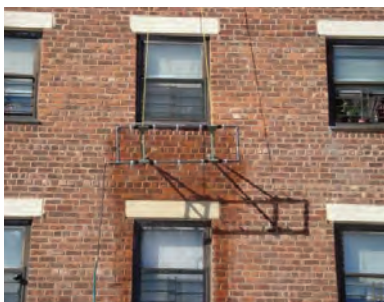
**Fig. 5.6.4**

Spray testing typically involves hanging a rig over the roof edge, and spraying water over a designated area for a set duration. Moisture levels at the interior are then observed with thermal imaging to determine where water is entering. Courtesy: Nelligan White Architects

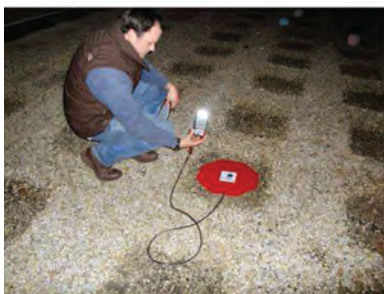
**Fig. 5.6.6**

Capacitance testing involves sending a low electrical current into the roofing assembly to measure the amount of electrical resistance in the test location. These tests are typically performed in a grid so the data gathered can be mapped for comparative analysis. Courtesy: GBG USA Inc.

4. **CAPACITANCE TESTING** - Capacitance tests are used primarily at low slope built-up-roofs, often to collect comparative data for thermal/infrared imaging results. These tests place a low electrical current into the roof membrane, measuring how conductive, or what capacity of electricity it can hold: an area of increased moisture content will generate a higher capacitance reading than a drier area. By collecting data over a grid the readings can be generated into a visual map of potential areas of retained moisture within the roof insulation. This map can be easily compared to the results a thermal imaging survey.

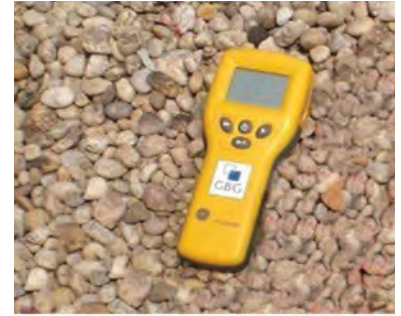
**Fig. 5.6.7**

Moisture meters are devices which provide data on surface moisture levels. The device typically has two pins which should be in contact with the material in question for proper readings to occur. Courtesy: GBG USA Inc.

5. **MOISTURE METERING** - Moisture metering is a testing method often used in conjunction with a primary testing regimen, either for confirmatory or comparative data. A fairly straightforward method, this test typically involves a hand held electrical meter which gives a moisture reading from the point of a needle. This test can be used before and after spray testing for comparative data, or as a stand-alone test recording several locations throughout a building to identify which areas are wetter than others.

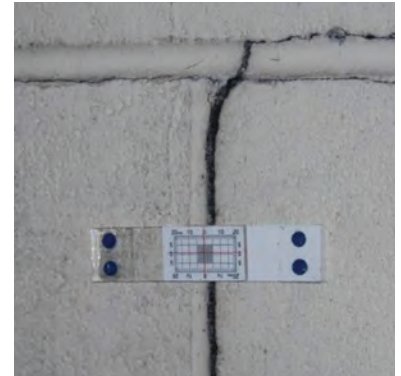
**Fig. 5.6.8**

Crack meter is used to monitor crack activity. Courtesy: Courtesy: WSNY Engineering Design P.C.

6. **RADAR (GPR) & X-RAY** - GPR Radars and X-rays are used as non destructive tests and can determine the exact location of concrete scanning.
7. **CRACK METERING** - Crack meters are used to measure movement of existing cracks. Placed on either side of the crack, any change in distance or location from the established reference point may be recorded.

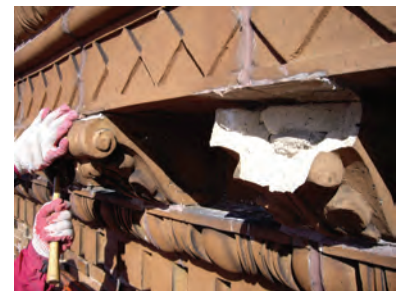
**Fig. 5.6.9**

Sounding is a method used to determine the structural stability of architectural terracotta. It involves hitting the test piece with a rubber mallet and listening to the sound. Undamaged terracotta will produce a distinct ringing noise, while a damaged piece will sound flat and hollow. Courtesy: Nelligan White Architects

8. **SOUNDING** - Specifically used to determine the strength of terracotta elements, sounding involves striking each unit with a rubber mallet and analyzing the sound made. Undamaged terracotta units will produce a distinct ringing noise when struck, while damage terracotta units will produce a flat, hollow sound. This is not always the most reliable method and may result in damaging existing terracotta units, thus is arguably a 'destructive' testing method.

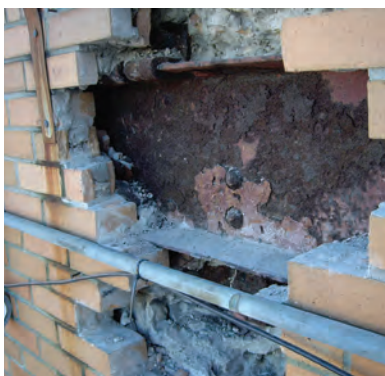
**Fig. 5.6.10 & 5.6.11 (above - below)**

Exploratory probes involve the removal of facing elements to inspect the conditions beneath. Standard probes at historic Public Schools include exterior probes through face brick, interior probes through finish plaster to inspect backup, or probes through the ceiling finishes to inspect the floor structures. Courtesy: Nelligan White Architects

1. **EXTERIOR EXPLORATORY PROBES** - With most buildings which are of concern to this guide, exterior exploratory probes involve the removal of the face-element of the facade. This may include face-brick, brick-veneer, and ornamental elements on the facade to inspect the condition of backup masonry, structural frames, to note any unusual levels of moisture and to collect material samples for laboratory testing.

2. **INTERIOR EXPLORATORY PROBES** - Similar to exterior probes, interior exploratory probes mostly involve the removal of finishes to inspect the interior condition of walls and ceiling structures. With most of the historic school buildings in question, this entails removal of plaster, lath, furring elements and terracotta 'soaps' to get to at the masonry backup or a structural component. These probes may be performed at interior ceiling as well to inspect the condition of floor arches, framing and concrete slabs.

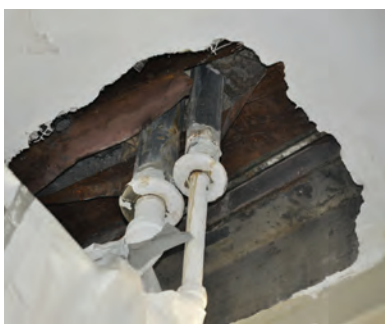
**Fig. 5.6.12 (above)**

Roof cuts are typically performed at built-up-roofs to inspect the condition of and verify the location roofing membranes, insulation, air barriers and substrate. Courtesy: Nelligan White Architects

3. **ROOF CUTS** - Roof cuts involve the stripping away of a specified area of roofing membrane at built-up-roofs for the purpose of inspecting the condition of insulation, waterproofing membranes, and substrate. After the roofing membrane is stripped away, a small area of insulation is cut out to view the substrate. The contractor performing the roof cut should proceed with caution to avoid penetrating any waterproofing membranes adhered to the substrate.
