# New York City's Historic Schools

A History and Guide to Rehabilitation

NYC SCHOOL CONSTRUCTION AUTHORITY

This Guide has been developed as a practical and technical resource to assist in the evaluation and design for the restoration of historic school buildings (more than 45 years old). It is worth noting that over half of our public school buildings are more than 60 years old! It is our intention to facilitate strategies for these projects that will target cost effective solutions while at the same time respecting their historic standing as landmarks in the community.

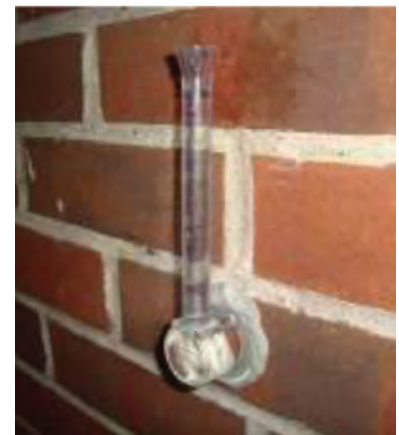
**Fig. 5.6.14**

Several types of absorption tests are used in the analysis of existing building materials. This method involves the installation of an open beaker to the brick face, and noting the water loss in the beaker after set intervals of time. Courtesy: GBG USA Inc.

2. **CONCRETE TESTING** - Cover meter testing, half-cell potential and corrosion section loss measurements, tests, and Windsor Pin.
3. **ABSORPTION TESTING** - This testing method, which is conducted on brick, terracotta, mortar and concrete, measures the amount of moisture which is retained by any of these materials. The absorption levels have a determining influence on the compressive strength and also the permeability of the material to water or liquid flow . There are several types of absorption tests, including a 5-hour boiling tests, and a 24-hour and a 30-minute immersion tests.

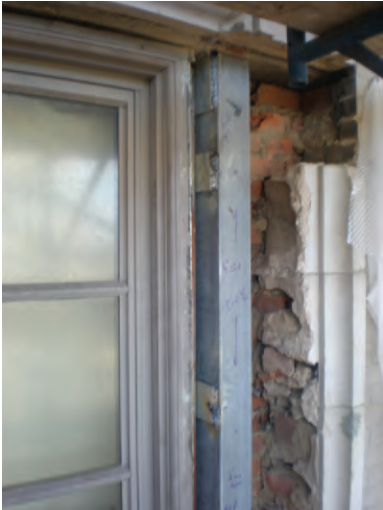
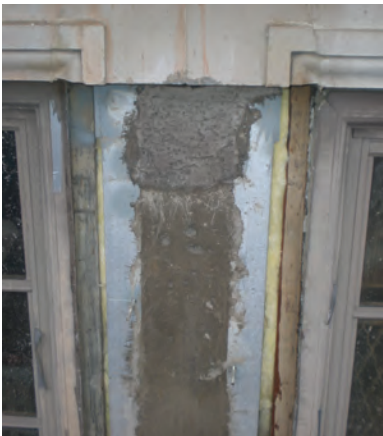
**Fig. 5.7.2 & 5.7.3 (above - below)**  
Steel 'wind girts' installed in unreinforced backup walls for lateral support. These are typically installed at the window openings, where walls are the most vulnerable to lateral deflection. Courtesy: Nelligan White Architects

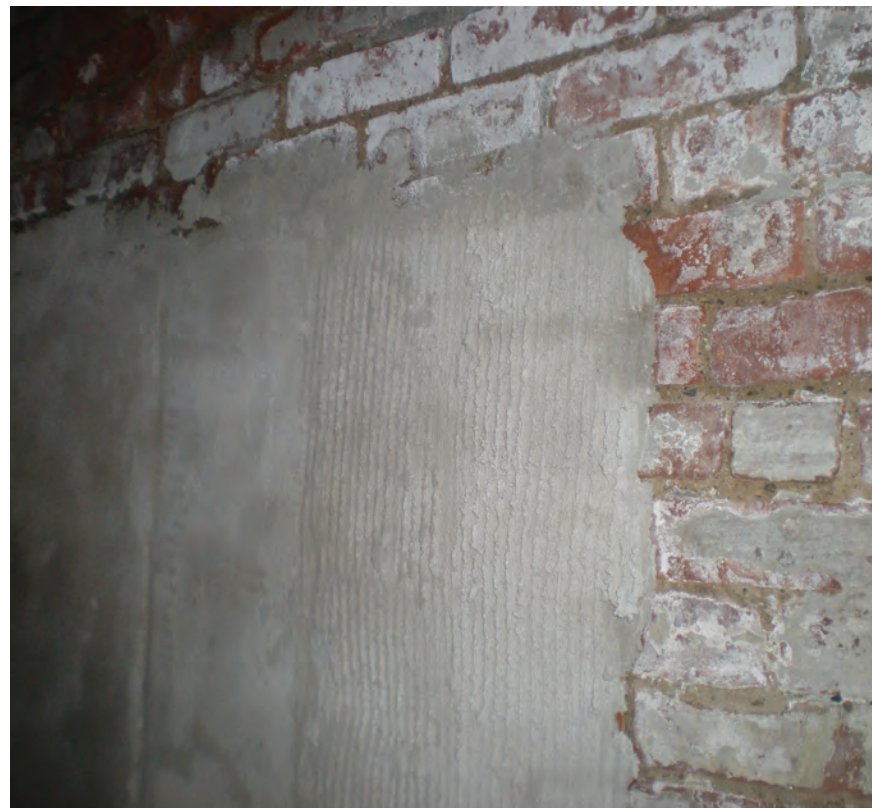
Fig. 5.7.5

**Fig. 5.7.5 (right)**  
Parge coats help to seal the backup and provide an even surface for the application of air membranes and cavity wall assemblies. Courtesy: Nelligan White Architects

The parge coat is intended to seal the backup and provide a smooth surface for the vapor barrier to be installed on. Prior the parge coat, a float coat should be provided for a continuous surface which evens out the high and low points, or any other variations in the brick plane. A cementitious parging slurry is then coated over the entire backup plane.

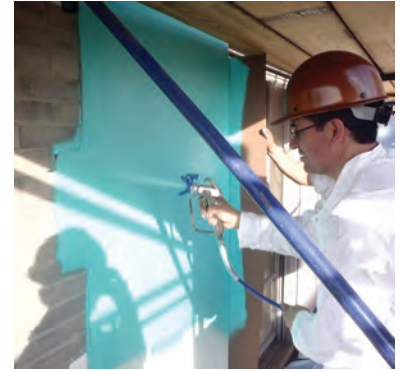
**Fig. 5.7.6**

Spray applied waterproofing membranes provide protection against air and moisture leakage through the wall. Membranes should be continuous to provide the best protection. Courtesy: Nelligan White Architects

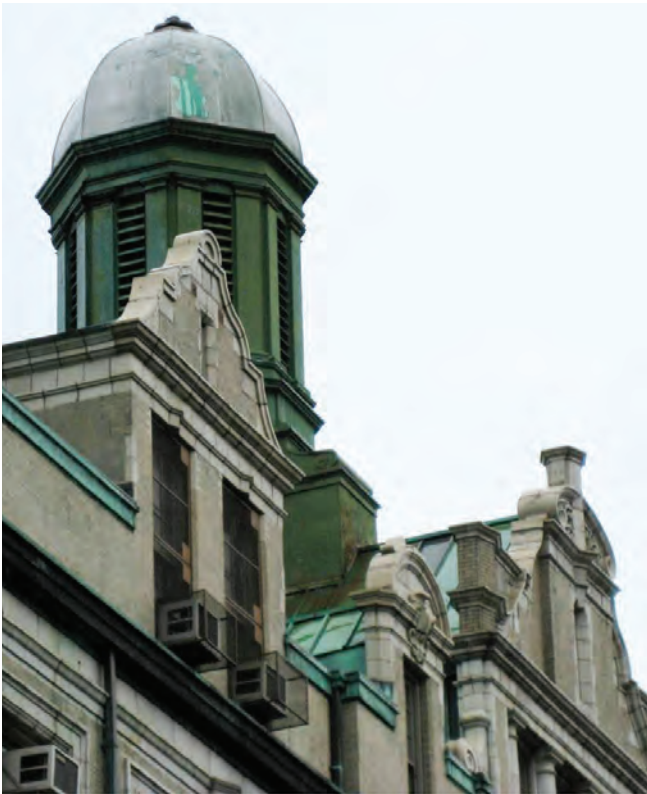
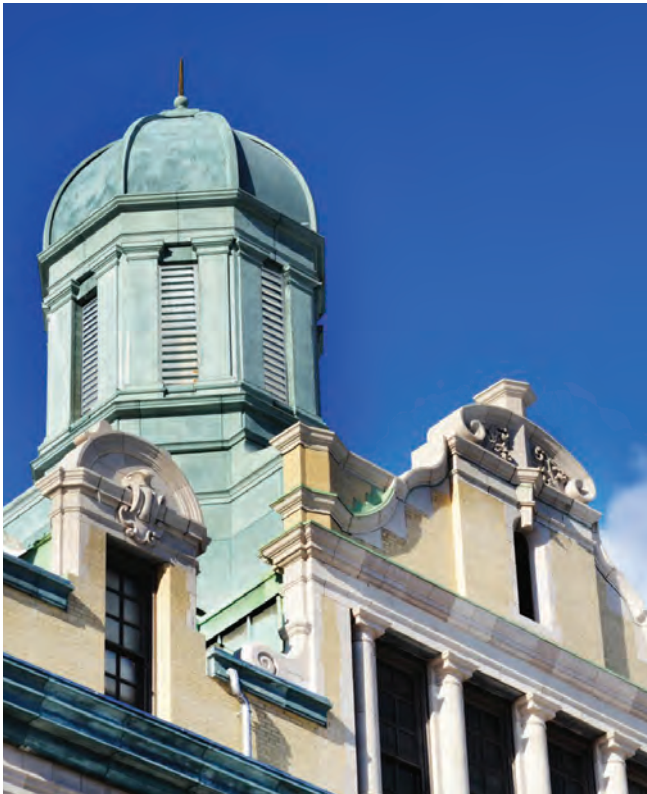
Fig. 6.1.1 - Before Rehabilitation

Fig. 6.1.2 - After Rehabilitation

**Fig. 6.1.1 & 6.1.2**  
A 'before and after' image of PS 277 X highlighting the rehabilitation at the spire and ornamental features at the front facade. The building's composite French Renaissance/Gothic style was intended to reference the great institutions of old world Europe. These inspirational structures stand in stark contrast to the dark, unsanitary schoolhouses common in New York City throughout the 19<sup>th</sup> century. Courtesy: Sylvia Hardy

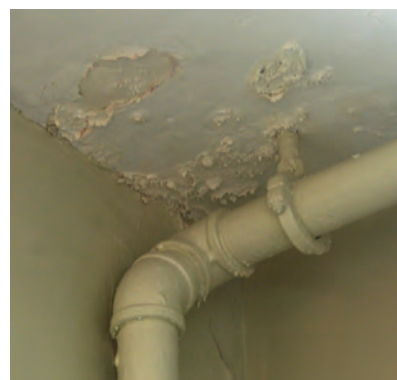
Fig. 6.1.6

Water damage in a fifth floor classroom at the interior of the dormers. Some damage had been cosmetically repaired, however constant water infiltration as a result of improper flashings causes continual damage. Courtesy: Nelligan White Architects

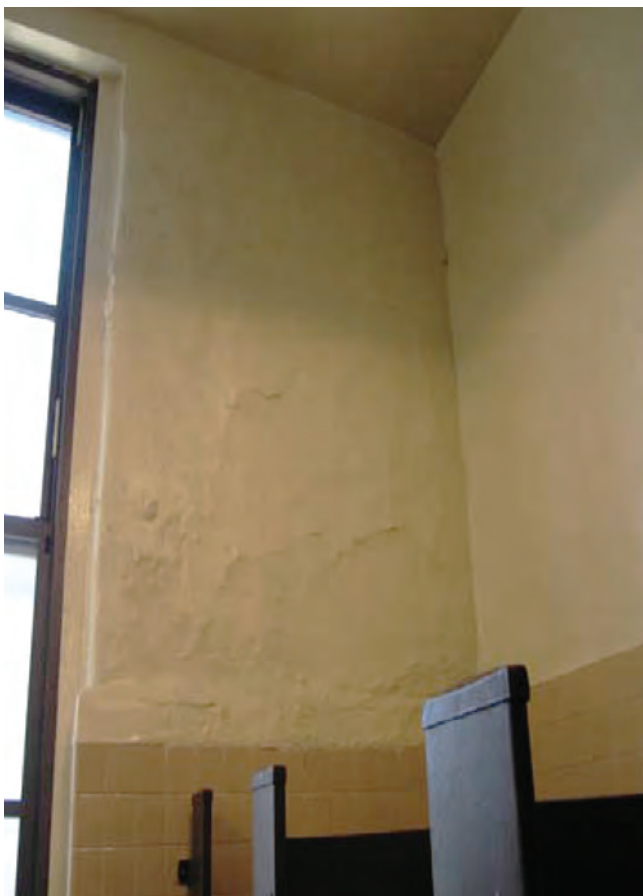
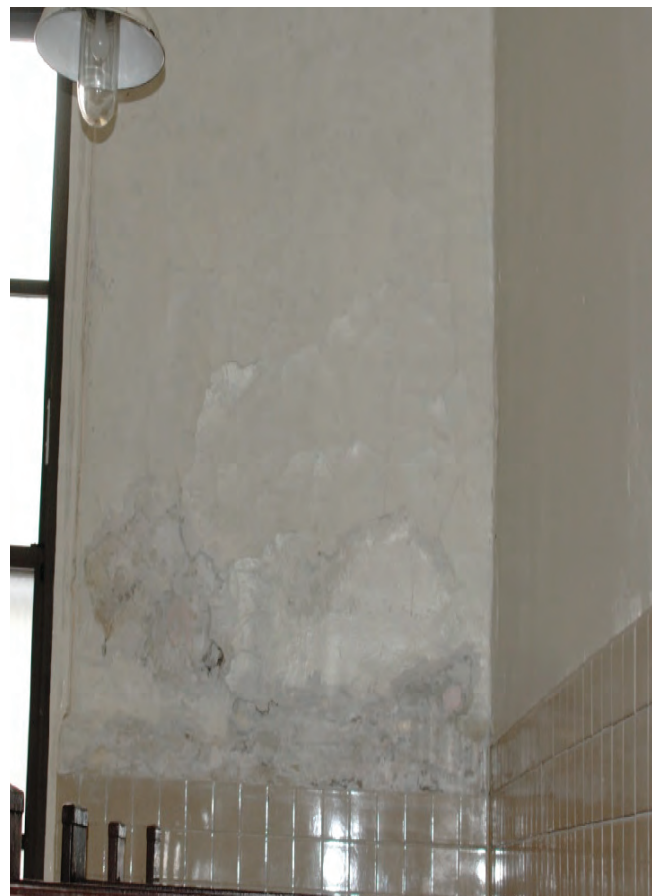
Two images taken at the same location approximately a year apart indicate quickly progressing damage. Courtesy: Nelligan White Architects

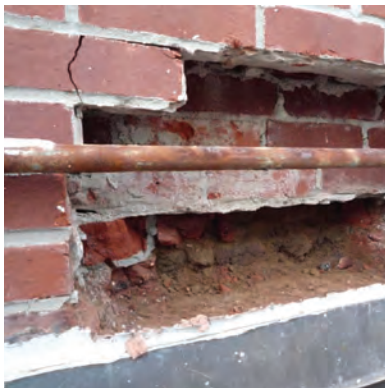
**Fig. 6.1.11**

Exploratory probes revealed backup masonry and mortar to be mostly in poor condition. Courtesy: Nelligan White Architects

Both the results of observation mapping and the Assessment of Water Ingress Report obtained from the SCA, guided the choice of locations for further investigation by exploratory probes. Using a boom lift, 17 probes were performed in October 2009, with the intent of evaluating the existing conditions of the building, inspecting the backup masonry and steel/iron framing, and to examine the condition of less accessible areas high on the buildings facades. Many of the observations were as expected; crumbling and disintegrating backup masonry and mortar, corroded steel, and moisture present inside the walls. In one location, century-old wood framing was found supporting masonry units. Recent repairs to the copper gutters at the upper portion of the building were observed to be ineffective, as there were underlying issues of failing masonry and cracked terracotta. Despite these deficiencies, the larger sections of cast iron columns were found to be in better than expected condition.

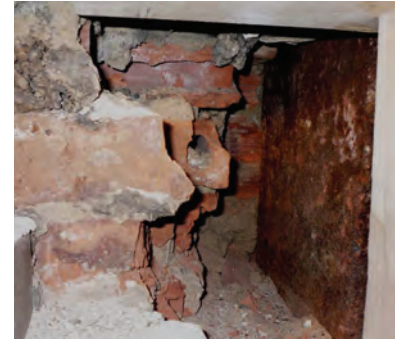
**Fig. 6.1.15 (above)**  
During the evaluation of exploratory probes, samples of backup masonry and mortar were extracted for testing. Courtesy: Nelligan White Architects

During the inspection of probes, material samples of face-brick, backup brick, and mortar were collected for laboratory testing of compressive strength, absorption and chemical composition. These tests indicated that the mortar used for the face-brick, backup and terracotta is Type-O mortar, a weak mortar with high lime-putty content, typically used at the turn of the 20<sup>th</sup> century, but is not currently recommended for climates that go through regular freeze-thaw cycles, like that of the Northeastern United States. Type-O mortar is more susceptible to wash-out than other mortars with lower lime putty content, and this mortar was mixed with a slightly high water-to-cement ratio. The laboratory tests also show that the mortar is completely carbonated, which results in the lowering of the pH around ferrous elements, including steel cramp anchors. This lower pH reduces the alkaline protection that cementitious materials provide to ferrous metals. The corrosion of steel and to a lesser extent cast and wrought iron elements has accelerated in the presence of water.

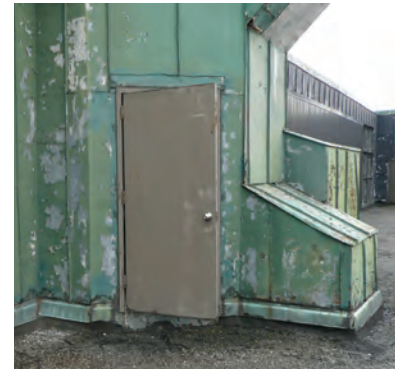
**Fig. 6.1.20**

Back side of the mansard roof before rehabilitation. Courtesy: Nelligan White Architects

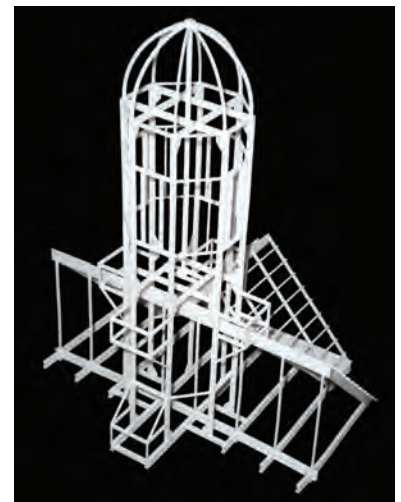
**Fig. 6.1.21**

3D printed model of the ventilation tower structure, used in the design process of the tower's replacement. Courtesy: Nelligan White Architects

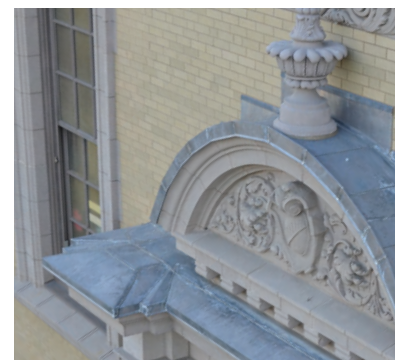
**Fig. 6.1.22**

Newly installed lead-coated copper at facade elements. Courtesy: Nelligan White Architects

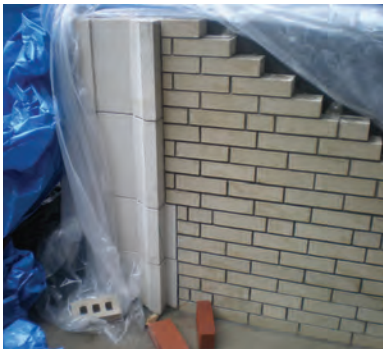
**Fig. 6.1.23**  
Masonry and architectural precast concrete mock-up. Courtesy: Nelligan White Architects

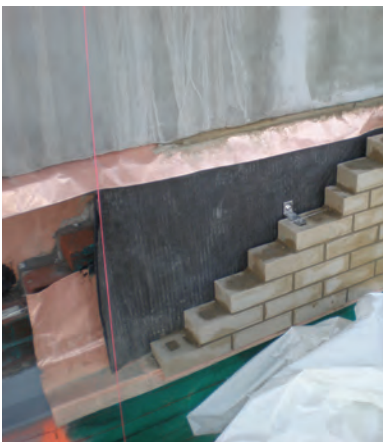
**Fig. 6.1.24**  
Narrow cavity drainage plane and copper flashings in construction. Courtesy: Nelligan White Architects

8. One of the most effective components of the entire approach to this rehabilitation is the installation of a continuous spray applied air/water barrier. Spray application is essential to avoid voids and holes (i.e., "leaks") and the best systems come with a peel-and-stick membrane flashing for terminations and penetrations. Such systems compensate for a host of deficiencies in the existing backup that must necessarily remain, and truly keep water out of a building. Better yet, they reduce air infiltration through masonry walls nearly to zero, which has a profound effect on the comfort and energy use of these schools.

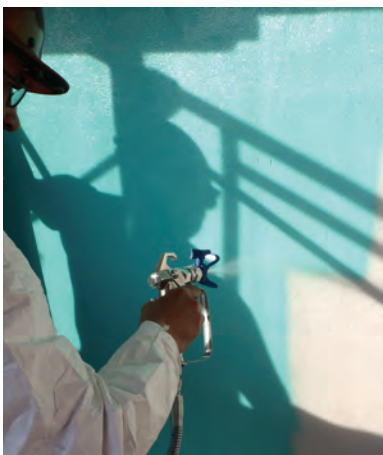
**Fig. 6.1.25**  
Spray applied membrane installation. Courtesy: Nelligan White Architects

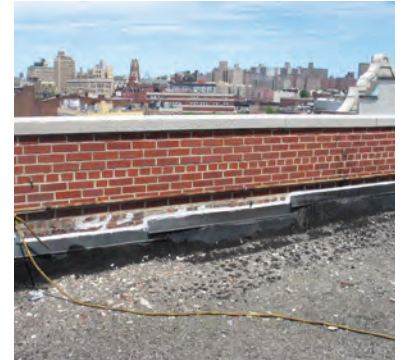
Fig. 6.1.27

Before rehabilitation, base flashing at parapet was not continuous. Courtesy: Nelligan White Architects

Original design drawings, visual observations and probe investigations confirmed the absence of through-wall-flashing at the parapets. Probes along with the Assessment of Water Ingress Report confirmed that water passing through the back side of the parapet, was a significant source of damage at the top floor. These findings prompted the following recommendations:

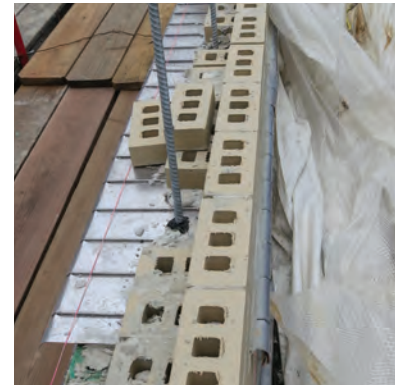
Fig. 6.1.28

Through-wall flashing during installation. Courtesy: Nelligan White Architects

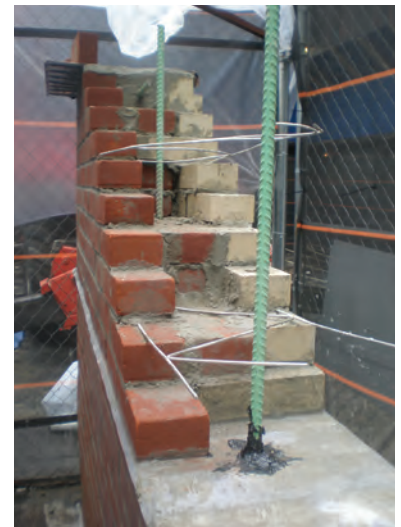
Fig. 6.1.29

Parapet mock-up with through wall flashing and truss reinforcing. Courtesy: Nelligan White Architects

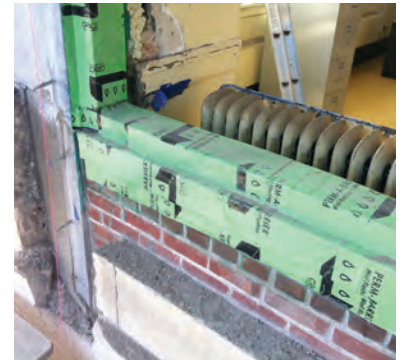
**Fig. 6.1.31**  
Peel and stick flashing and wind girts at the window opening during installation. Courtesy: Nelligan White Architects

Cracking and flexing of the structure over the years has contributed to water penetration into the building. When face masonry is removed, the new building enclosure must be designed to accommodate code wind loads. At PS 277X this new structure has taken the form of “wind girts” – steel angles spanning vertically from spandrel to spandrel at each window opening and horizontal angles below each window sill. The intention of these girts is to reduce the span of each section of masonry to reduce its deflection under wind loads to a very small value, less than L/600, in order to prevent cracking of the masonry.

7. The wind-girts were designed as angles running from spandrel to spandrel at each window opening, with a cross angle set below the window sill. One leg of each angle is set flush with the backup masonry, the second leg set perpendicular – between the window jamb and the backup masonry, and between the window sill and the backup masonry. The angles were designed to clamp the wall with short pieces set from the inside of the wall and welded to the girts. Even though this piece of work could be most easily performed with the windows removed, to maintain any progress at all, it was essential to de-couple this piece of work from the removal and re-installation of windows. It proved to be possible to chop the terracotta backup with the windows in place and slide one leg of the angle into the cut. The cut was grouted and temporary dowels installed until the windows were removed during the summer and the clip angles were installed. This allowed the masonry work to be completed before the removal and re-installation of windows.

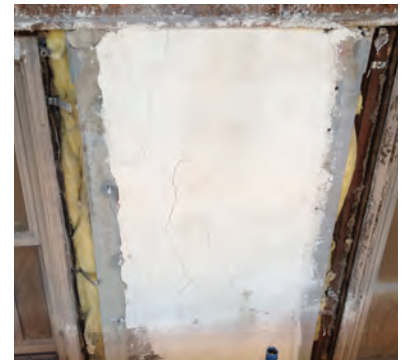
**Fig. 6.1.32**  
Two wind girts at window openings during installation. Courtesy: Nelligan White Architects

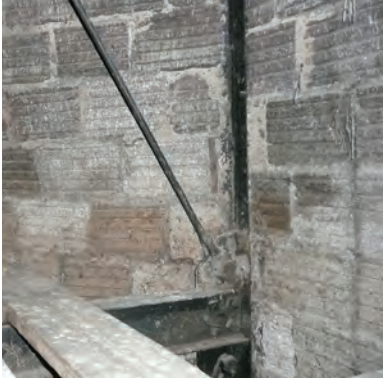
**Fig. 6.1.34**

Interior of the ventilation tower before cleaning. The ventilation system was abandoned decades prior, and nesting birds in the tower and shaft system contributed to concerns regarding poor/dangerous air quality. Courtesy: Nelligan White Architects

There presently exists no system for ventilation to classrooms and assembly spaces throughout the building, which stands as a code violation. It was observed that pigeons were nesting in the main duct risers, and had filled the ducts with large amounts of waste which posed a health hazard. While installing new mechanical ventilation systems was beyond the scope of this exterior rehabilitation, it was agreed that this project should address the breach in fire separation between the floors of the building created by the original exhaust ventilation shafts, which had open louvers at each floor. These findings prompted the following recommendations:

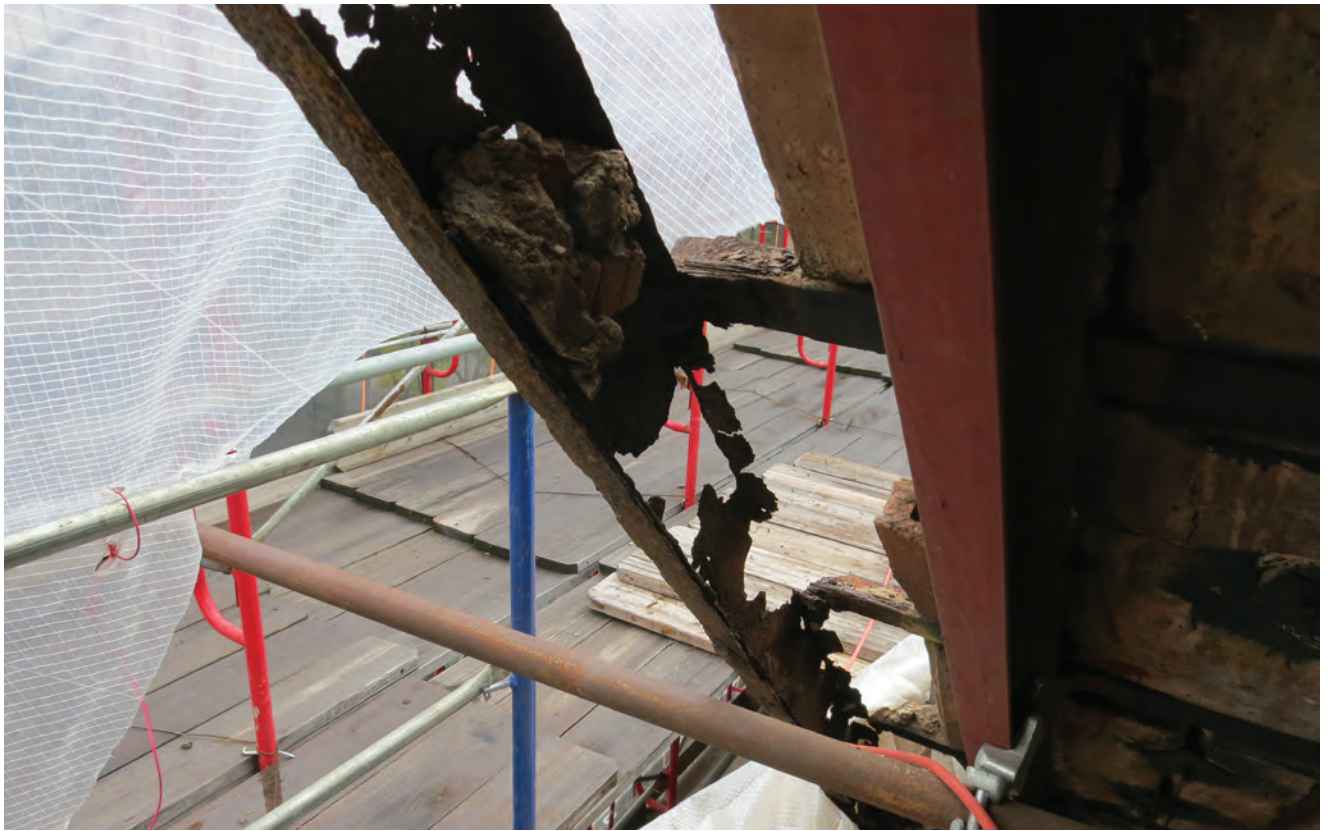
Fig. 6.1.38

**Fig. 6.1.38 (overleaf - top) & 6.1.39 (overleaf - bottom)**

Extreme corrosion in the gables. Courtesy: Nelligan White Architects

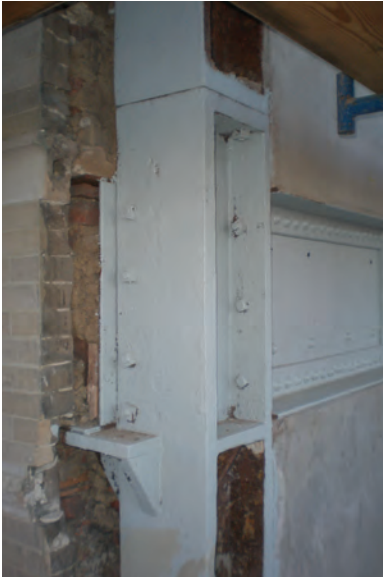
**Fig. 6.1.40 & 6.1.41 (above - below)**  
Cast iron columns and the very heavy built-up spandrel beams were in remarkably good condition. Courtesy: Nelligan White Architects

4. The cast iron, wrought iron, and steel throughout the building exhibited a range of conditions. The cast iron columns and the very heavy built-up spandrel beams (with angle flanges thicker than 1") were in remarkably good condition – in some areas the original red-lead primer was still intact. Lighter steel sections – particularly the channels and angles used to frame the dormers were severely corroded to the point where they were almost non-existent. (See image) Wrought iron cramps fared better than light steel sections, however, even moderate corrosion where they were embedded in terracotta caused 'rust-jacking' failures.

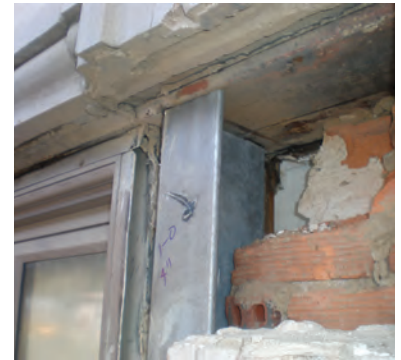
**Fig. 6.1.42**  
Probe observing terracotta backup. Courtesy:  
Nelligan White Architects

5. The most significant discovery was the extent to which the terracotta backup had contributed to the building's water related failures. Probes show the terracotta to be brick sized, and hollow with the cores oriented in the long direction of the tile rather than up-and-down like modern cored brick. Thus, any headers present the cores running perpendicular to the facade. Some of these were seen in probes and considered a source of water infiltration. When the face brick was removed, it was discovered that a header course was installed in the backup every 5<sup>th</sup> or 6<sup>th</sup> course, creating continuous lines of leaks through the building envelope.

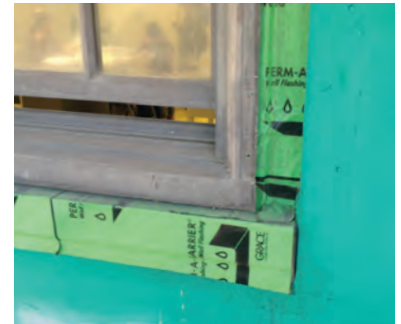
**Fig. 6.1.43**  
Aluminum window reinstalled. Courtesy:  
Nelligan White Architects

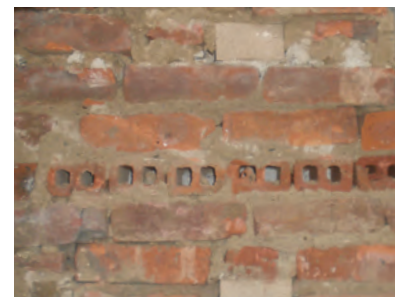
**Fig. 6.1.44**  
Existing backup prior to spray application.  
Courtesy: Nelligan White Architects

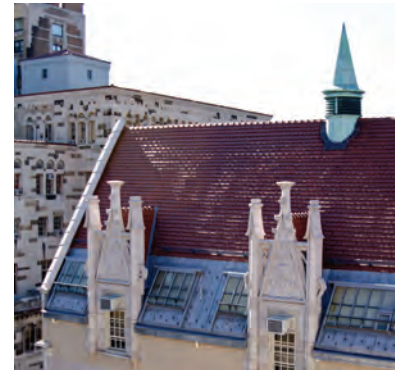
**Fig. 6.2.3**

Continuous skylights along the roof line bring light into hallways, classrooms, and the gymnasium located at the fifth floor. Among the programmatic innovations Snyder incorporated into the H-plan schools was to place rooms which required more light, like art rooms, at the upper floors to avoid light blockage by surrounding buildings. Courtesy: Sylvia Hardy

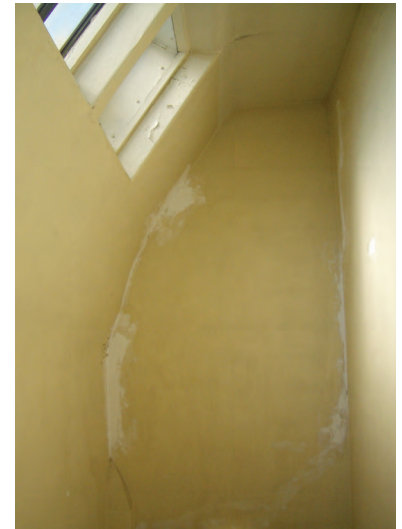
Fig. 6.2.8 & 6.2.9 (above - below)

Efforts to patch water damage were visible at the fifth floor interior hallways. While patching may have temporarily subdued the problem, it does not solve the source of leaks. Courtesy: Nelligan White Architects

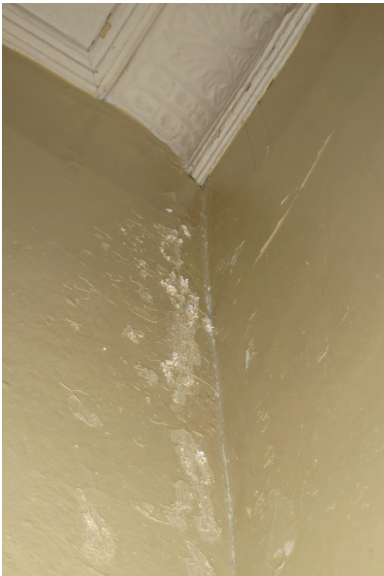
**Fig. 6.2.11**  
Water damage visible at the interior during the moisture meter survey. Courtesy: Nelligan White Architects

A survey was then carried out using a moisture meter at areas of observed damage; it was noted that many of the damaged areas had a high moisture reading, corresponding to infiltration of water from the exterior. The causes of infiltration were determined to be systemic in nature, related to the existing roof system and cracks on the upper part of the building.

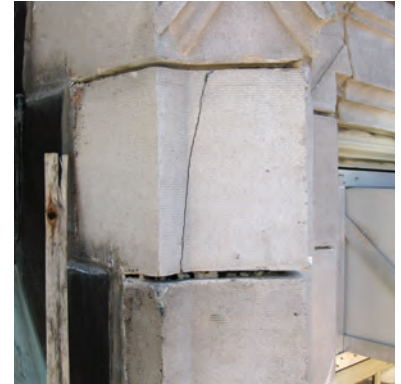
**Fig. 6.2.14**  
Much of the cracking visible at limestone and terracotta around the dormers was not observable until scaffolding was in place once work had begun. Courtesy: Nelligan White Architects

Exploratory probes are typically carried out during the scoping phase of a project, but initial lack of access while scoping at PS 171 M, made observation of certain areas unsafe or impossible. Upon observation of the dormers via scaffolding early in construction, it was clear that terracotta at the dormers exhibited signs of distress and would require repair beyond the scope indicated in the contract documents. The original scope of work at the dormers only specified cutting and re-pointing of masonry joints, but as work began, portions of terracotta broke away, revealing dangerously corroded steel beneath. A visual inspection revealed that even recently replaced elements were cracking. As a result of these observed conditions, exploratory probes were carried out during the construction phase to determine any additional scope.

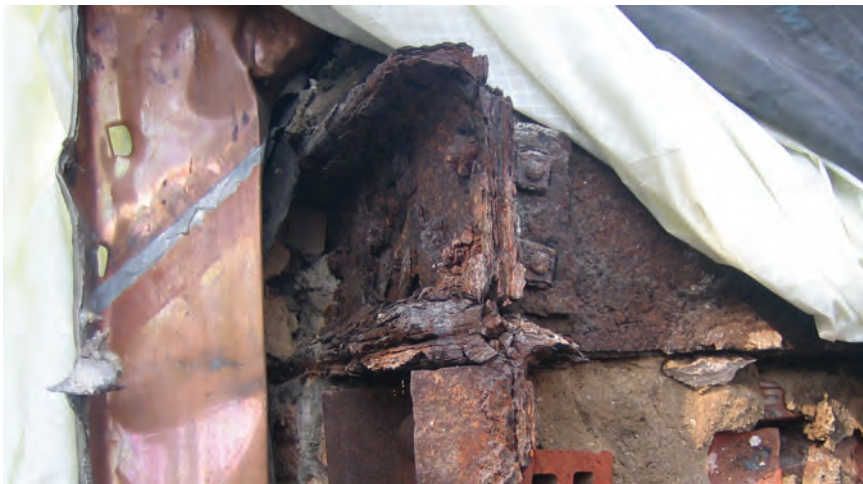
**Fig. 6.2.16**

**Fig. 6.2.16 (left-above)**  
Post and lintel connections at the dormers were in an advanced state of corrosion. This deficiency was not observed until the demolition had begun. Courtesy: Nelligan White Architects

After inspection through exploratory probes, it was clear that most of the steel post and lintel type supports and their connections were in a state of advanced disrepair. Similar probes were also carried out at the knee braces for roof trusses at the Gymnasium, after the initial scope phase. It was determined that material testing must be carried out to analyze the condition of steel.

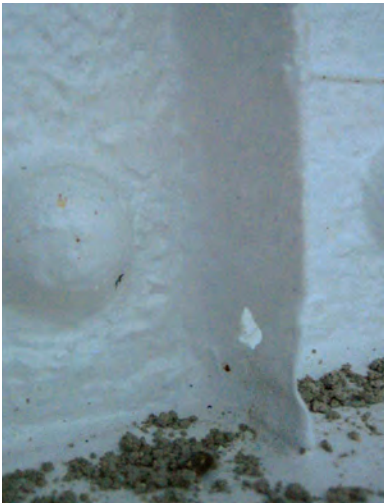
**Fig. 6.2.18**  
The web stiffener of this dormer spandrel had corroded through buckled at the base. Courtesy: Nelligan White Architects

In addition to tests for PCBs, lead-containing and asbestos-containing materials at the specific locations of proposed work, testing was carried out at the steel supports for the dormers and knee braces for roof trusses at the Gymnasium. It was observed that many of the dormer spandrels had yielded beyond the point of elasticity; spandrels were permanently and visibly deflected. Steel was also de-laminating and buckling at multiple locations.

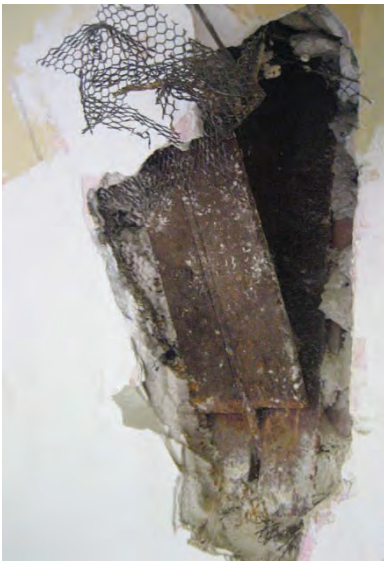
**Fig. 6.2.21 (below)**  
Knee brace connection to truss post shows corrosion. Courtesy: Nelligan White Architects

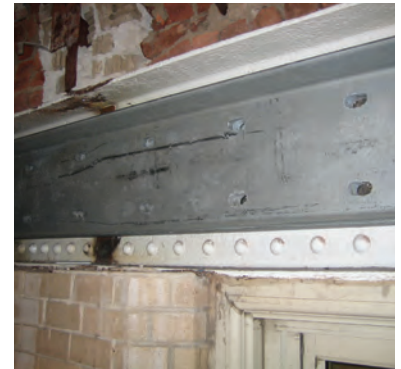
**Fig. 6.2.22**

New steel at spandrels to augment the deteriorated existing steel. Existing spandrel have been scraped and painted with a high-build epoxy paint (white) to deter further corrosion.

- Remove and replace failing terracotta lintels with cast stone replicas.
- Repair steel behind lintels with plate steel, primed and painted.
- Provide additional provisions for steel and cast stone for discovered conditions.
- Provide additional provisions for power tool cleaning of existing steel, priming and painting with high-build epoxy paint.

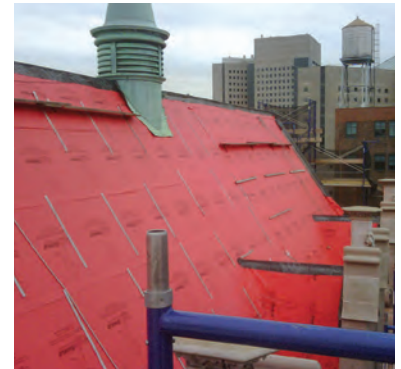
**Fig. 6.2.27**

Roof membrane has been replaced before reinstalling new terracotta tiles. Courtesy: Nelligan White Architects

- Remove and replace copper flashing at the dormers on the fifth floor.
- Remove and replace copper flashing at the gable ends of the four wings of the school.
- Remove and reinstall terracotta roof tile as needed to replace flashings, provide provision for replacement of broken tiles.
- Replace existing roof membrane as required.
- Remove and replace snow arrestors at all roofs.
- Flat roofs at the towers are to be replaced.

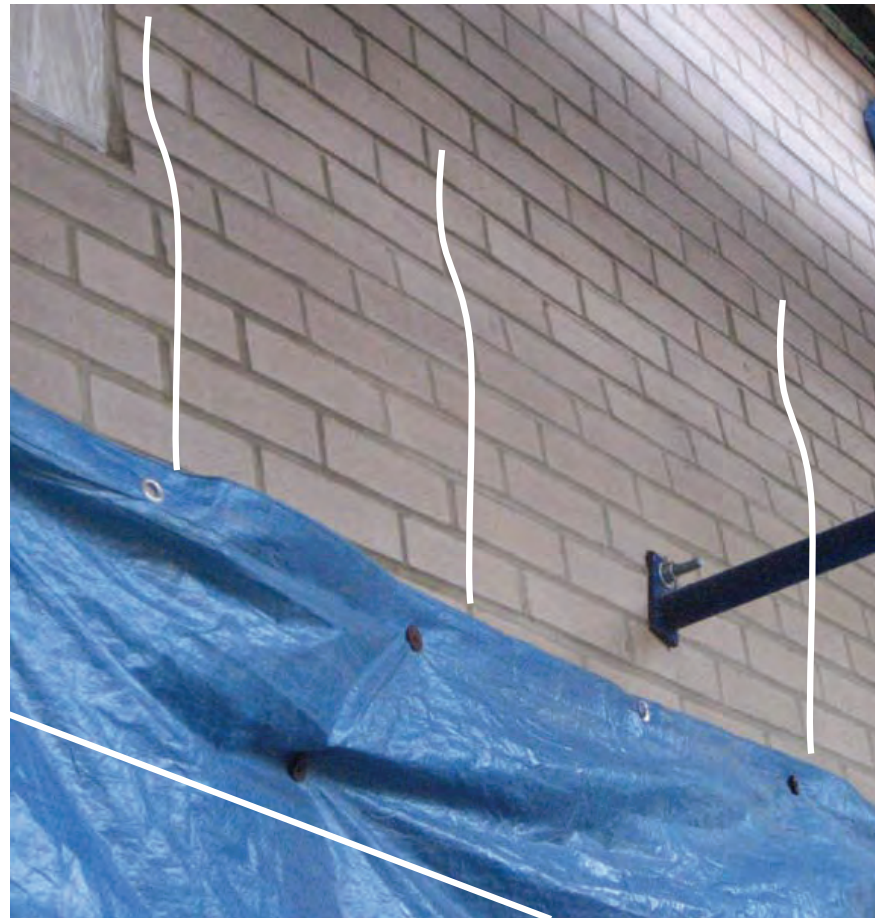
**Fig. 6.2.30 (right)**

The area where waves were observed, with lines superimposed, making difference in the face-brick obvious. Courtesy: Nelligan White Architects

Waves in the wall were observed where face-brick was falling inward at the fifth floor. It was assumed that some lateral movement occurred in the steel framing after initial construction, which was accompanied by the infill wall leaning with it, possibly to the point of cracking the veneer. This was caused by weakness of the corroded knee braces at the roof trusses. Face-brick had been replaced at some point because of cracking; however, this did not solve problems associated with the corroded steel.

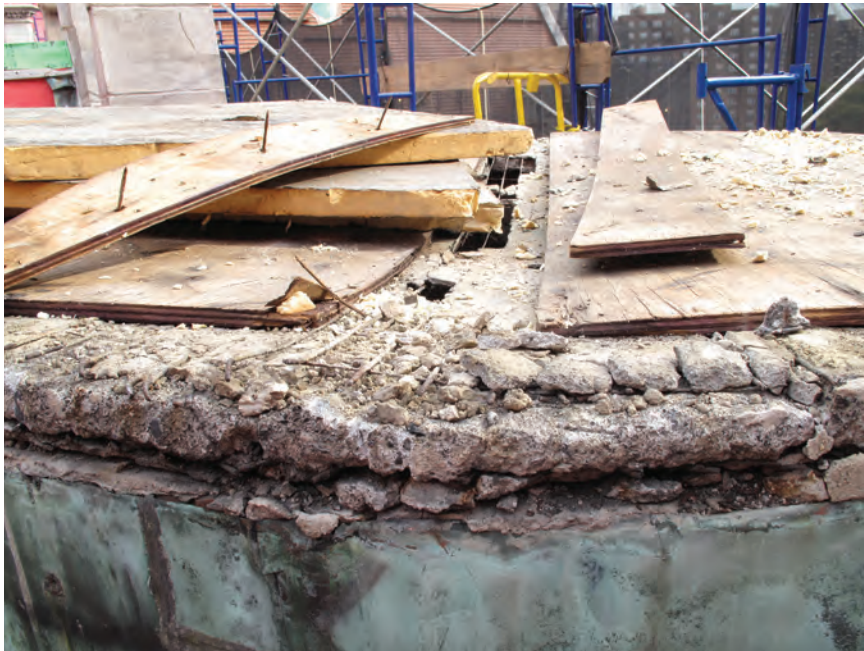
Fig. 6.2.33

**Fig. 6.2.32 (above) & 6.2.33 (left)**  
Concrete roof. Courtesy: Nelligan White Architects

When finishes were removed from the southwest observation tower (Fig 6.2.32) during construction, it was observed that the concrete slab which formed its roof was deflected and disintegrating. The structure was originally constructed of a 4" slab with welded wire reinforcing fabric, however, in its existing state there were holes in the concrete large enough to put a foot through (Fig 6.2.33), and fallen pieces of concrete were observed directly below. In the classroom below this roof, recurring water damage had been noted at the repaired surfaces. This discovered condition confirmed one of the many causes of moisture infiltration.

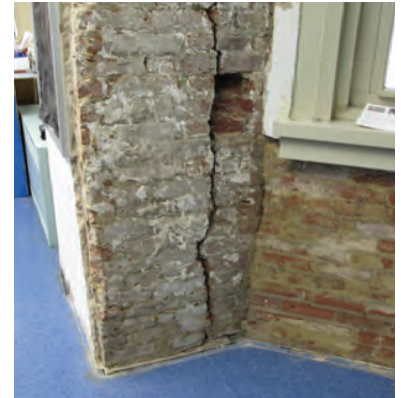
**Fig. 6.2.31**  
Cracked masonry wall. Courtesy: Nelligan White Architects

During the plaster repair of a brick-encased column, a crack was discovered. The crack ran through the brick, from the floor to approximately 1' below the ceiling, measuring  $\frac{3}{4}$ " in width. Upon removal of masonry, a corroded steel flange was found. Further inspection revealed that the steel was actually in fair condition. It was agreed that the crack may have been caused by racking and vertical deflection of the roof trusses loading the masonry.

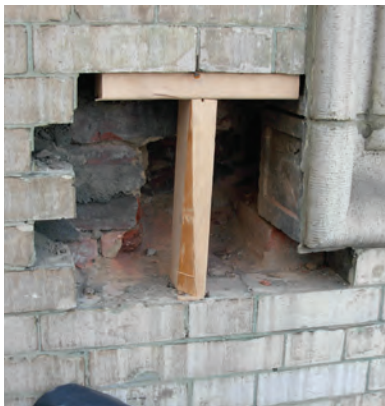
**Fig. 6.3.7**  
Probe at the original 1901-1904 building.  
Courtesy: Nelligan White Architects

Besides visual observations and assessment of the building's existing condition, early in the scoping phase of the project probes were initiated. Due to the lack of drawings related to the construction of the original building the probes were vital in determining the existing conditions in order to develop restoration details. Of the thirty-three probes requested only eighteen were performed, this was in part due to the difficulty of reaching the upper portions of the building.

When the brick masonry was removed at the probe locations the steel deterioration was observed.

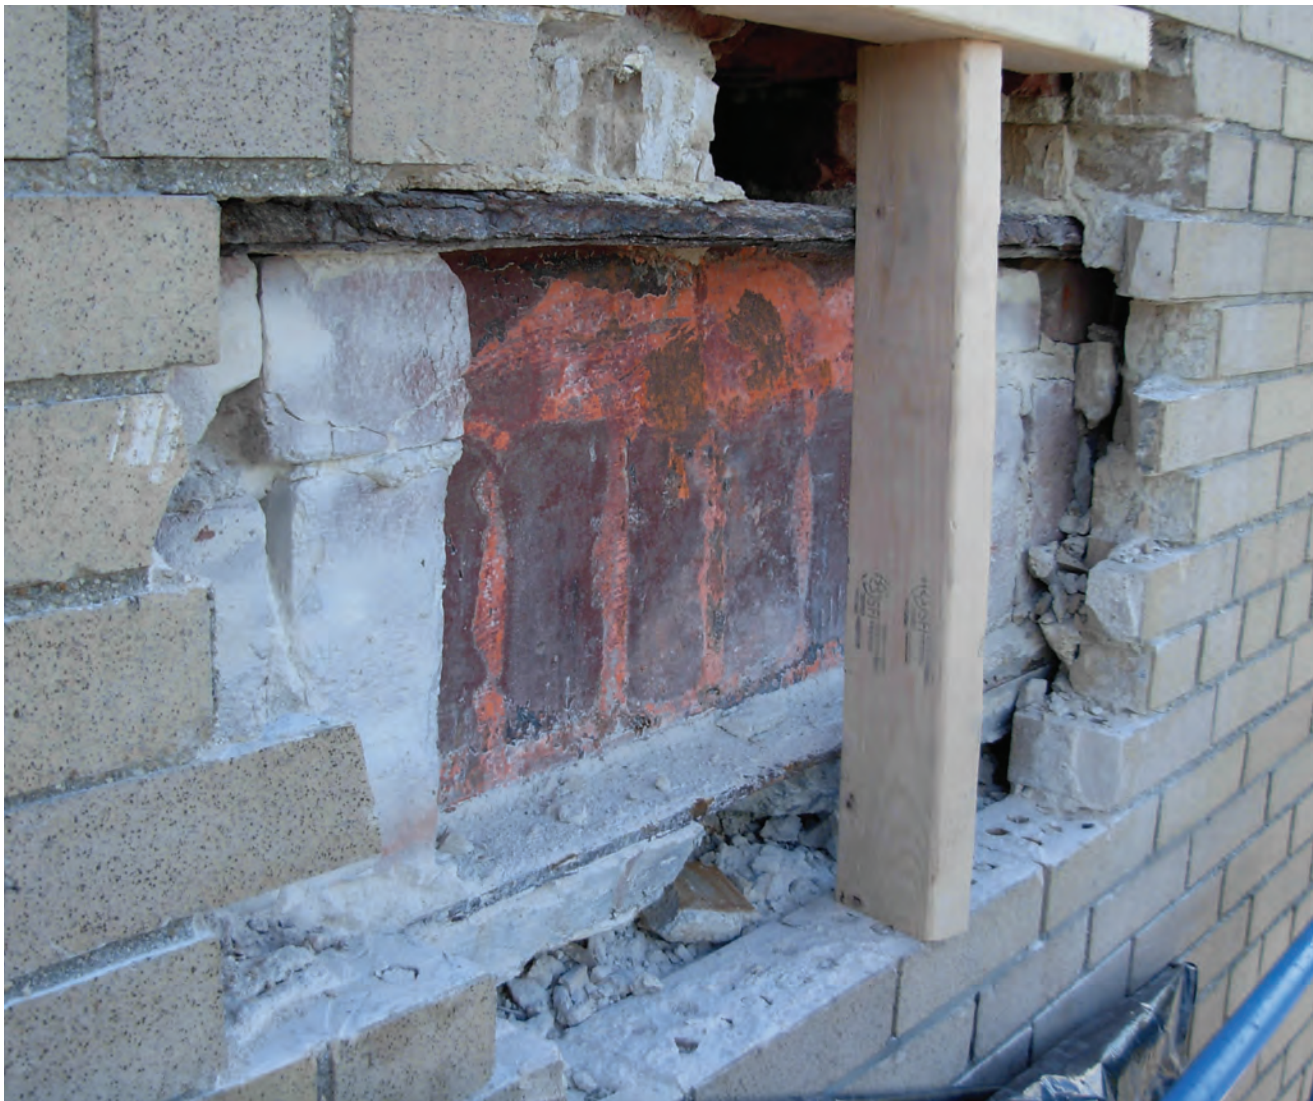
Fig. 6.3.8

**Fig 6.3.8 (below)**  
Probe at the 1950s addition. Courtesy: Nelligan  
White Architects

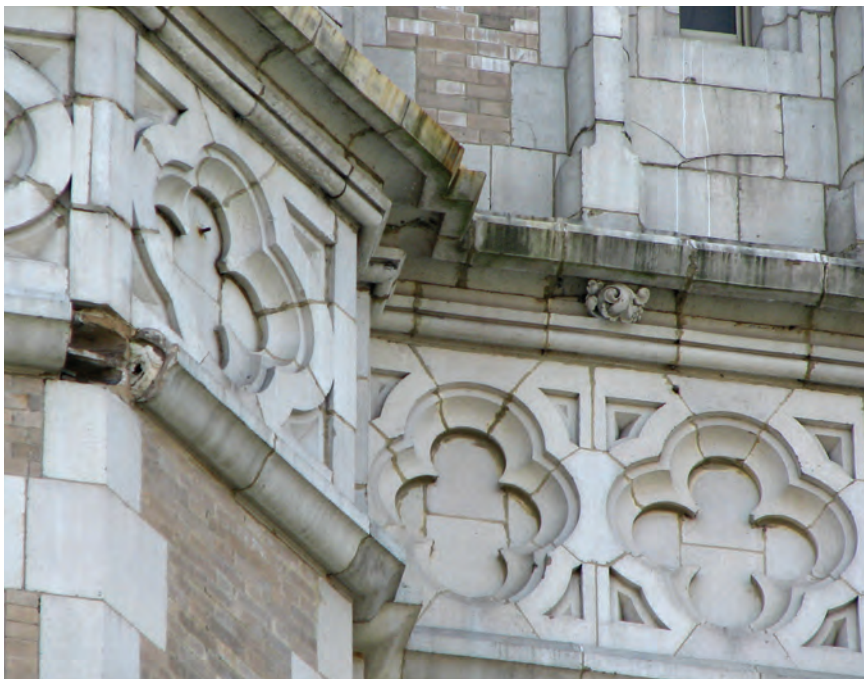
Fig. 6.3.13

**Fig. 6.3.13 (left)**  
Typical terracotta deterioration at eighth floor of tower. Courtesy: Nelligan White Architects

Terracotta damage was observed throughout the facades of the original building with the worst conditions being at the eighth floor of the tower and the gable copings. Severe cracking, spalling and failing joints were commonly observed.

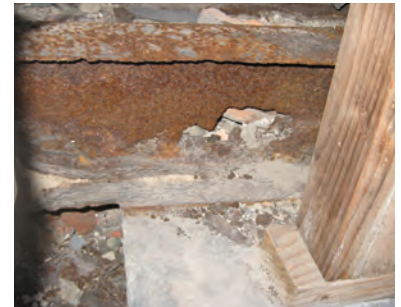
**Fig. 6.3.9**  
Deteriorated steel spandrel at gable. Courtesy: Nelligan White Architects

The steel within the gables was severely deteriorated due to ongoing moisture infiltration. Clogged gutter drains and scupper overflows were found to be the main culprit. The gutters would fill up with water which then traveled under the batten seam copper roofing and into the attic crawlspace and wall structure below.

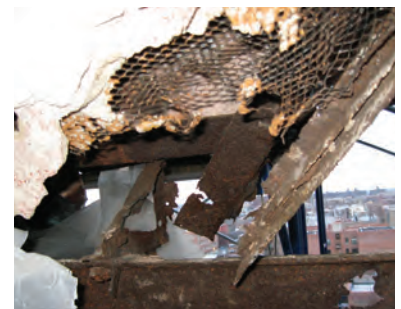
**Fig. 6.3.10**  
Deteriorated gutter and gable roof framing. Courtesy: Nelligan White Architects

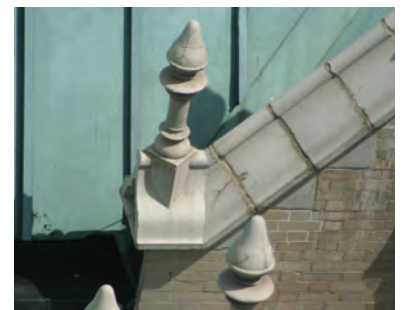
**Fig. 6.3.11**  
Typical terracotta deterioration at gable copings. Courtesy: Nelligan White Architects

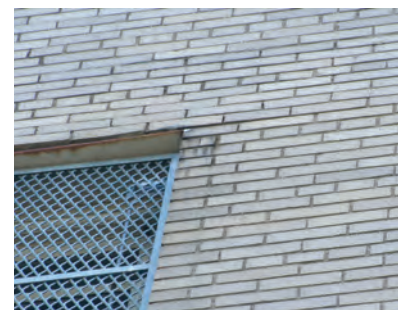
**Fig. 6.3.12**  
Lintel distress at addition. Courtesy: Nelligan White Architects

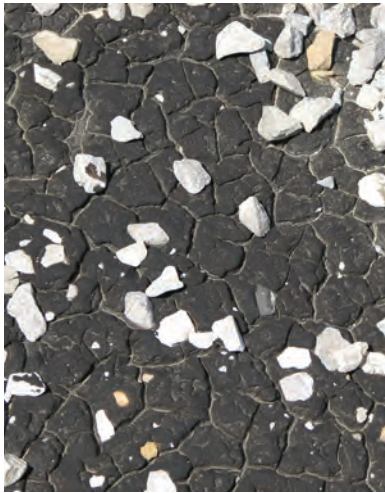
**Fig. 6.3.14**  
Typical roof membrane cracking. Courtesy: Nelligan White Architects

The steep-sloped copper roofs were in good to fair condition, with the exception of the deteriorated gutters. Built-up roofs were found to be in fair to poor condition, and all had expired warranties. Notable defects in the flat roofs included cracking throughout the membrane, punctures, missing gravel, bubbled bitumen and deteriorated seams, exposed fiberglass reinforcement tape; standing and trapped water below membranes, and interior water damage.

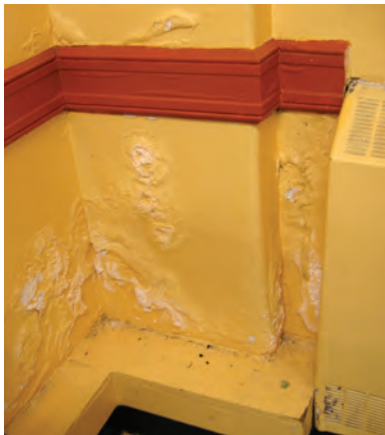
**Fig. 6.3.15**  
Typical interior damage due to water infiltration below areaway. Courtesy: Nelligan White Architects

Occupied basement rooms adjacent to all (4) areaways exhibited interior finish damage. The observed damage was thought to be related to site issues including insufficient slab pitch, standing water/clogged drains, plant growth at the areaway slab's junction with main building wall, and areaway grating supported by wooden shoring.

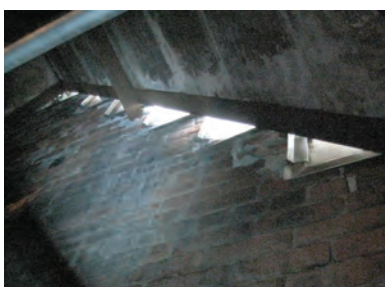
**Fig. 6.3.16 (below)**  
Stepped interior of gable wall. Courtesy: Nelligan White Architects

A secondary source of the moisture infiltration was observed to be the connection of the batten seam roof to the back of the gable wall. The stepped nature of the gable wall led to the bases of the copings extending below the gable roof and the copper roofing was turned up the face of the copings. This did not provide for a tight connection and water was able to enter between the roof flashing and the back of the copings.

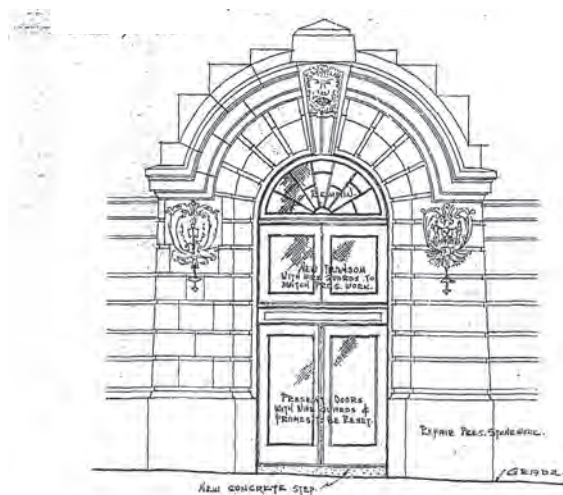
**Fig. 6.4.7**

**Fig. 6.4.7 (right)**

Entry detail at the front of the building. Courtesy: SCA Alchemy

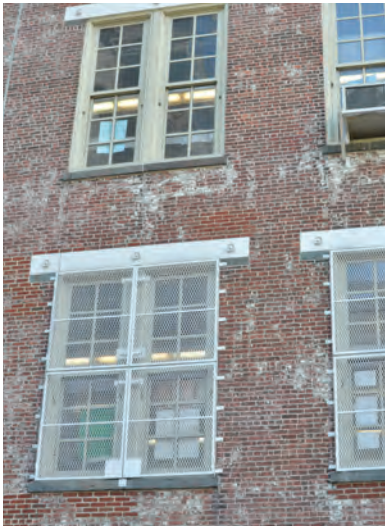
**Fig. 6.4.9 & 6.4.10 (above - below)**  
Exposed backup masonry in a classroom after repeated leaks prompted the removal of plaster as a safety precaution. Efflorescence is present on much of the exterior especially on the north facades. Courtesy: Nelligan White Architects

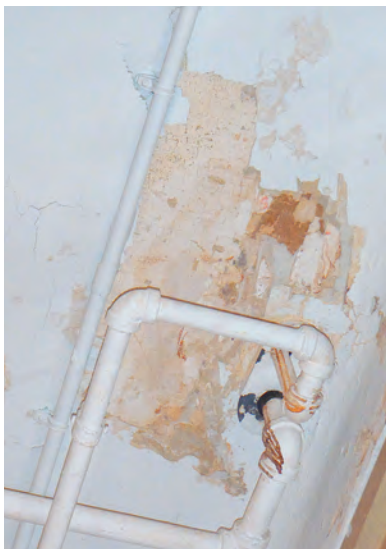
**Fig. 6.4.12**  
 Water damage visible at the interior of a classroom. Courtesy: Nelligan White Architects

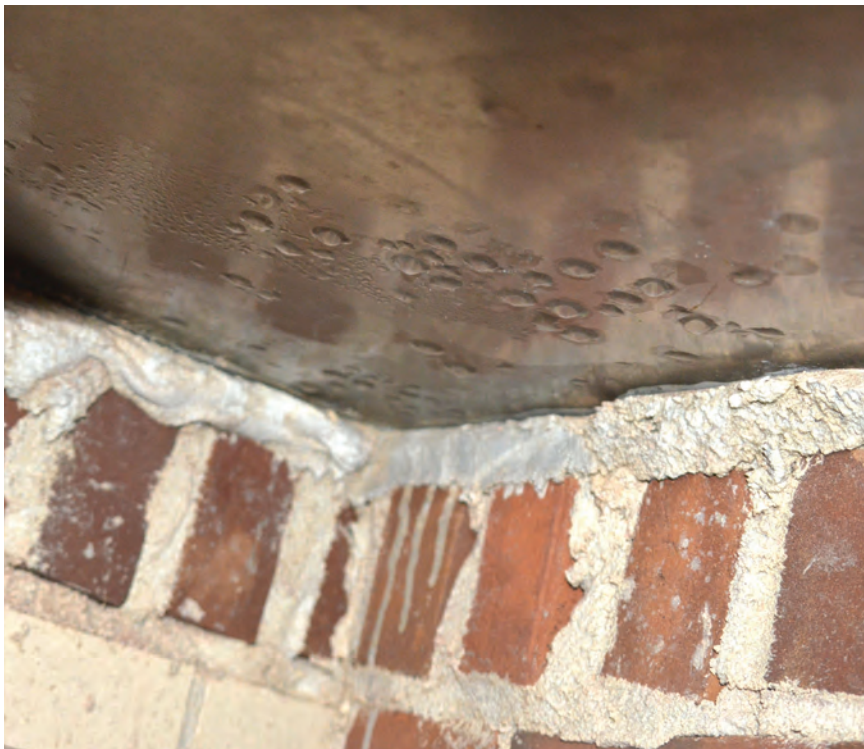
Fig. 6.4.16

**Fig. 6.4.16 (left)**

The bastion caps, replaced in the 2008 campaign, were found to be hollow with visible water droplets present. Drawings from that repair did not indicate these caps to be hollow yet the detail was changed during construction. They are believed to be significant sources of water infiltration at the roof level. Courtesy: Nelligan White Architects

In this same campaign, the brick masonry, terracotta and stone base were repointed entirely on all elevations below the fifth floor sill. As observed in the probes on the south elevation, this repointing mortar appeared to be applied at an inadequate depth and contain voids. The four bastion caps at the parapet were replaced in the 2008 campaign as well. They are believed to be significant sources of water infiltration at the roof level. Efflorescence was observed on the exterior of all of the caps. A probe at one of the caps verified that it was hollow and wet on the interior with extensive damage in the area directly below.
