# New York City's Historic Schools

A History and Guide to Rehabilitation

NYC SCHOOL CONSTRUCTION AUTHORITY

This Guide has been developed as a practical and technical resource to assist in the evaluation and design for the restoration of historic school buildings (more than 45 years old). It is worth noting that over half of our public school buildings are more than 60 years old! It is our intention to facilitate strategies for these projects that will target cost effective solutions while at the same time respecting their historic standing as landmarks in the community.

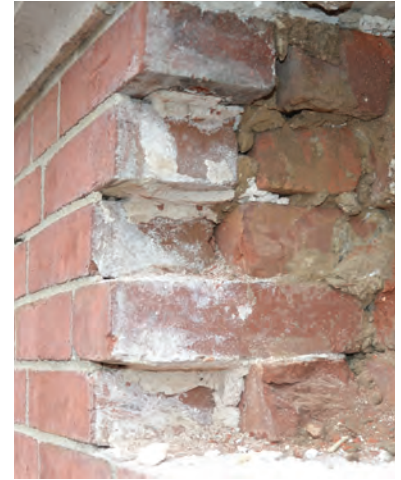
**Fig. 6.4.14**

During the probe explorations voids were found throughout the masonry assembly. It was also discovered that voids existed in the collar joints where earlier repairs had taken place in 2008, against SCA standard specifications. Courtesy: Nelligan White Architects

The backup masonry was quickly determined to be a source of water infiltration. Voids in the masonry and mortar were observed in four of the six exterior probes on the south elevation. Brick-sized terracotta headers with longitudinal hollow cores were used throughout the backup masonry and serve as conduits for water. The backup mortar appeared very damp and highly deteriorated where the lime has washed out. The remaining mortar is brown and soft enough to remove with a finger, the effect of slow moisture infiltration over many years directly through the face brick. Leaking appears to be occurring randomly throughout the building, mostly on the upper floors, but at the middle and lower floors as well, particularly on the north and south elevations that are more exposed to the elements (east and west sheltered by adjacent buildings).

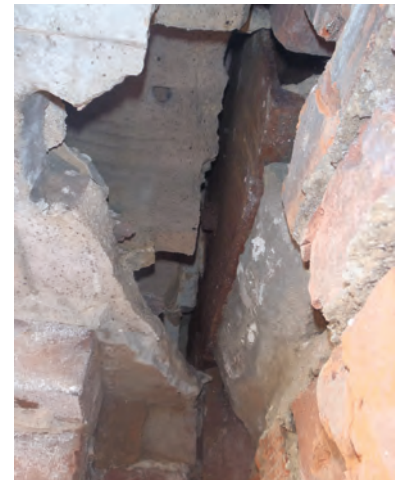
**Fig. 6.4.15**

Repointing that took place during the 2008 campaign appeared to be at an inadequate depth and contain voids. Backup masonry was found to be deteriorated and damp. Courtesy: Nelligan White Architects

In this same campaign, the brick masonry, terracotta and stone base were repointed entirely on all elevations below the fifth floor sill. As observed in the probes on the south elevation, this repointing mortar appeared to be applied at an inadequate depth and contain voids. The four bastion caps at the parapet were replaced in the 2008 campaign as well. They are believed to be significant sources of water infiltration at the roof level. Efflorescence was observed on the exterior of all of the caps. A probe at one of the caps verified that it was hollow and wet on the interior with extensive damage in the area directly below.

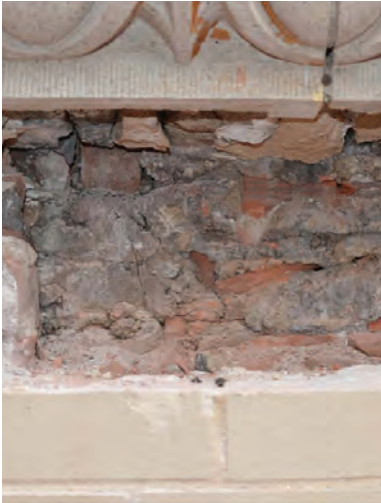
**Fig. 6.4.17**  
Deteriorated back up brick at probe 3. Courtesy:  
Nelligan White Architects

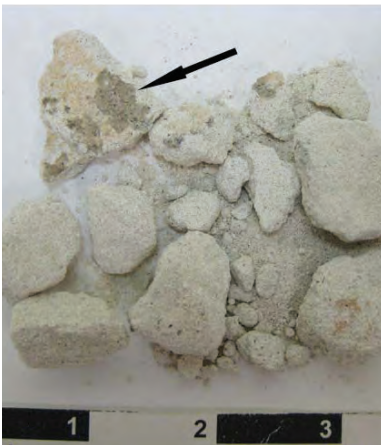
**Fig. 6.4.18**  
Mortar sample provided, the mortar is uniform in  
appearance and nearly white in color. The arrow  
indicates a residue of brownish gray material  
identified as a natural cement mortar. Courtesy:  
Nelligan White Architects

Petrographic analysis provided a breakdown of the mortar's contents; a cement-lime mortar with quartz sand and relatively high lime content. The mortar is soft and relatively absorptive, but no evidence of cracking due to physical deterioration was observed. Gray portland cement was identified in this mortar. A portion of the submitted sample contained residue of the backup brick bedding mortar, which was found to contain natural cement. The four mortars from the probe locations used four distinct sands, which may account for the slight variations in color between the similar backup or face-brick mortars.

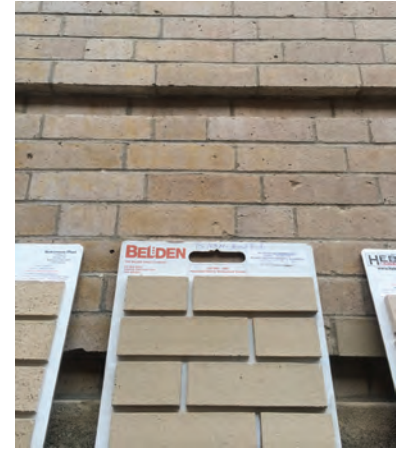
Fig. 6.4.19

Samples of replacement face brick for the piers on the south elevation. Courtesy: Nelligan White Architects

- Remove and replace all face brick on all facades
- All exposed backup masonry shall be repaired, repointed, and parged
- Spray apply liquid membrane waterproofing, and attach narrow cavity drainage plane and weeps
- Provide new Micro-cotta simulated stone cornice with galvanized support
- Provide new APC window lintels and new cast stone window sills at all elevations on the fifth floor
- Provide expansion joints and continuous relieving angles at all elevations
- Install horizontal soft joints at all elevations.
- Install masonry stabilization (SS rods set in back up masonry) throughout entire face wythe
- Repair stucco at West facade, incorporate spray applied membrane waterproofing, 3" mineral wool insulation, drainage fabric and 3 coats stucco on furring channels and stainless steel lath with control joints
- Replace sills and exposed lintels on west facade

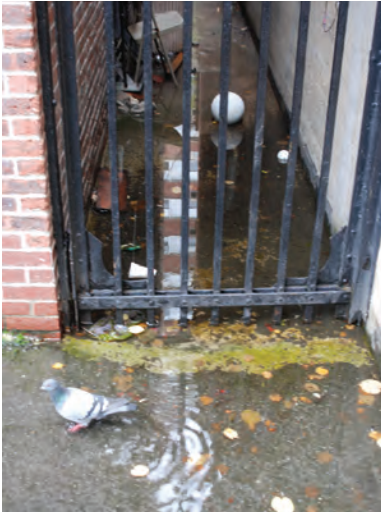
**Fig. 6.4.22**  
Ponding observed at west alley, caused by improper slope. Courtesy: Nelligan White Architects

### 2. Sitework (Fig. 6.4.22, 6.4.23 & 6.4.24)

- Remove and replace the paving at the west alley with a new concrete slab sloped toward the rear yard where there are two existing drains
- Provide backer rod, compressible filler and sealant, and joints adjacent to buildings
- Remove and replace the areaway grate and frame
- Clean and hydro-scrub the existing drains
- Remove and reinstall the escape hatch and frame
- Remove the existing slab and provide a new waterproofed slab at escape-hatch

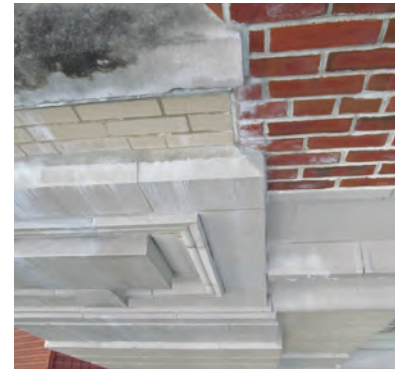
**Fig. 6.4.26**

Efflorescence, staining, and organic growth present at current parapet, bastion cap, and cornice. Courtesy: Nelligan White Architects

- Remove all parapet elements down to roof slab
- All exposed backup masonry shall be repaired, repointed and parged and subsequently protected with new SS through wall flashing
- Install a new reinforced parapet set on a continuous relieving angle
- Install new SS coping flashing and coping stones on parapet
- Remove and replace the existing masonry at the buttress parapet wall and bastion caps with new GFRC caps on stainless steel flashing over a poured in place concrete slab with a closed cell foam solid infill
- Replace the existing terracotta string course and panels at the bastion caps at the south elevation.
- Remove and replace 3' perimeter roof and base flashing associated with parapet replacement at the main roof
- Remove and replace slag/corrugated arches at buttress area.

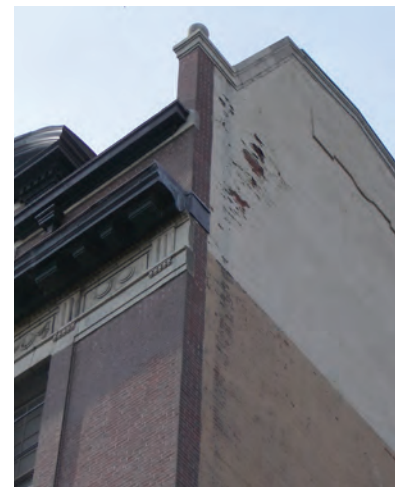
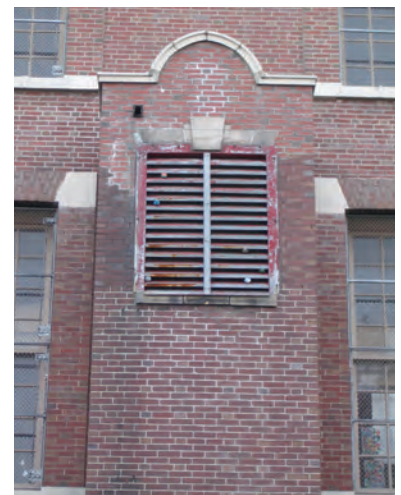
**Fig. 6.5.11 & 6.5.12 (above - below)**  
Deteriorating sealant on north-east facade. Deteriorated masonry around the louvers and scupper at the rear facade vent tower. Courtesy: Nelligan White Architects

Deteriorated elastomeric-waterproofing sealant was observed at the north-east facade. This deterioration is also causing spalling of the face-brick. Cracks were also observed at the north-east corner, probes found the cracks did not extend beyond the face-brick or to the interior. Damp masonry behind the sealant was found as well as deteriorated back up masonry. The collar joints were found to be open and/or washed out. Around the perimeter of the building brick repairs were observed as well as small areas of deterioration around the louvers and scupper at the rear facade vent tower.

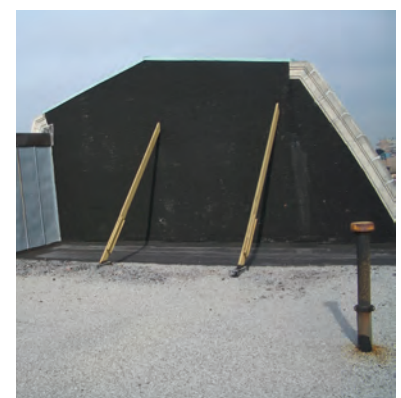
**Fig. 6.5.13**  
North-west parapet coated with asphaltic tar, braced with structural steel channels that bear directly against the masonry without any base plates. Courtesy: Nelligan White Architects

The building has two parapet walls approximately 15-feet high; one at the north-east corner and the other at the north-west corner. Cracks were observed at both parapets on the exterior and interior/roof facades. Both parapets were braced with structural steel channels that bear directly against the masonry without any base plates. The rear of the north-west parapet wall had been coated with asphaltic tar waterproofing, which was causing the masonry to spall in some locations and was likely masking cracks in the parapet (Fig. 6.5.13). Similarly, the rear of the north-east parapet wall was coated with stucco parging that is also spalling. Original building drawings showed no vertical reinforcing in the parapets, other than the observed steel braces. At the north facade (rear elevation), the existing parapet dropped to a height of less than 30-inches above the existing roof in five locations between the existing arched dormers. The low height of this portion of the parapet presented a potentially hazardous condition.

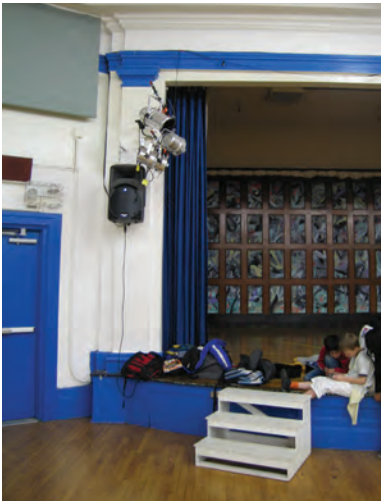
**Fig. 6.5.14 & 6.5.15 (above - below)**  
 Damaged ceramic tile in bathroom. Existing lighting and speaker in auditorium. Courtesy: Nelligan White Architects

Interior water-damaged plaster was observed in the bathrooms at the north-east end of the building on all floors. The damage appeared to be the result of the failure of the elastomeric-coated masonry. Water has also damaged portions of the ceramic wall tile in these bathrooms (Fig. 6.5.14). Additional water-damage was observed along the entire north wall of the 5<sup>th</sup> floor. This damage was likely the result of both cracks in the exterior masonry and the failing roof system.

Current stage lighting was limited, including a row of PAR-type spotlights located behind the stage curtain and rudimentary spot lighting mounted on arms to either side of the stage proscenium. (Fig. 6.4.15). Sufficient electrical power for theatrical lighting was either nonexistent or too antiquated for current requirements. An unused projection booth was observed opposite the stage, on the west wall. A total of 26 enclosed two-lamp fluorescent fixtures were surface mounted along the lengths of the existing plaster-encased ceiling beams. Additional lighting was provided by 6 scone uplights, all protected by wire guards, which were located along the north and south walls of the auditorium. The electrical panel serving the stage, auditorium, and possible other areas was located in the west property room.

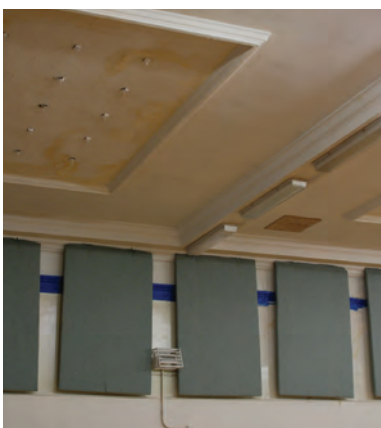
**Fig. 6.5.16 (above)**  
 Water damage at ceiling and acoustical tiles on wall. Hooks were observed from ceiling acoustical tiles that were removed. Courtesy: Nelligan White Architects

Plaster ceilings were painted off-white. Eight original skylights were filled in to be in line with the existing ceiling. Water-damage was observed from continual infiltration during the last four months of 2007. Damage was concentrated along one beam at the north-west corner of the space. Acoustic panels, similar to the existing wall panels, had been hung from the recesses of the filled in skylights in the ceiling, but were removed when the panels began to fall off of the ceiling. (Fig. 6.5.16).

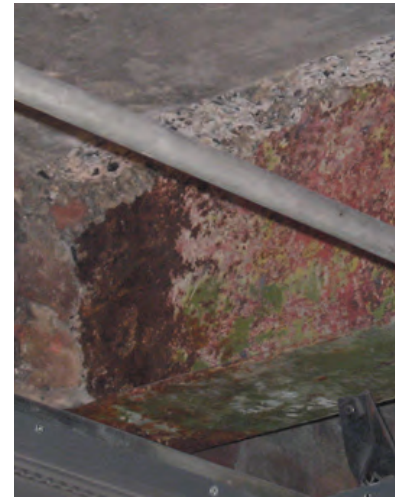
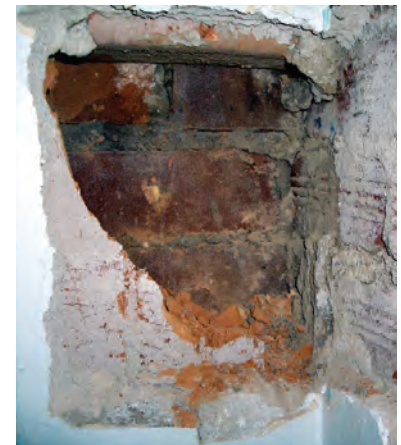
**Fig. 6.5.22 & 6.5.23 (above - below)**  
Saturated concrete encase steel beam at the auditorium. Interior probe revealed crack observed on the north-east facade did not go through the wall, however, the observed mortar was damp. Courtesy: Nelligan White Architects

Two probes were opened at vertical cracks observed in the masonry of the north-east corner; one at the third floor (Fig. 6.5.24), and the other at the fifth floor. Where the crack aligned with the mortar joints of the back-up masonry, the depth was measured at up to 8-inches (Fig. 6.5.25). In all other observed areas, however, the crack did not extend beyond the face-brick. The interior probe of the plaster in the fourth floor Girl's Toilet Room confirmed that the cracks observed on the building exterior do not extend through to the building interior. Inspection of the exterior probed areas revealed generally damp masonry behind the elastomeric coating. (Fig. 6.5.23). These damp conditions appeared to be the result of moisture trapped behind the impermeable coating. The backup masonry at the probe locations was in relatively poor condition, and the mortar and collar joints were open and/or washed out. A probe was taken at the location of the water damage at the auditorium ceiling, and it was found that the concrete encasement of the steel beam had been saturated with water and dripped to the ceiling below. (Fig. 6.5.22)

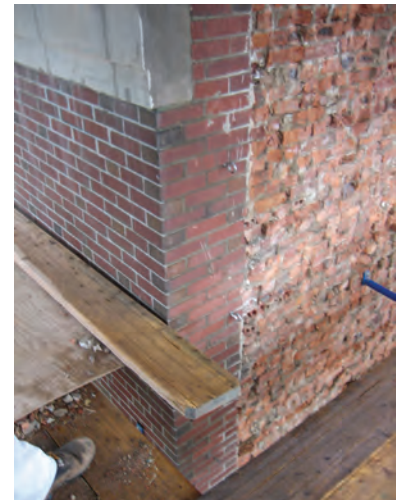
**Fig. 6.5.28**

Exposed backup brick awaiting new face-brick wythe. Courtesy: Nelligan White Architects

- Replace face-brick of all elastomeric-coated masonry at the north-east facade of the main building
- Special precaution should be noted due to the deteriorated backup masonry when performing the demolition of the face-brick (Fig. 6.528)
- Additional reinforcing at the building corners at Grove Street is to be considered to prevent future cracking of the replacement face brick
- Replace the face-brick around the failing scupper and rusting louvers at the rear playground vent tower facade
- Replace scupper, flashing, and metal louvers
- Remove existing lintel above the 2<sup>nd</sup> floor playground door at the north-east facade
- Provide new galvanized loose lintel with copper composite flashing
- Replace existing door and frame with new hollow metal door and frame
- New masonry should match existing

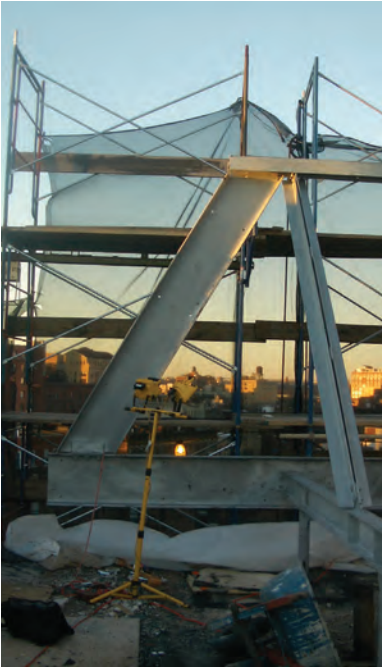
**Fig. 6.5.29**  
New structural steel parapet bracing under construction. Courtesy: Nelligan White Architects

- Remove and replace existing 16-inch wide solid masonry parapets including vertical rebar and truss wythe reinforcing
- Provide new galvanized structural steel parapet bracing and bearing plates (Fig. 6.5.29)
- Repair existing slate mansard roof and copper step flashing at parapets
- Coordinate parapet work with roofing work
- Provide galvanized steel guardrail, 42-inches tall, inset from parapet and hidden from sight lines at the low portions of parapet along the north facade

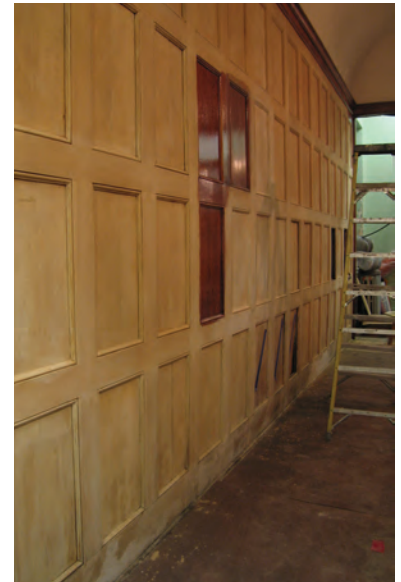
**Fig. 6.5.31**  
Panel partition folds into niche when open.  
Courtesy: Nelligan White Architects

- Refinish stage floor
- Restore wood paneling surrounding the stage (Fig. 6.5.31)
- Investigate new folding or movable seating systems, including storage implications
- Purchase three 9-foot collapsible risers for use in school productions
- Refinish and patch floor as necessary
- Remove existing hooks from the filled in ceiling surface of former skylights
- Investigate feasibility of raising the height of the infill
- All walls are to be repainted after plaster repair is completed

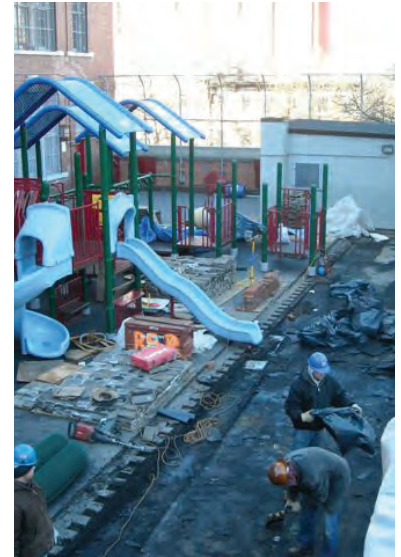
**Fig. 6.5.35**

Roofing repair at playground. Courtesy: Nelligan White Architects

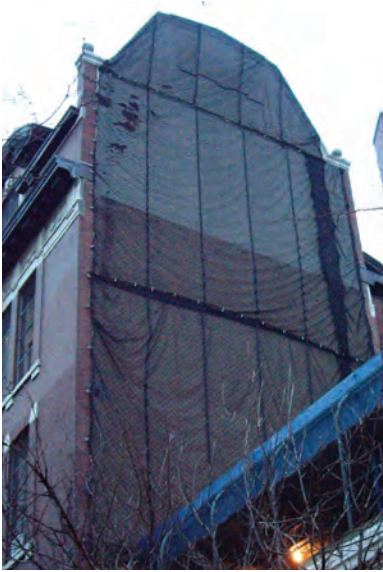
**Fig. 6.5.37**  
Netting was installed to prevent more sealant and brick from falling off. Courtesy: Nelligan White Architects

An elastomeric-waterproofing sealant had coated the entire north-east facade at the end of the main building. Overall the sealant was in poor condition; peeling and bubbling was observed throughout. As a result, brick that was exposed was also in poor condition, as the sealant had been fraying off fragments when it peeled away. Vertical cracks that aligned with the mortar joints were also observed at the north-east facade.

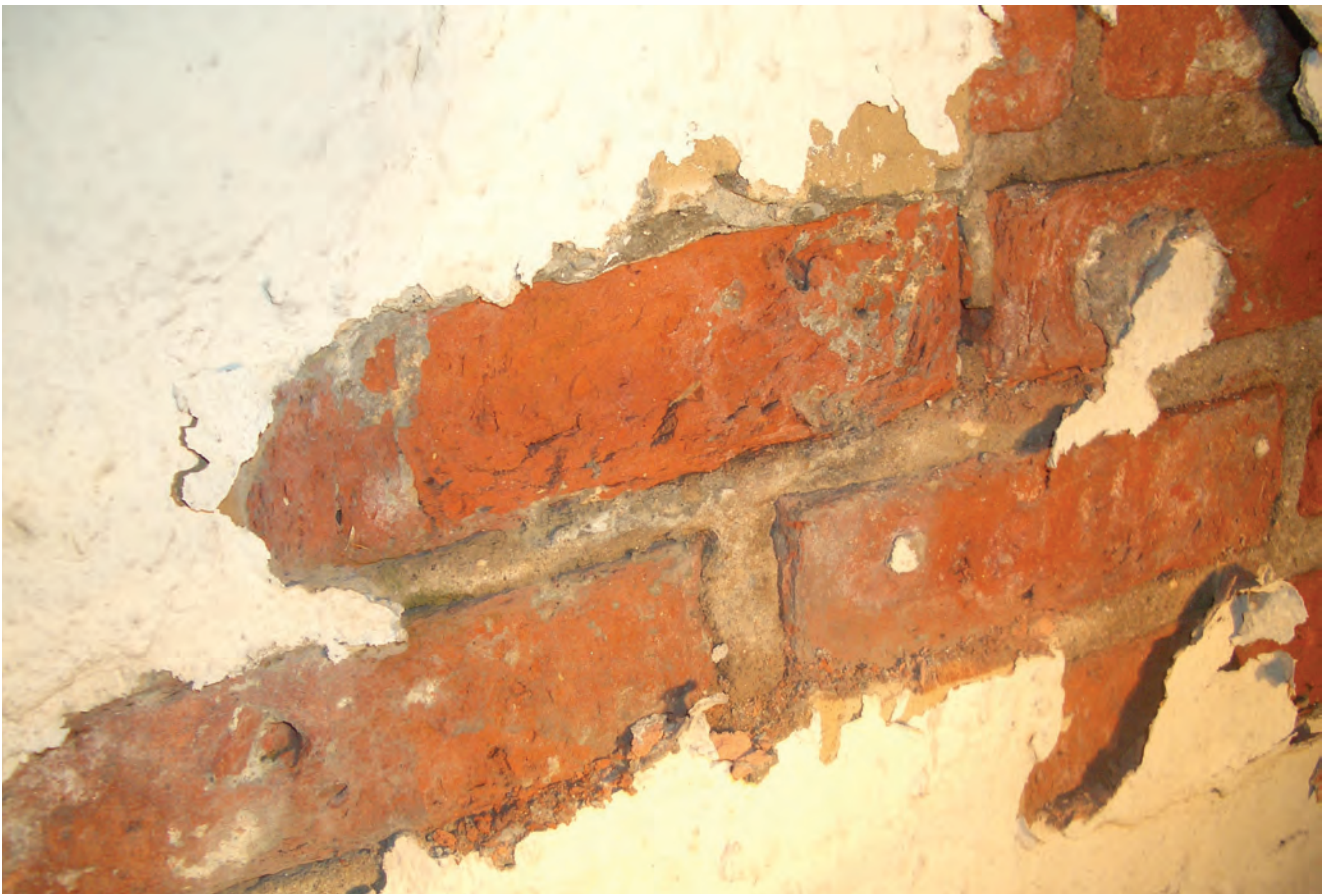
Fig. 6.5.38

**Fig. 6.5.38 (below)**  
Deteriorated brick at north-east facade. Courtesy: Nelligan White Architects

Through investigations, it was determined that moisture was becoming trapped behind the impermeable elastomeric coating causing the deterioration. While the masonry was found to be damp along with mortar and collar joints open the cracks observed were not found to extend beyond the face-brick.

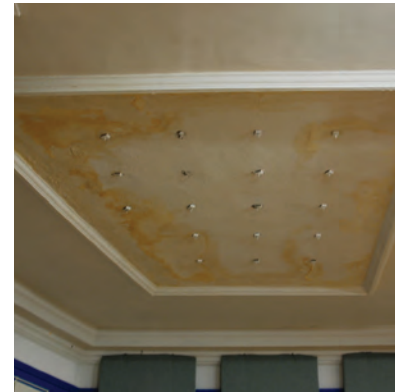
**Fig. 6.5.39**  
Water-damage at auditorium ceiling. Courtesy: Nelligan White Architects

Before work began on the auditorium, leaking was observed at the ceiling in the last few months of 2007. This leaking was a new occurrence and had not been observed before. While the water-damage was visible throughout the ceiling finish, the primary concentration of water was located along one beam at the north-west corner of the space. A probe taken at this location found that the concrete encasement of the steel beam had been saturated with water and dripped to the ceiling below.

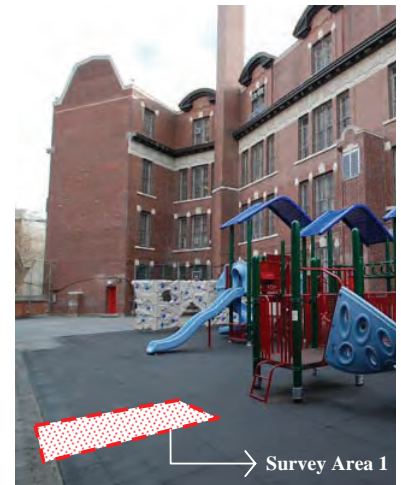
**Fig. 6.5.40**  
Area of roof above most significant leaking. Courtesy: Nelligan White Architects

Taking the lack of water ingress at the parapets into account, the findings definitively illustrated that the main source of water infiltration at the beam comes from the area of the play roof, approximately 9'-6" in from the interior edge of the north parapets, directly above the beam. Since this location falls well within the new roof assembly, it was most likely that the detail for the installation of the new roof assembly at the edge of the existing roof was not executed properly and was resulting in water infiltration.

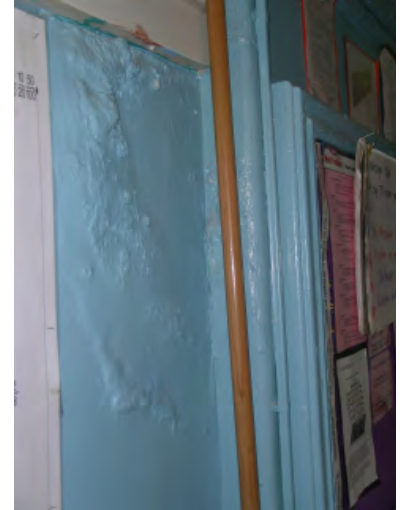
**Fig. 6.6.4 (above)**  
Typical Interior Plaster Damage. Courtesy: RKTB Architects, P.C.

The school had severe interior water damage on the fourth floor and moderate damage on the lower floors. Water damage consisted of plaster damage in most rooms. In the most severe areas the plaster and 2" interior layer of terracotta block had collapsed exposing a damp brick wall.

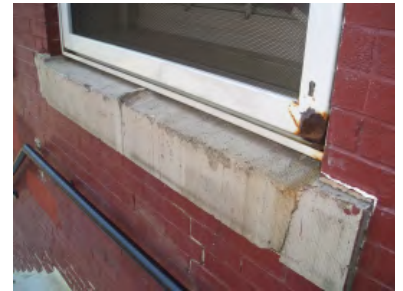
**Fig. 6.6.6**  
Damaged terracotta sill. Courtesy: RKTB Architects, P.C.

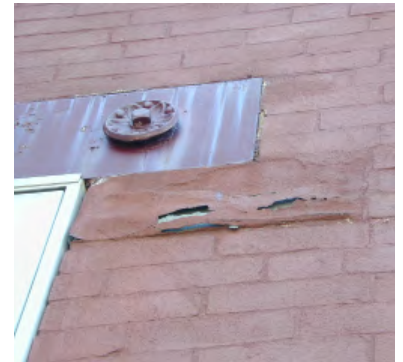
**Fig. 6.6.7**  
Existing steel header resting on coated blue stone bearing block. Courtesy: RKTB Architects, P.C.

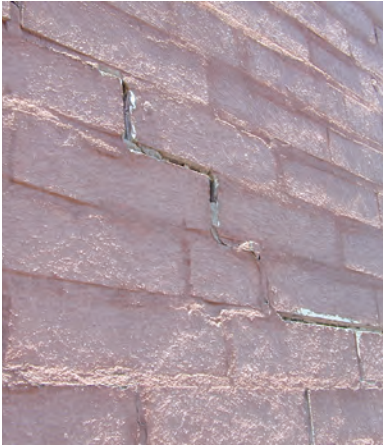
**Fig. 6.6.8**  
Cracking over an area of masonry with a non-breathable coating, which was later found to contain asbestos. Courtesy: RKTB Architects, P.C.

- Brick masonry was coated with a non-breathable masonry coating. The coating was spalling in many areas, with large flaking pieces falling off of the building surface. Later ACM testing found the building coating to be asbestos containing.

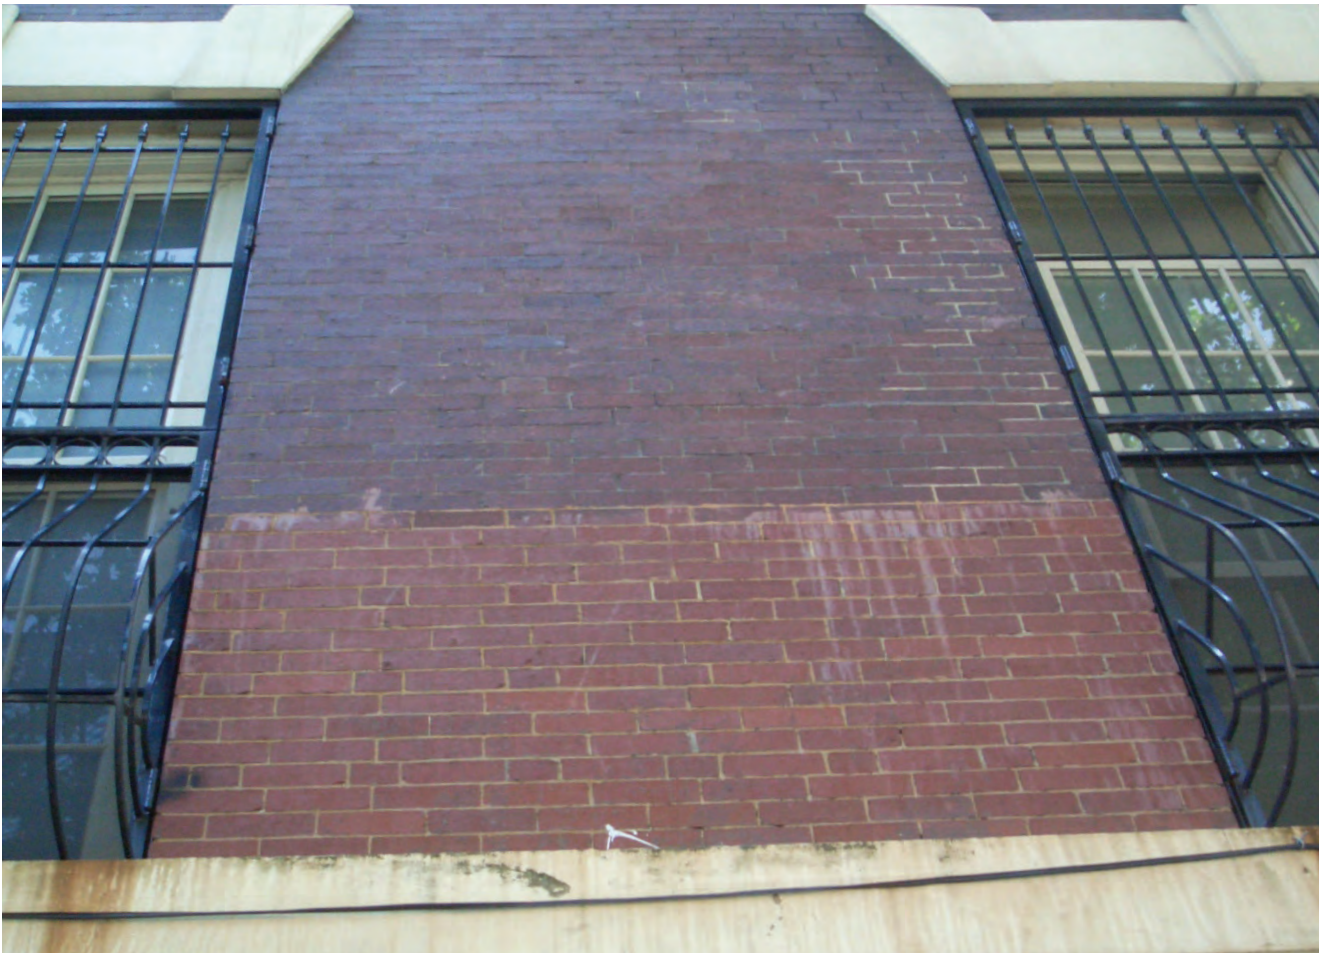
Fig. 6.6.9

**Fig. 6.6.9 (below)**  
Close-up of face brick showing discoloration, inconsistent mortar joints, and flaking paint at the limestone below. Courtesy: RKTB Architects, P.C.

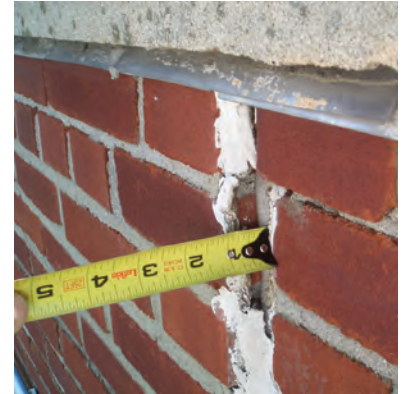
Fig. 6.6.10

Failed expansion joint and shifted parapet. Courtesy: RKTB Architects, P.C.

- The original parapet was replaced during a 1991 parapet replacement project. Existing parapet was in very poor condition. A large part of the parapet facing Pitkin Avenue had shifted and was structurally unsound. After the initial site visit sidewalk bridging was requested in areas of hazardous masonry.
- Caulking at parapet expansion joints had failed.
- Parapet masonry was saturated with moisture and moss growth was found on the mortar joints.
- A large portion of the parapet interior had a black coating.
- Through-wall flashings and cap flashings were in poor condition.

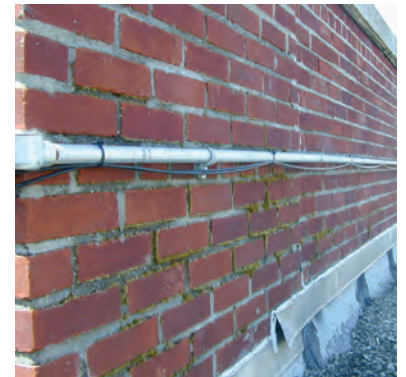
Fig. 6.6.11

Vegetation at parapet mortar joints. Courtesy: RKTB Architects, P.C.

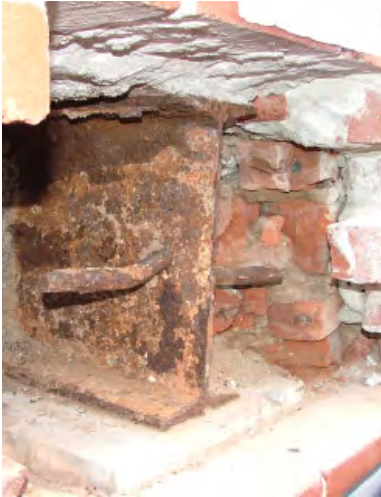
**Fig. 6.6.14**  
Probe showing the bearing end of steel beam.  
Courtesy: RKT Architects, P.C.

1. **Window header beams:** Probes showed that the existing steel had no flashing except in areas where the new parapet was installed. Most of the exposed steel was found rusted but not deteriorated.
2. **Lintels:** Existing lintels were deteriorated to varying degrees throughout the building.
3. **Floor beams:** Floor beams at masonry piers bear directly onto masonry walls. Some beams were installed directly behind the face bricks. In these areas, the ends of the floor beams had rusted causing cracks in the face brick.

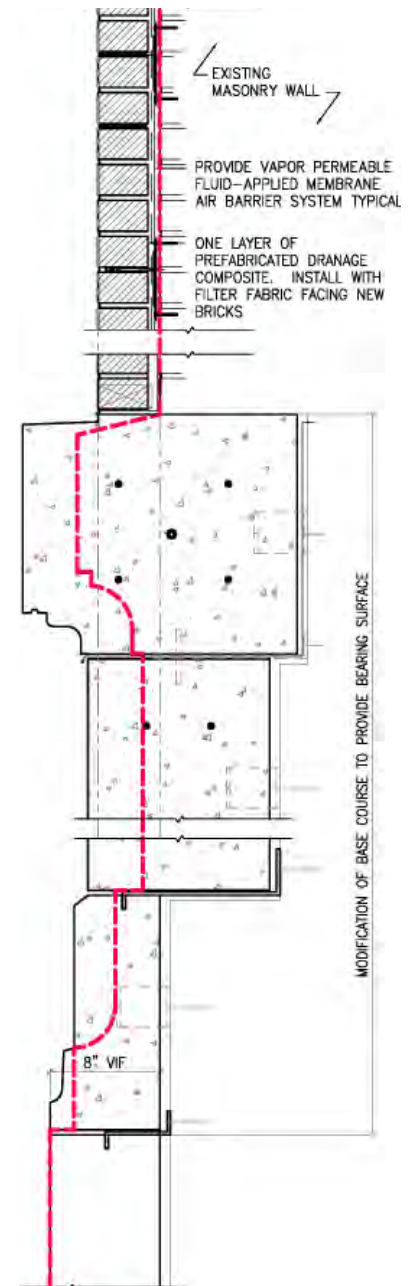
**Fig. 6.6.16**  
The above wall section shows the line of the original face-brick and the line of the new face-brick. It also shows the proposed modification of the base stones. The new stones provide a bearing surface for the additional wythe of brick. The red dashed line represents the original profile. Courtesy: RKTB Architects, P.C.

3. A layer of vapor barrier was applied to the masonry similar to Tyvek. (Note: in future projects we use liquid vapor barrier).
4. The top stones of the limestone base were replaced to provide a bearing surface for the new wythe of face-brick (Fig. 6.6.16)

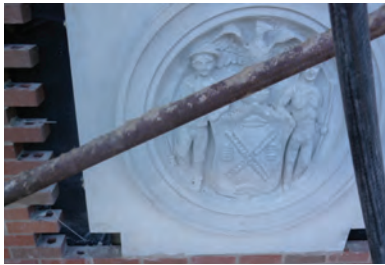
**Fig. 6.6.17 (above)**  
Replication of historic seal with cast stone.  
Courtesy: RKTb Architects, P.C.

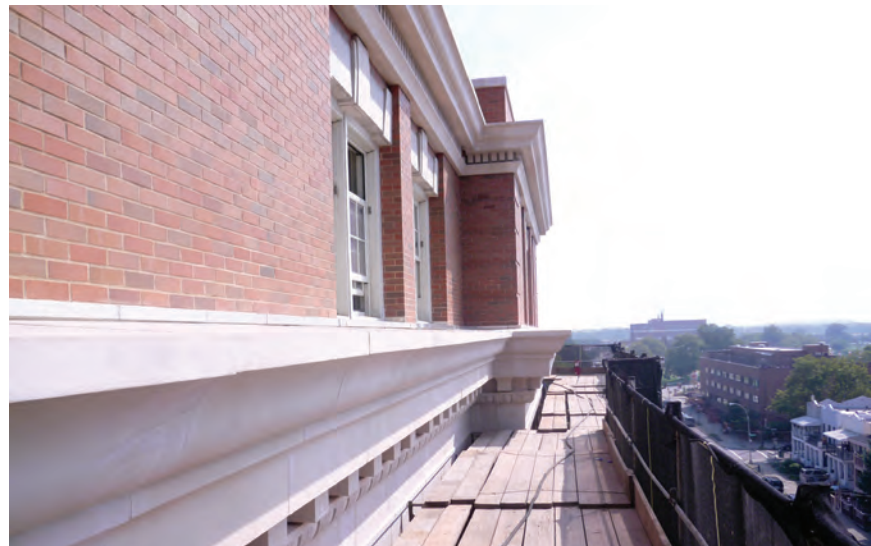
Fig. 6.6.18

**Fig. 6.6.18 (right)**  
View from 4<sup>th</sup> floor scaffold after installation of brick over-cladding and GFRC cornices.  
Courtesy: Nelligan White Architects

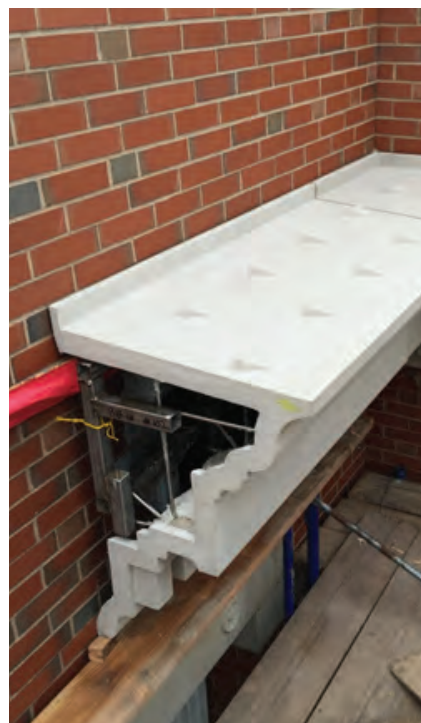
Fig. 6.6.19

**Fig. 6.6.19 (below right)**  
Installation of GFRC cornice. Courtesy: RKTb Architects, P.C.

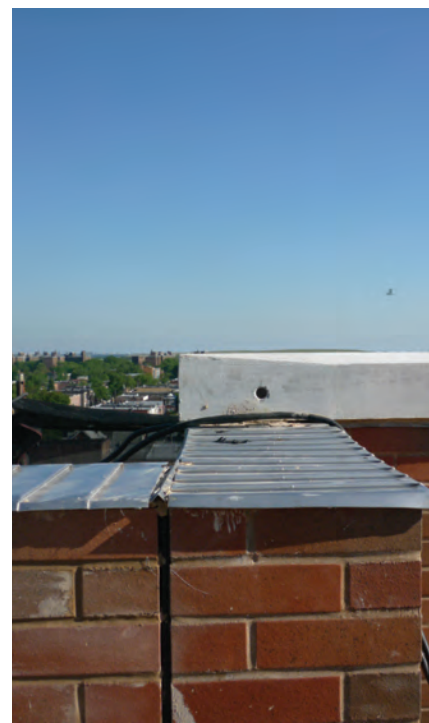
Fig. 6.6.20

**Fig. 6.6.20 (below far right)**  
Installation of expansion joints, interlocking flashing, and coping stone at parapets. Courtesy: RKTb Architects, P.C.

1. Parapets were replaced.
2. A new Glass Fiber Reinforced Concrete (GFRC) cornice was installed above fourth floor windows.
3. New through-wall copper fabric flashings, expansion joints, coping stones, coping flashing, and cap flashing were provided at the parapet
4. The existing roof was 20 years old and showing signs of aging. Because the parapet work already triggered partial roof replacement we recommended complete roof replacement as an additional recommended item. This request was approved and roof replacement was added to the scope of work.

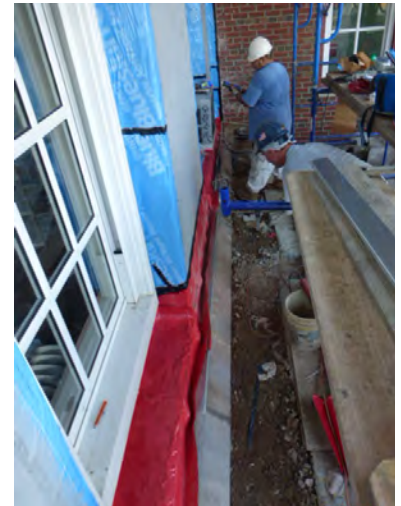
Fig. 6.6.22

Fluid applied vapor barrier has been installed at the existing face-brick. Copper Fabric flashing and blue skin is installed at the windows, preventing water from traveling through the wall. Courtesy: RKTB Architects, P.C.

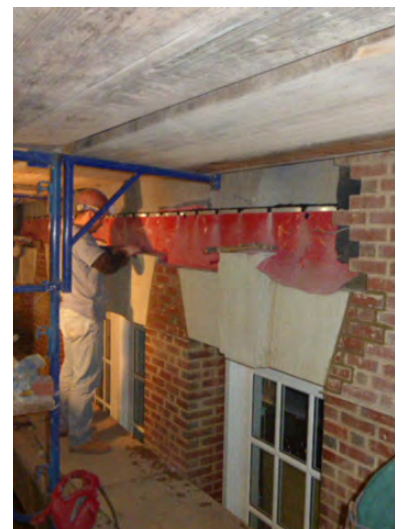
Fig. 6.6.23

At PS 88 Q, to comply with SHPO comments, the masonry is flush between window sills and headers. Courtesy: RKTB Architects, P.C.

1. Over-cladding entire facade versus over-cladding at load bearing "piers" only: At PS 159 K the design intent was to over-clad only at the structural portions of the walls. Subsequently, the brick panels above and below windows (which are not load bearing) were replaced, not over-clad. This allows you to keep the original headers and sills, but it also resulted in a 4 ½" depression above and below the windows, which alters the elevation slightly. SHPO objected to this and requested that we fill in these panels for the proposed SHPO eligible schools. This also preserves the angled termination of the header.

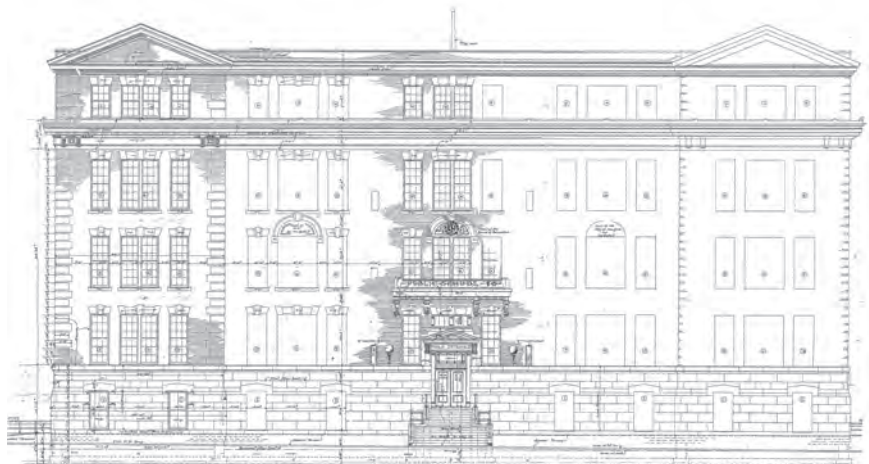
**Fig. 6.6.29 (right)**

Original elevation of PS 16 Q, compare with sister school PS 159 K (Fig. 6.6.15) and original image of PS 88 Q (Fig. 6.6.27). Courtesy: SCA Alchemy

An important part of any exterior restoration project is research. SCA's alchemy server is a great resource; however the most historic buildings often have the fewest original drawings. Fortunately, with PS 159 K, we had original structural plans and exterior elevations. With PS88Q, we had plans only. Initially, we assumed that the elevation details would match 159K, but in reality, the elevations had many differences. Luckily, the Municipal Archives had an original photo of PS 88 Q showing the original condition. PS 88 Q had pediment gables at each end of the building. The photo was dark and blurry, so our next step was to research sister schools. There are 14 sister schools for this particular plan, but the number of floors instead of five. We found that PS 16 Q, which had much better alchemy drawings, also originally had the same pediment style parapet gables and we were able to use the original PS 16 Q drawings, to replicate the details for PS 88 Q.

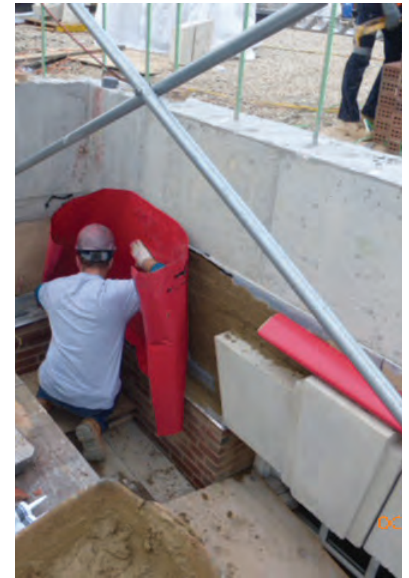
**Fig. 6.6.30 (above)**  
Installation of concrete ring beam at PS 88 Q.  
Courtesy: RKTB Architects, P.C.

At PS 159 K, there were two cornices replicated to match the original elevation; one small cornice along the roof level and a larger cornice at 4<sup>th</sup> floor level. At PS 9 Q and PS 88 Q, the roof level cornices are much larger. In order to properly support the cornice, and to provide lateral structural reinforcement at parapets we have incorporated a reinforced concrete ring beam into the parapet design.

The ring beam usually consists of a channel welded to the existing roof beams with a concrete beam poured over the channel. The size of the beam varies depending on existing conditions. GFRP steel framework as well as parapet re-bar is anchored into the concrete ring beam. The ring beam is wrapped with copper fabric through-wall flashing to keep moisture away from new and existing steel and to create tight barrier at the base of the parapet.

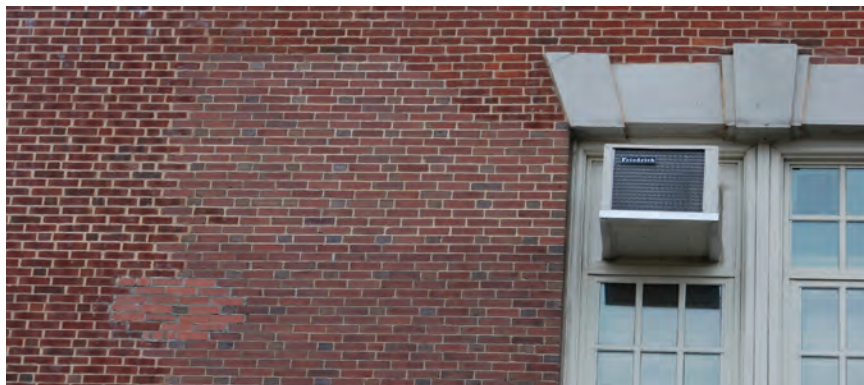
Fig. 6.7.11

Ceiling and wall damage in classroom 109. At the exterior mismatched brick, cracks, and inconsistent mortar joints were observed. Darker brick on the left was associated with the 2004 campaign. Courtesy: Nelligan White Architects

At the exterior deficiencies in the face brick were observed on all facades. These included cracked bricks, missing mortar, and inconsistent/overly large mortar joints at patches, all of which amplify any moisture infiltration associated with other building elements.

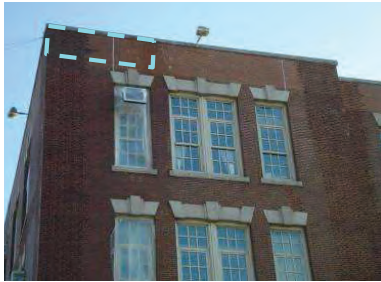
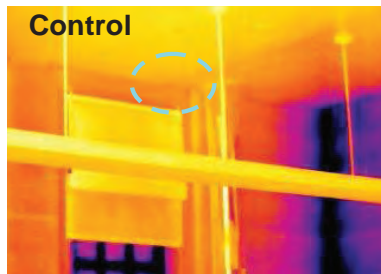
Fig. 6.7.12

Spray tests showing positive results for classroom 302. Courtesy: GBG USA Inc.

The second round of spray testing in November 2009, focused on the windows and window openings. Of the windows and window openings 75% tested positive for moisture infiltration. The third round of spray testing in March 2011, focused on various isolated masonry corners on the building's exterior to determine if a previous repair campaign was deficient. Results found a strong indication of moisture infiltration at 6 of the 7 areas tested with Thermal Imaging, including visual confirmation of moisture at 2 of those locations.

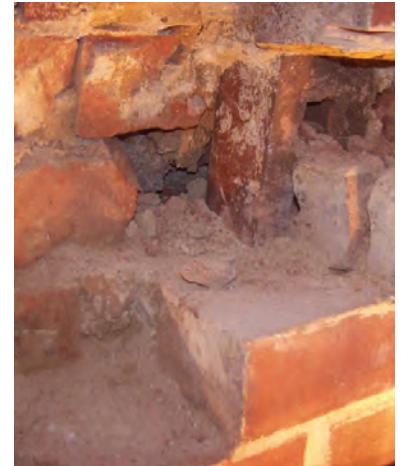
**Fig. 6.7.16**

It was observed the mortar and backup were wet and crumbling. The backup masonry was laid uniformly but there were intermittent voids, which was a likely source of water infiltration. Courtesy: Nelligan White Architects

In January 2009, another set of probes were opened to inspect the existing construction of the original brickwork, including the collar joint and the backup. This inspection revealed crumbling mortar, and that backup masonry was in poor condition with intermittent voids. The collar joint was only partially filled, allowing water to infiltrate the wall. A series of roof cuts were also performed in January 2009, though all assemblies were observed to be dry.

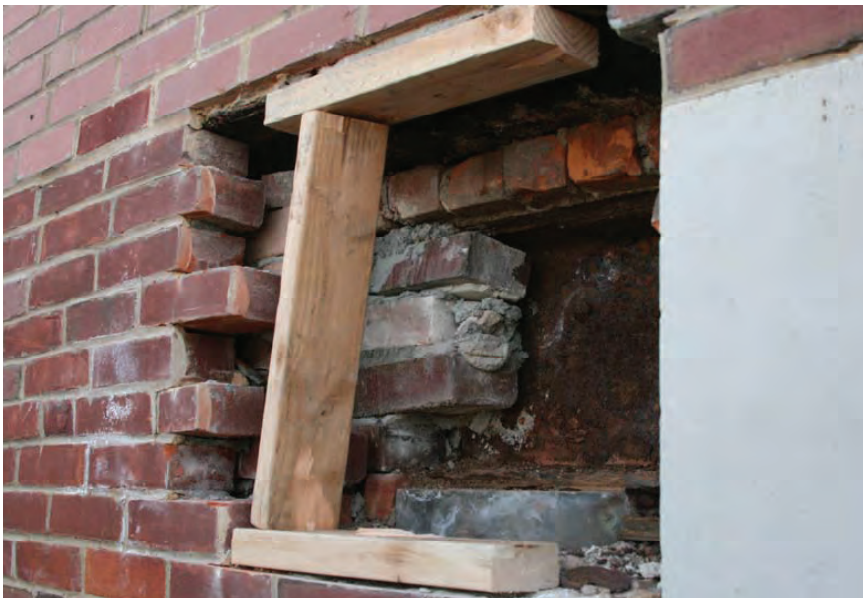
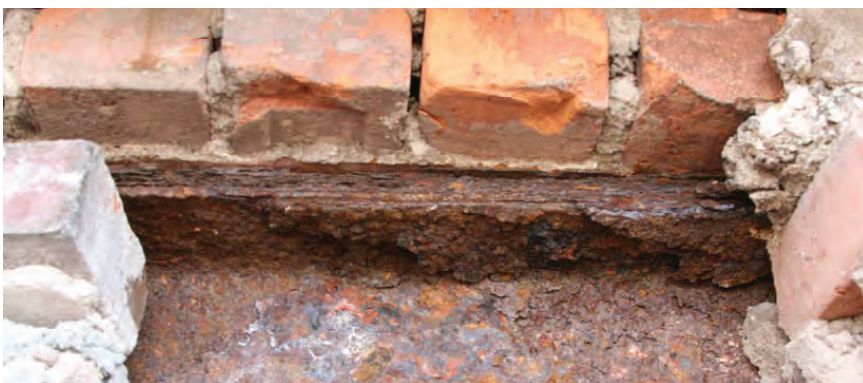
**Fig. 6.7.17 & 6.7.18 (left - bottom left)**

Probes at the 1988 parapet replacement. The steel was found to be in poor condition. Space under the steel between the bluestone supports appeared to be unfilled. Courtesy: Nelligan White Architects

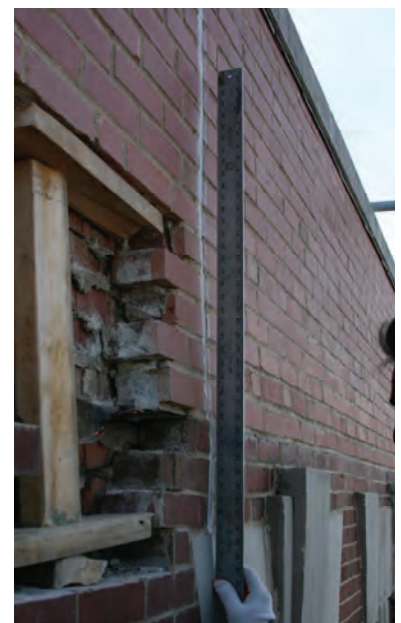
**Fig. 6.7.19 (belove)**

The 1988 replacement parapet was out of plumb with the original construction, with a slight lean inward toward the roof. Courtesy: Nelligan White Architects

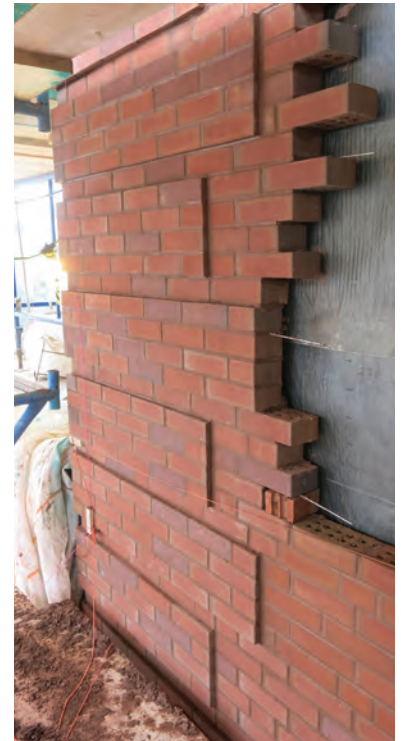
**Fig. 6.7.21**

Construction underway to restore the brick quoins. Courtesy: Nelligan White Architects

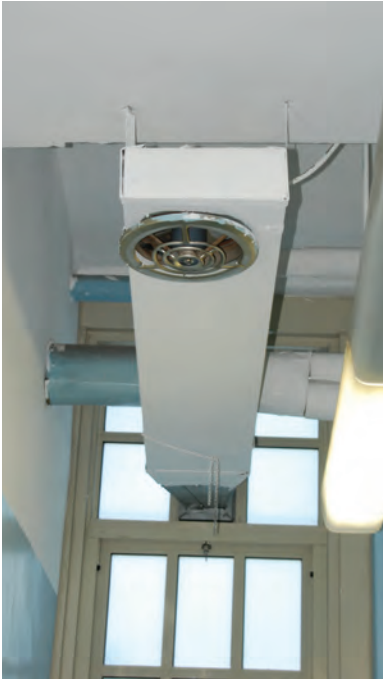
**Fig. 6.7.25**  
Existing 1978 inline fan to be replaced. Courtesy:  
Nelligan White Architects

- Remove existing 1978 design in-line fans and residential wall fan assembly at toilets (Fig. 7.6.24)
- Confirm condition, continuity, and runs of the 1907 ventilation system for toilets
- Reactivate the original 1907 ventilation system for toilets by using existing ductwork, new exhaust fans on roof and providing new controls to make the system code compliant
- Remove existing 3/4" hose bibs with attached piping
- Provide a new opening in the exterior wall for a 3/4" hose bib with 40' of 3/4" piping on the north and west facades

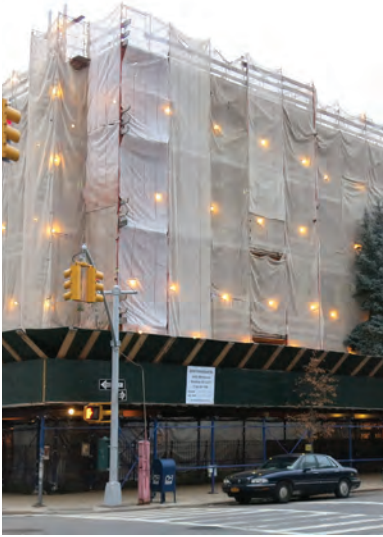
**Fig. 6.7.27**  
Exterior masonry construction work underway.  
Courtesy: Nelligan White Architects

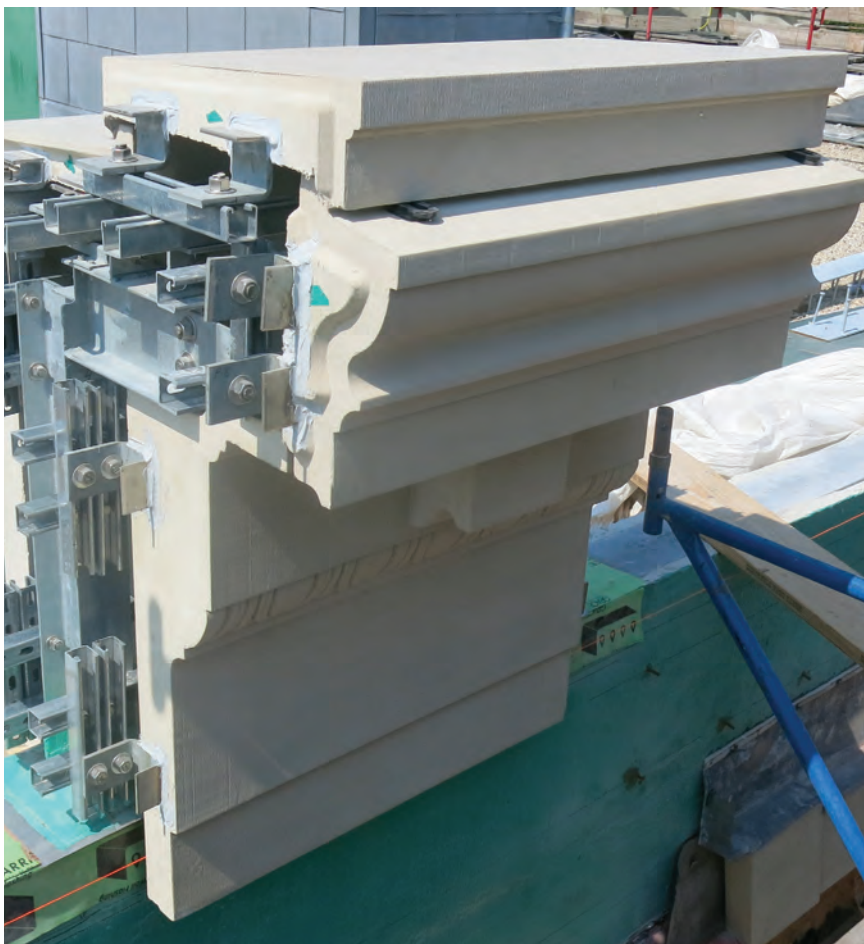
Fig. 6.7.30 (left)  
Mock-up of new, more historically accurate parapet. Courtesy: Nelligan White Architects

The original cornice was PS 154 K's most prominent feature, however, it was removed and replaced with a simpler parapet in the 1988 campaign. Overall, the replacement parapet was designed to be built solid. Voids and missing construction elements were observed. In addition the replacement parapet was out of plumb with the old. When a straight edge was aligned with the old brick, the replacement parapet was set back from the face of the original brick and leaned slightly inward. The new parapet of the 2008 campaign was meant to restore the appearance of the building similar to its 1908 construction (Fig. 6.7.29).

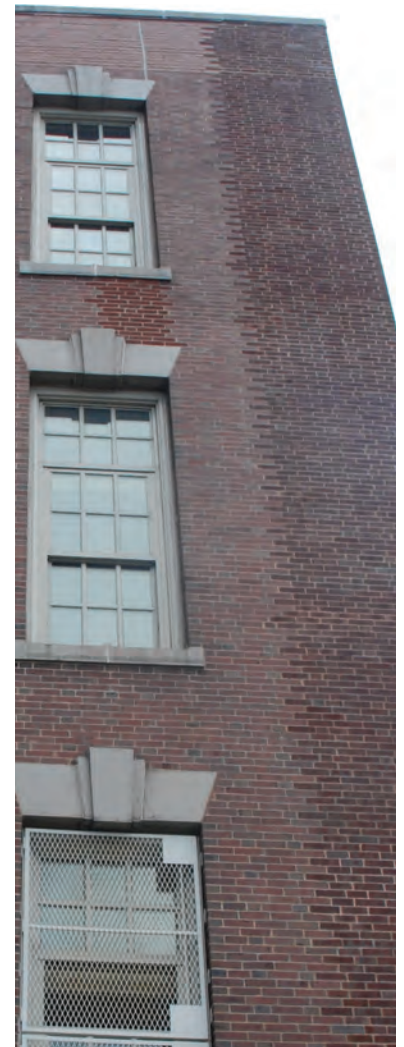
Fig. 6.7.29 (above)  
Mismatched brick at corners. Courtesy: Nelligan White Architects

The brick quoins were removed and replaced in the 2004 campaign, however, this did not completely address the masonry issues. The replacement brick did not match the existing brick, adding to the mismatched appearance of the facade (Fig. 6.6.28). Correcting the deficient work as well as restoring the brick quoins was a part of the 2008 campaign (Fig. 6.7.29).
