# New York City's Historic Schools

A History and Guide to Rehabilitation

NYC SCHOOL CONSTRUCTION AUTHORITY

This Guide has been developed as a practical and technical resource to assist in the evaluation and design for the restoration of historic school buildings (more than 45 years old). It is worth noting that over half of our public school buildings are more than 60 years old! It is our intention to facilitate strategies for these projects that will target cost effective solutions while at the same time respecting their historic standing as landmarks in the community.

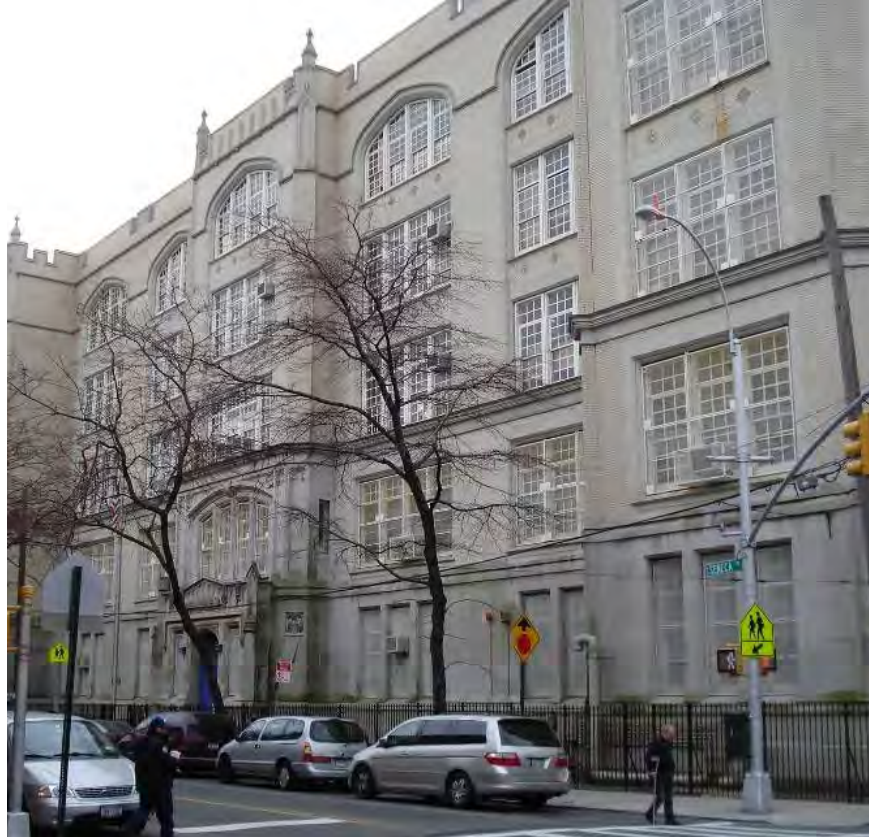
Fig. 6.8.2

Fig. 6.8.1 &amp; 6.8.2 (above - right)

The high demand of new schools warranted a simplistic design in which schools like IS 77 Q fulfilled. This school is an early example of the Type A ornamented in a Gothic style. Front view of the school before renovations. Courtesy: GBG USA Inc, Nelligan White Architects

By the second decade of the 20<sup>th</sup> century, school designs began to become more simplified, in order to be constructed rapidly to serve the growing neighborhoods. The most common of these schools became known as Type-A. It had a standardized rectangular layout of classrooms and accommodated as many as 1500 students. Typically, Type-A schools were constructed on 'end-block' sites and had a rear extension that housed the cafeteria, auditorium, and a steel-caged rooftop outdoor play area. They feature high crenellated parapets and vertical bays of multiple double-hung windows with terracotta banding and window surrounds. Window bays terminate at the top with a shallow pointed arch. Two symmetrical window bays flank the recessed middle portion. The main entries are a one or two story built out structure ornamented in the typical Simplified Gothic motif with terracotta ornament (Fig. 6.8.1 & 6.8.2).

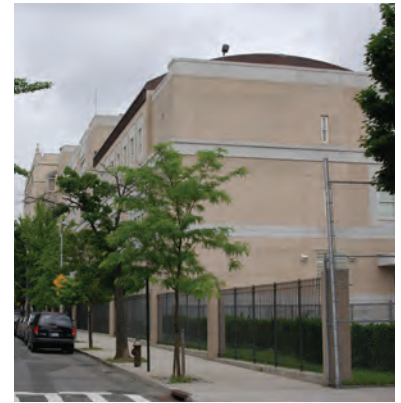
Fig. 6.8.3

At the rear of the school on the western side an addition was added in 2001 containing a cafeteria, gymnasium, and atrium. This addition keeps within the same color scheme of the original 1911 building. Courtesy: Nelligan White Architects

IS 77 Q represents an early example of the Type-A school. Located on Seneca Avenue in Ridgewood, Queens and designed by C. B. J. Snyder in 1909, the school was constructed in the years 1910-1911. This school stands five stories high, plus a cellar. The structure is a steel frame with slag-filled floors on corrugated steel arches and exterior walls of solid brick with decorative limestone masonry. While this school was constructed on an 'end block' site and had a rear extension, the extension is only one story containing the auditorium and lacks a rooftop play area. Overall, the style can best be described as Tudor-Gothic. It has an overall lighter complexion, with its use of beige toned face-brick and light gray limestone. The main entry is denoted by a built out structure that extends to the top of the building. IS 77 Q received its first addition in 2001; this contained a cafeteria, gymnasium, and atrium (Fig. 6.8.3 & 6.8.4).

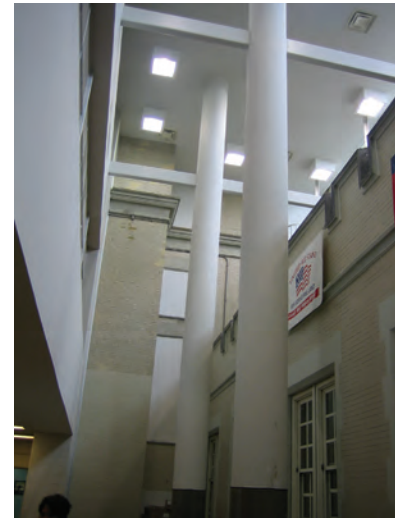
Fig. 6.8.4

Inside the atrium of the 2001 addition, it partially wraps around the auditorium and rear facade juxtaposing the original 1911 construction with the new construction. Courtesy: Nelligan White Architects

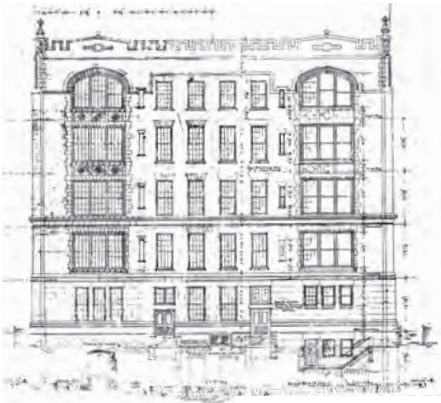
**Fig. 6.8.7**  
Side elevation from original 1909 drawings.  
Courtesy: SCA Alchemy

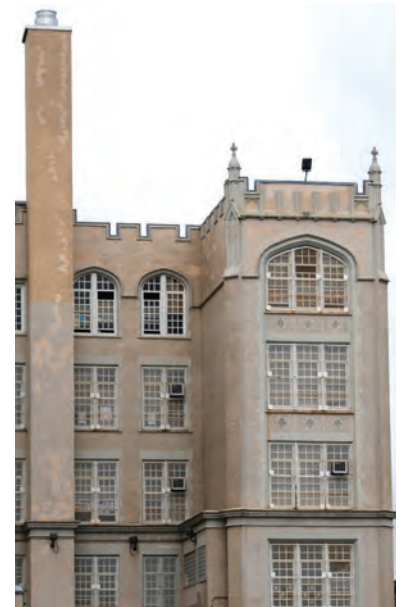
Fig. 6.8.10

Masonry repair over the years had led to an overall appearance that was not uniform in color. Courtesy: Nelligan White Architects

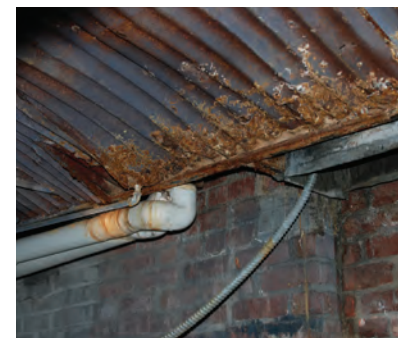
Fig. 6.8.11

Rusting of corrugated metal arch. Courtesy: Nelligan White Architects

Visual surveys of interior and exterior damage were performed at the 1911 building and damage maps were produced (Fig. 6.8.13). On the upper levels of the original building and its auditorium building, there were variations in the brick color. Prior partial brick-replacement campaigns had resulted in a masonry field that was inconsistent throughout (Fig. 6.8.10). Masonry at the chimneys had also been periodically patched and coping stones were cracked. Lightning had struck the chimney at some point resulting in repair work and according to the staff, this was not the first time. Repeated deterioration and replacement of the face-brick was due to the continued presence of water in the masonry wall. The type of damage observed indicated some amount of steel deterioration may have occurred. Comparable schools that suffered from similar damage were found to have steel deterioration (Fig. 6.8.11).

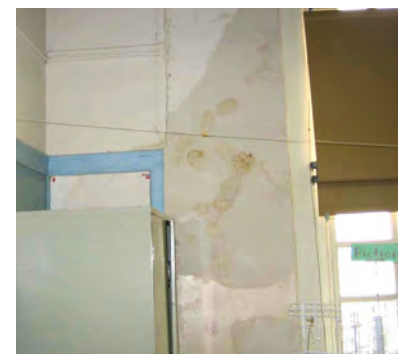
Fig. 6.8.12

Significant water damage at wall adjacent to window. Courtesy: Nelligan White Architects

Damage was also observed on the interior surfaces, especially, around the exterior windows (Fig. 6.8.12) and ceiling wall juncture. Plaster-damage and staining at the fourth floor walls and ceiling were observed to be closely correlated with the location of the expansion joint (Figure 6.8.15). The existing aluminum windows were not original to the 1911 building and drawings did not indicate that these windows were flashed. There was extensive staining around fourth floor windows. Rooms 401, 405, 408 and 410, among many others, exhibited plaster damage below, to the sides, and above the windows. The steel window guards were in fair to poor condition. Window guards that were made of regular carbon steel were rusting, and paint on the galvanized guards was peeling off in sheets. All window guards were observed to be in operable condition.

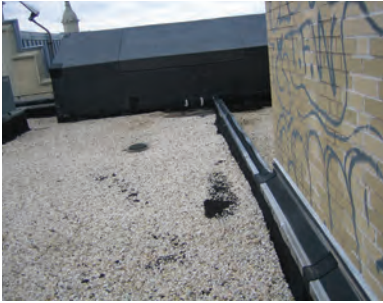
**Fig. 6.8.14**

Expansion joint past chimney and beyond is the temporary stop-gap measure installed to prevent further interior water damage. Courtesy: Nelligan White Architects

The roof on the 1911 building was built up roof with gravel ballast and was in fair condition, albeit some missing or damaged flashing. At the 2001 addition, built-up roofing was used along with a standing seam copper barrel roof. They were in fair condition, though the gutter and drains on the barrel roof were blocked. Near the expansion joint between the original building and addition, an EPDM membrane had been installed over plywood mounted on metal studs, covering an extended length of parapet. The custodial staff had implemented this as a temporary measure to prevent water intrusion at that location (Fig. 6.8.14).

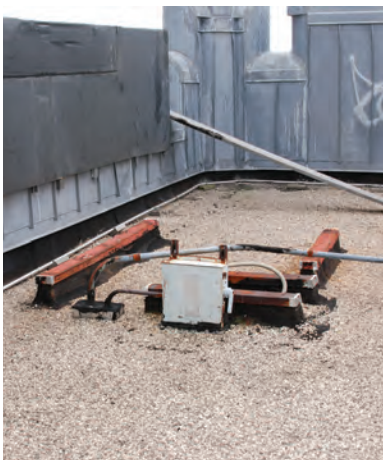
**Fig. 6.8.17 (below)**

Abandoned stub-ups and dunnage at original building's roof. Courtesy: Nelligan White Architects

Adjacent to this were abandoned stub-ups and dunnage for mechanical equipment that once resided there (Fig. 6.8.17). These stub-ups were considered to be another source of water-infiltration. A steel flue on the chimney was damaged when it was struck by lightning, resulting in the installation of a temporary enclosure on the opening. The stair bulkhead on the main building was clad in standing seam lead-coated copper and water damage on the interior plaster was present. When pressure was applied to the roof at the threshold of the bulkhead door, water seeped out indicating that water was trapped beneath the roof membrane at this bulkhead, and likely elsewhere.

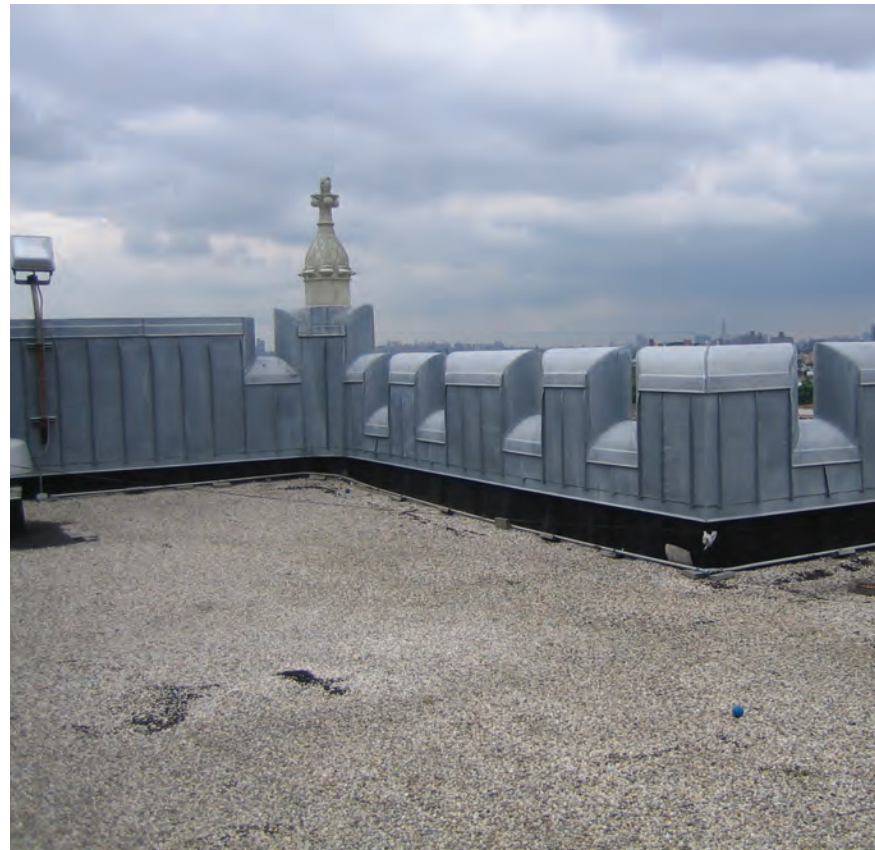
Fig. 6.8.16

Crenellated parapets at roof were sheathed with lead-coated copper on the roof side. Gaps between the sheathing and masonry were observed as well as soldered seams were cracked. Courtesy: Nelligan White Architects

The crenellated parapets had been partially sheathed with lead-coated copper in order to prevent water ingress (Fig. 6.8.16). However, the sheathing was applied to the roof side of the parapets, which protected half the parapet from water infiltration, leaving the façade vulnerable to water. There were gaps between the sheathing and masonry on the outside face and exposed soldered seams were cracked. As the sheathing had been integrated with the roof flashing system, it would have been impossible to remove the roof without removing the lead-coated copper sheathing. At the addition, the base flashing on the parapets was damaged.

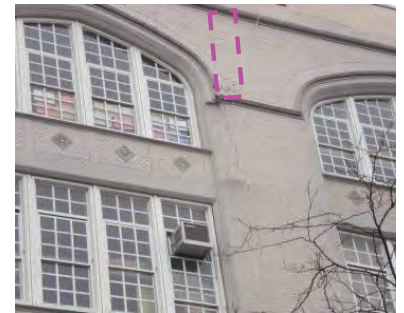
**Fig. 6.8.19**

Location of spray test for classroom 409. Courtesy: GBG USA Inc

As for the above grade walls, deterioration and poorly finished facade brickwork had allowed water to filter directly through the exterior walls resulting in damage to internal plastered walls and ceilings through the full height of the building. Terracotta water courses and window lintels appeared to exacerbate the problem by trapping and diverting water towards the interior. A total of 23 water ingress tests were carried out in 8 separate areas with 7 of the tests yielding positive results as confirmed by thermal imaging and moisture meter readings (Fig. 6.8.19, 6.8.20 & 6.8.21).

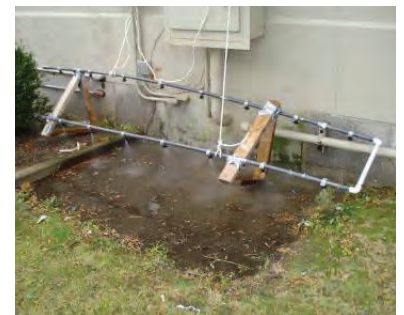
**Fig. 6.8.20**

Location of spray test at back-filled light well. Courtesy: GBG USA Inc

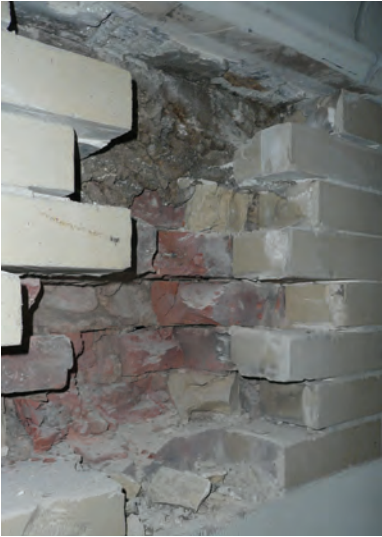
**Fig. 6.8.24**  
Probe performed between the two terracotta moldings above the 4<sup>th</sup> floor windows. Deteriorated mortar and voids in the back up mortar was observed. Courtesy: Nelligan White Architects

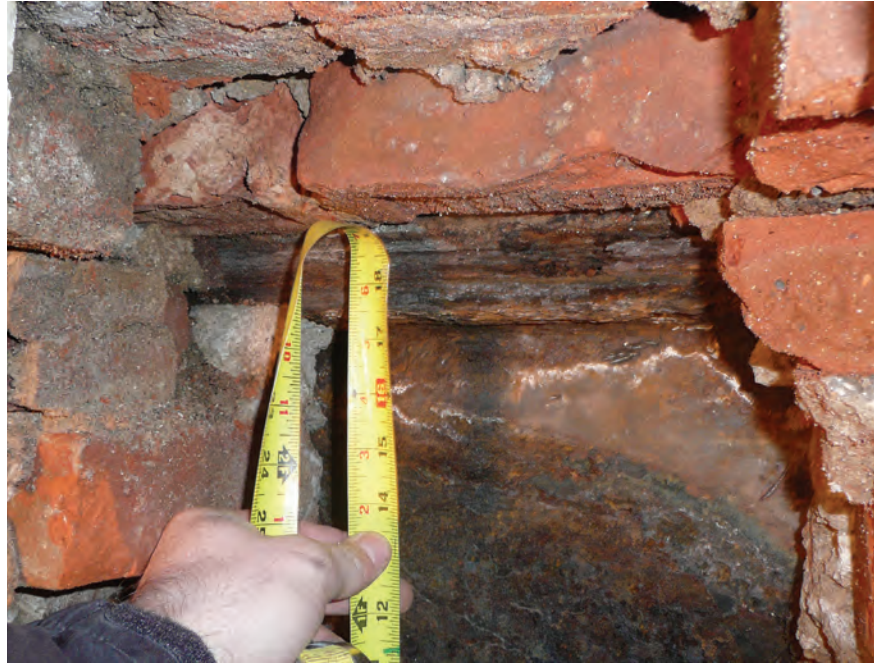
Fig 6.8.25

**Fig. 6.8.25 & 6.8.26 (right-below right)**  
A corroded spandrel beam was observed in an exterior probe. The backup masonry was generally found to be in poor condition. Courtesy: Nelligan White Architects

Exploratory probes were performed between December 2007 and January 2008. Positive reading from spray tests dictated where many of the probes would be made (Fig. 6.8.24, 6.8.25 & 6.8.26).

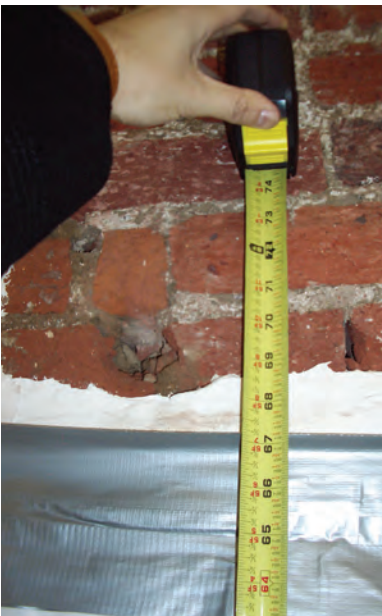
**Fig. 6.8.27 (below)**  
Interior probe of classroom 409, voids and deteriorated mortar was observed. Courtesy: Nelligan White Architects

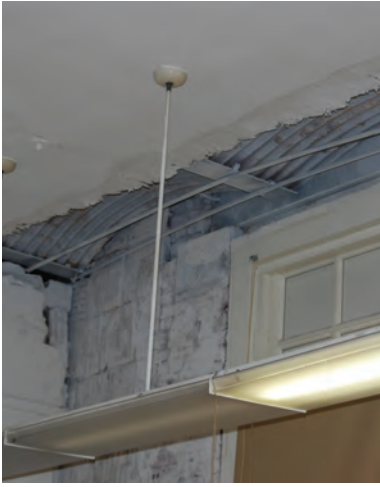
**Fig. 6.8.29**  
Interior view of classroom 409 adjacent to window. Courtesy: Nelligan White Architects

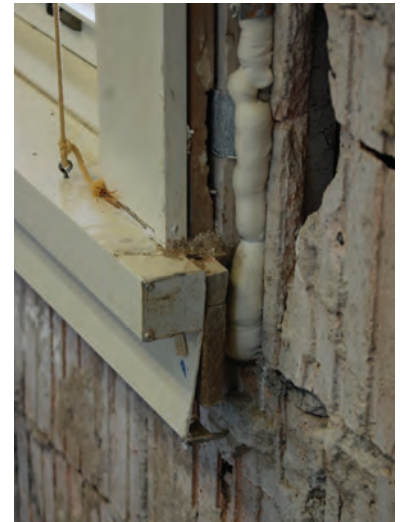
**Fig. 6.8.31**

Repairs underway at windows. Courtesy: Nelligan White Architects

### 1. Exterior Windows (Fig. 6.8.31)

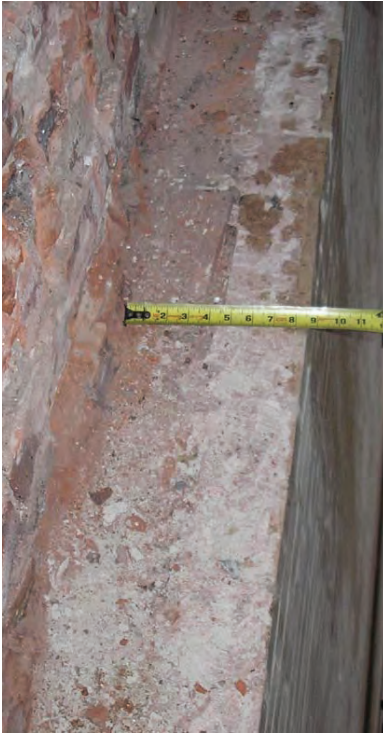
**Fig. 6.8.32**  
Two of the three wythes of brick were removed, resulting in a significant part of the roof load to rest only on one wythe of brick. Courtesy: Nelligan White Architects

During a walk-through in April 2009, it was observed that the masonry was demolished outside of what was specified in the contract documents. Two wythes of brick at the top floor along the south facade were removed. The contract documents only called for one wythe of brick to be removed. As an effect, significant portions of the roof were left supported by 1 wythe of brick. This was substantiated when workers removed one common brick to reveal interior plaster and lath.

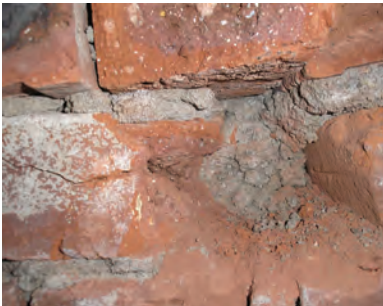
**Fig. 6.8.34 (below)**  
Plaster and lath observed when one common brick was removed. Courtesy: Nelligan White Architects

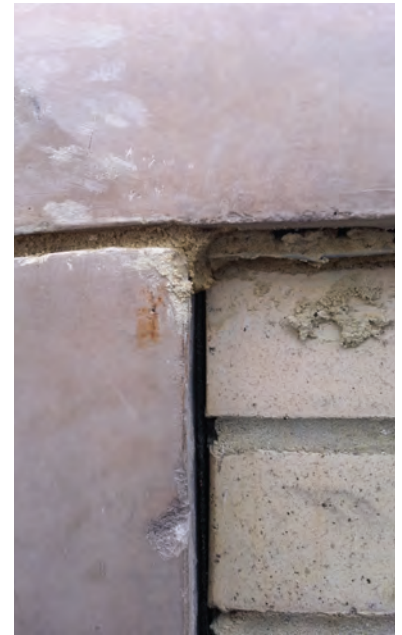
**Fig. 6.8.35**

Spalling was observed on many of the replacement coping stones. Courtesy: Nelligan White Architects

Out of all the replacement architectural pre-cast coping, 69 stones were found to be damaged at the parapet. Including two stones that were rejected, not just because they weren't on the shop drawings, but were cut to fit. Spalling was observed at the edges of the coping stones through out (Fig. 6.8.35). Stress cracks were also apparent in many of the units (Fig. 6.8.37).

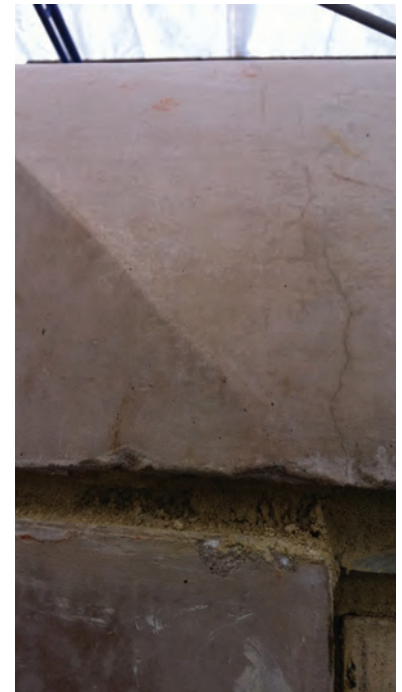
**Fig. 6.8.37 (below)**

Stress cracks observed on coping stone.  
Courtesy: Nelligan White Architects

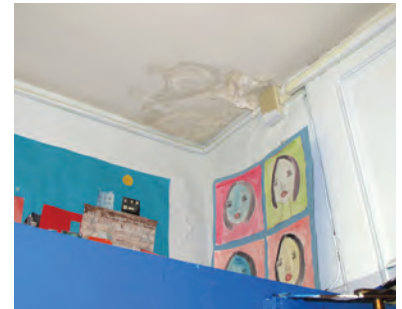
**Fig. 6.9.9**

Damage is most pronounced at the upper floors at the north-east corner of the building. In some areas regular patching of the damaged areas was undertaken and as a result some of the damage was not apparent. Courtesy: Nelligan White Architects

Damage from water intrusion was evident on all floors of the interior in the 1920 building. (Fig. 6.9.9). On the exterior face, efflorescence was observed in the areas where water infiltration was suspected. (Fig. 6.9.10). The BCAS report gave the exterior masonry a rating of 2 (indicating an overall condition of between good and fair), specifically noting areas that required remediation. Spalled bricks were evident on each facade along with extensive deterioration of mortar joints. This type of damage to the brick masonry was an indication that moisture was collecting in the masonry.

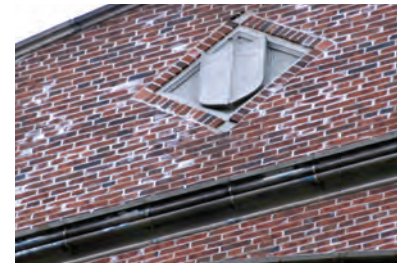
**Fig. 6.9.10**

Large amounts of moisture in the masonry will exert great force on the assembly if frozen. As there were no expansion joints, the mortar joints should have absorbed the force, leaving the bricks intact. However, the mortar joints and the face-brick were both damaged, an indication that the mortar type is inconsistent and exceeds the strength of the brick at certain locations. Courtesy: Nelligan White Architects

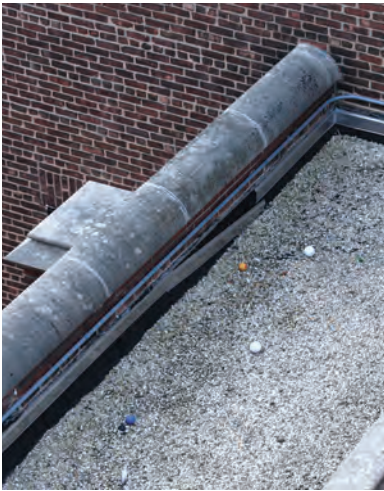
**Fig. 6.9.12**  
Roof of corridor between the 1920 and 1938 buildings. Parapets were below the height requirements. Courtesy: Nelligan White Architects

At both the main annex roof and the roof of the corridor to the original building the parapet walls were below the 42" minimum building code requirement. (Fig. 6.9.12). A panel of the stainless steel counter flashing between the roof and parapet had dislodged and required repair. There is also organic growth present on the coping stones.

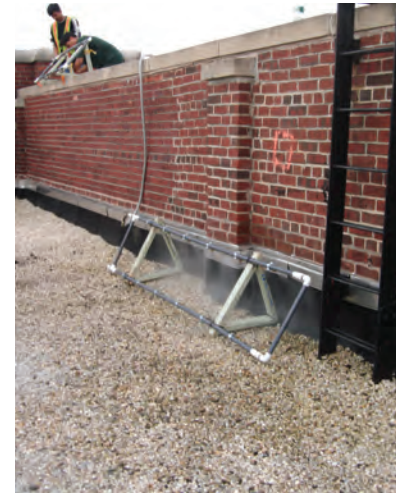
Fig. 6.9.14

Spray tests in progress at roof. Courtesy: Nelligan White Architects

Roof scans, spray tests, flood tests and observations were employed in the non-destructive phase of testing (Fig. 6.9.14). In early April 2010, roof scans and spray tests were conducted to locate potential areas of moisture retention beneath the roof membranes and at various locations where water damage was evident. Of the 33 spray tests, 15 were positive for water ingress. The investigation was carried out using infrared thermal imaging (Fig. 6.9.15) and electrical capacitance combined with visual inspection and relative moisture content assessment using a hand held moisture meter probe. A total of fourteen Electrical Capacitance anomalies were identified over the five roof areas, investigated with a combined surface area of approximately 4395 sq ft; this equates to approx 17.7% of the total roof area. A total of seven thermal anomalies were identified over the five roof areas investigated with a combined surface area of approximately 5780 sq ft; this equates to approximately 23.2% of the total roof area. The electrical capacitance and thermal anomalies have been found to coincide at 11 locations over the five roof areas, investigated with a combined surface area of approximately 2360 sq ft; this equates to approx 22.4% of the total roof area.

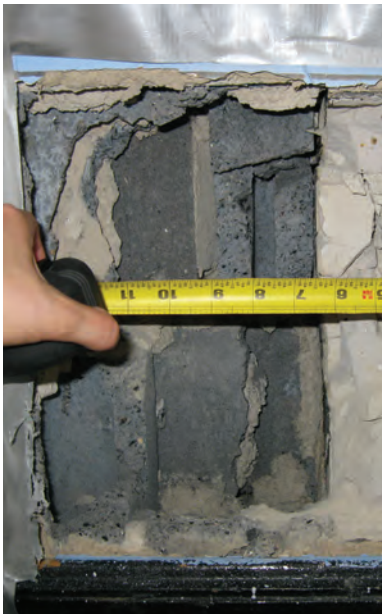
**Fig. 6.9.16**  
In the 1938 annex, the probe showed a crack in the plaster correlated with a transition between block and brick directly behind. Courtesy: Nelligan White Architects

Another probe in the north-east corner of a 2<sup>nd</sup> floor classroom revealed the same construction as the third floor classroom. The crack observed in the finish plaster appeared to project from the transition between the block partition wall and the brick column encasing (Fig. 6.9.16). Blue and white plaster coated wires were also observed installed within the concrete block.

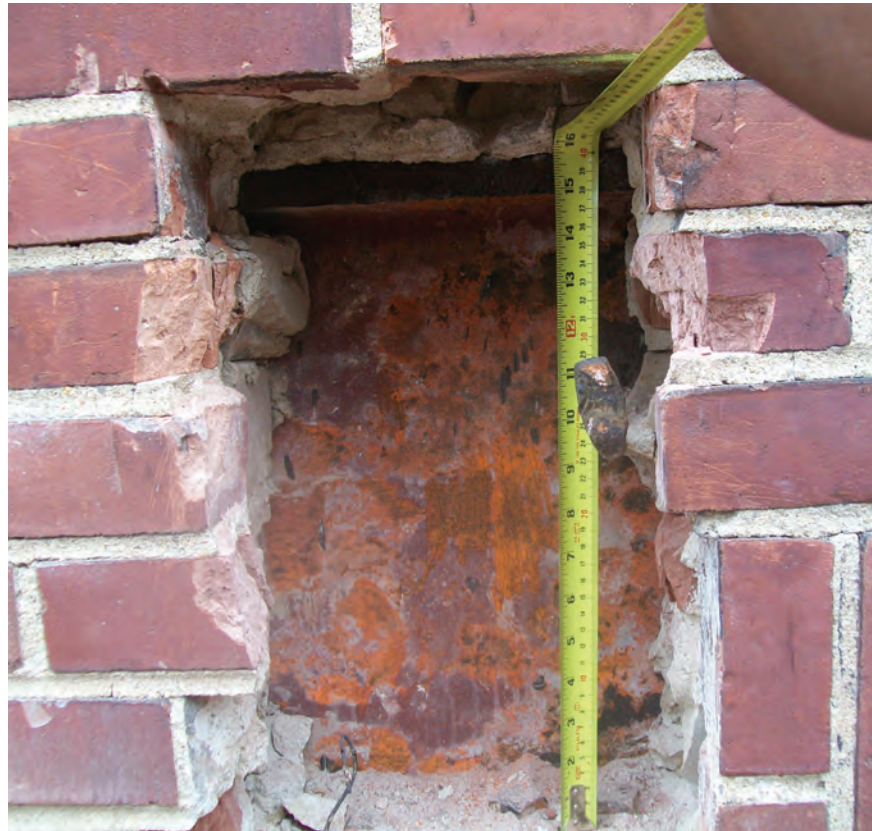
**Fig. 6.9.17 (right)**  
Corroded steel member revealed during probe. Courtesy: Nelligan White Architects

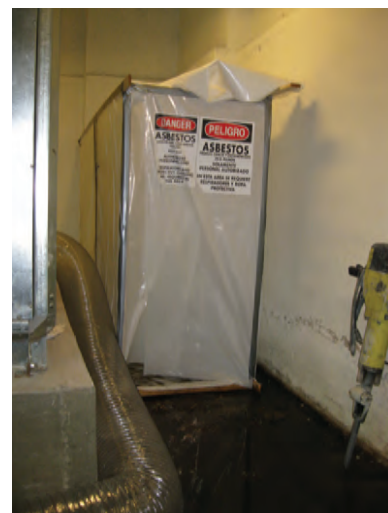
**Fig. 6.9.18**  
Asbestos protection in suspected areas in the 1920 cellar. Courtesy: Nelligan White Architects

The asbestos inspection was conducted in November 2010 and involved a thorough visual examination of all accessible areas and sampling of suspect materials, which would be affected by the proposed work. Asbestos-containing materials, which will be affected by the scope of work, were positively identified at various locations throughout the building. Laboratory analysis confirmed no presence of asbestos in the amount greater than 1% in the all of the samples collected. Visually inspected materials that were not tested, were assumed to contain asbestos while various other materials tested for less than 1% asbestos.

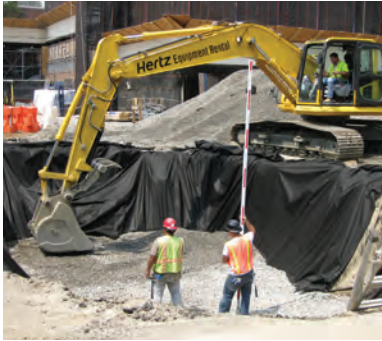
**Fig. 6.9.20**

Excavation of play yard for storm water detention system. Courtesy: Nelligan White Architects

An additional remedy to the moisture infiltration problem, was the construction of two detention systems under the play yards. This would act as temporary water storage during storm events in which water would be held until the public sewer could handle the surplus. Borings conducted during the design phase indicated that bedrock could be anticipated at approximately 11.5 feet below the level of the existing paved surface. Instead, bedrock and very large boulders were encountered above this elevation at intermittent locations below the south playground. The contractor was directed to provide excavation and removal of rock as required to achieve the depths required for correct placement of site piping, manholes, detention tanks, and the interior sump.

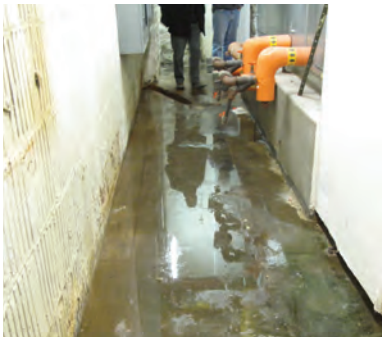
**Fig. 6.9.21**

Standing water in 1920 cellar. Courtesy: Nelligan White Architects

Much of the 1920 building's cellar was being affected by water-infiltration. During rain storms, water backed up through the boiler room floor drain. Flowing water drained into a 4" wide trench, cut into the floor slab leading to a sump pump. Testing completed by IEH showed the infiltrating water was clean ground water.

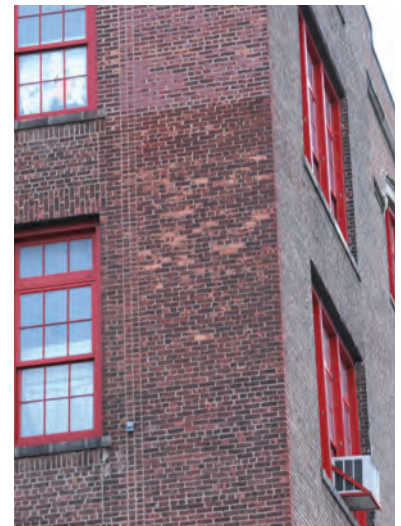
Fig. 6.9.21

Spalling damage at facade. Courtesy: Nelligan White Architects

The type of damage to the brick masonry observed at the 1920 building, was an indication that moisture was collecting in the masonry. The brick may, therefore, have had an unacceptably high absorption rate. Widespread efflorescence and spalling observed at times, lends credence to this supposition. Exploratory probes showed deficiencies common to failing masonry, the collar joint (between the face wythe and the backup masonry) was observed to be devoid of mortar. The backup masonry also had many voids, providing further avenue for water to travel. There was no through-wall flashing at the parapet, or at beams, columns, and lintels, or around windows. Routinely performed plaster repairs to the damaged areas on an annual basis were evident. It was observed that the water infiltration damage primarily occurs near the windows, in close proximity to the lintels.

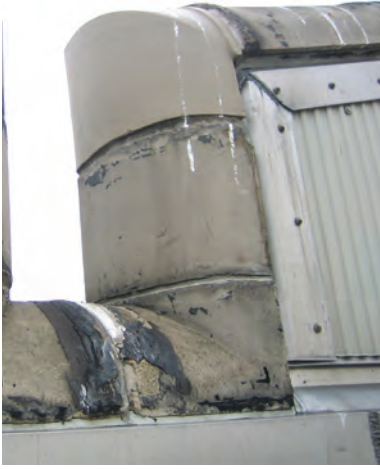
**Fig. 6.9.23**  
Terracotta coping damage and failing remediation at 1920 parapet. Courtesy: Nelligan White Architects

Previous repair work to the 1920 parapets resulted in mismatched colors. It was found that the parapet wall did not contain any structural steel bracing possibly affecting its capacity to resist lateral loads. Terracotta coping stones were chipped and cracked at several locations and crazed throughout. There was no flashing under the copings. The custodial staff had attempted to patch these deficiencies with sealant, however, this remediation was failing. Deterioration caused the caulking to detach from the terracotta thereby opening the joints to water infiltration. The roof-side of the parapets was clad in sheet metal siding. Spray tests showed that it was effective in keeping water out of the back of the parapet wall (spray tests on the outside were positive, however).

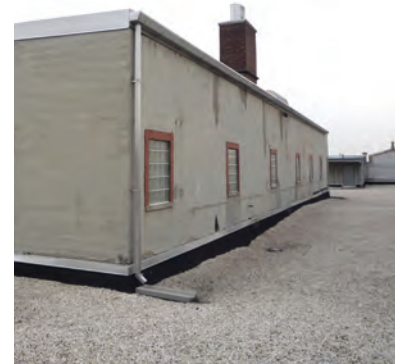
**Fig. 6.9.25**

Windows in fan room bulkhead to be replaced.  
Courtesy: Nelligan White Architects

- Provide spray applied membrane and metal cladding on outside of fan room
- Replace windows in fan room bulkhead; provide flashing (Fig. 6.9.25)

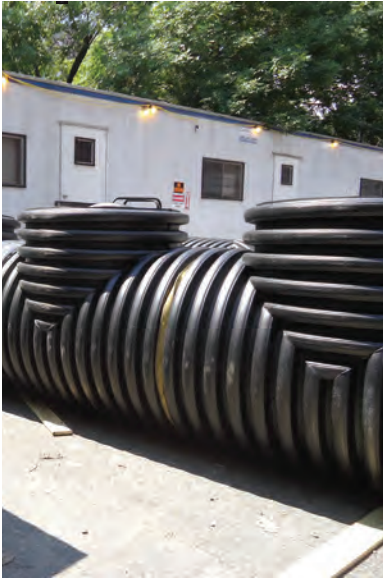
**Fig. 6.9.27**  
Detention system awaiting installation. Courtesy: Nelligan White Architects

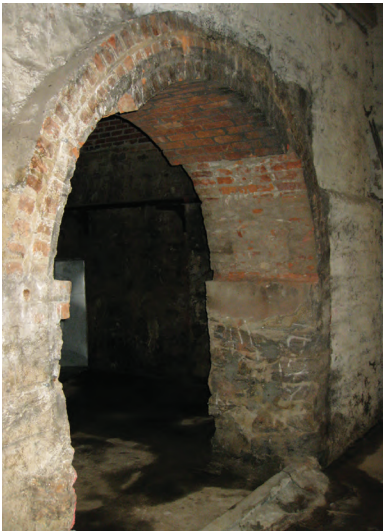
**Fig. 6.9.28**  
Heating chamber during demolition phase. Courtesy: Nelligan White Architects

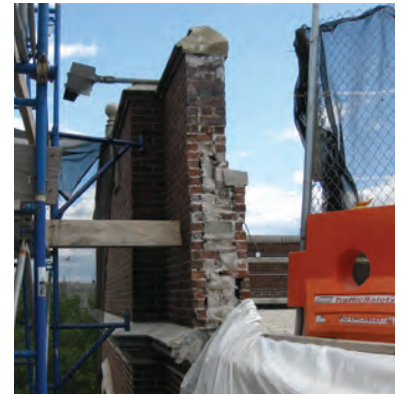
**Fig. 6.9.30 & 6.9.31 (above - below)**

Parapet of 1920 building, no structural steel evident. Partial curb above window on east elevation was found to be shorter and thicker than indicated. Courtesy: Nelligan White Architects

It was found that the 1920 parapet wall did not contain any structural steel bracing, affecting its capacity to resist lateral loads. Similarly, the 1938 parapets only contained reinforced steel for part of their full height.

For the 1920 building, it was discovered that the existing concrete curb assumed to exist based upon the original drawings was not present along the 90% of the roof perimeter. Where it did exist above the four east elevation windows, it was short in height and thicker in width than indicated on the contract documents. An alternate construction detail was submitted, in order to make up for the missing curb.

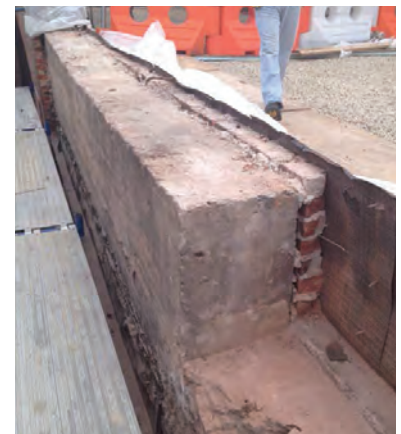
**Fig 6.9.32 (below)**

At many locations, the base flashing was improperly installed with horizontal seams. These seams have split open over time, allowing water to infiltrate. Courtesy: Nelligan White Architects

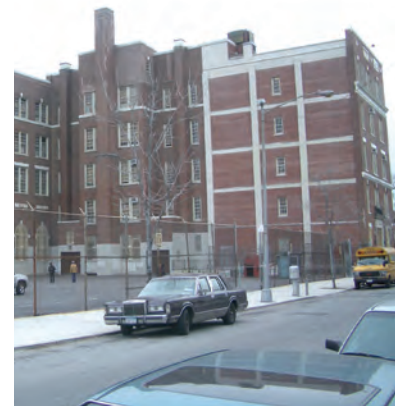
Fig. 6.10.4 (below)

The Type-E plan started out as L-shaped but could be expanded in a U-shape for more classrooms depending on the needs of the school and neighborhood. PS 121 Q remained L-shaped but was able to expand if needed.

By 1923, William H. Gompert had succeeded C. B. J. Snyder as the Superintendent of School Buildings. While there was a shift in leadership, Gompert continued Snyder's work to standardize the design of school buildings. The standardized school design continued to be a necessity as the city's population grew even more through the 1920s and spread out further from the industrial and commercial centers. Like its predecessor, Type-A, the floor plan of PS 121 Q and its sister schools were suited for end-block sites. However, the difference was the placement of the auditorium, instead of at the center-rear, Gompert placed the auditorium at the end of one of the wings (Fig. 6.10.3). This plan came to be known as Type-E. The Type-E floor plan could also be versatile starting as an L-shape, but more often becoming U-shaped, depending on the immediate and anticipated needs of the neighborhood (Fig. 6.10.4).

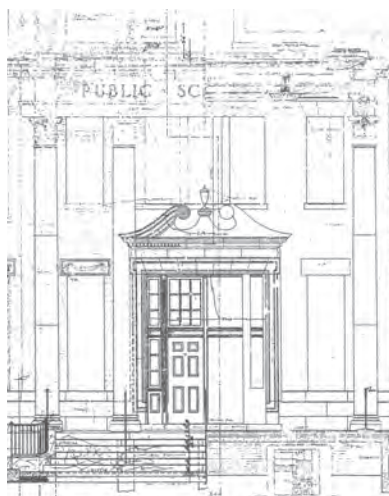
**Fig. 6.10.6**  
Detail of entry portico from the original 1924 drawings. Courtesy: SCA Alchemy

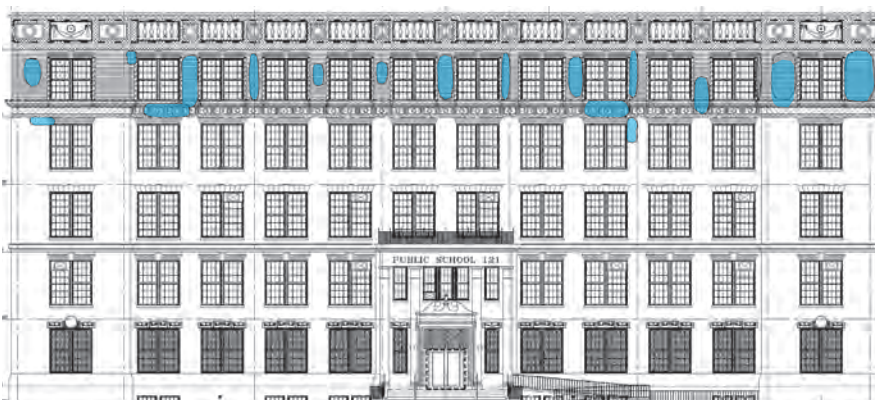
Fig. 6.10.10

Front elevation showing extent of repairs and interior damage in blue. Courtesy: Nelligan White Architects

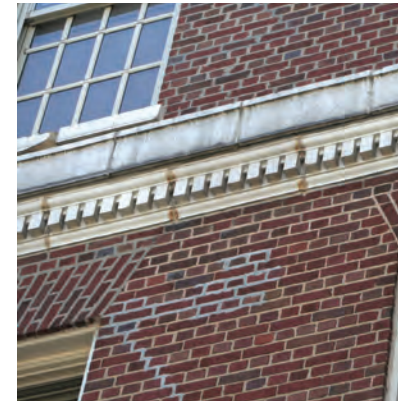
Fig. 6.10.8

Gray mortar repointing did not match the original tan mortar and staining was found on the string courses. Courtesy: Nelligan White Architects

Visual surveys of interior and exterior damage were performed. On the exterior the inaccurate mortar from the 1996 campaign was disintegrating. Cracking of the terracotta string courses, lintels, and relief panels was also observed. Rust stains were below most window jambs down the face of the second floor string course (Fig. 6.10.8). The cause of the staining was unknown as there were no window guards at that floor to rust.

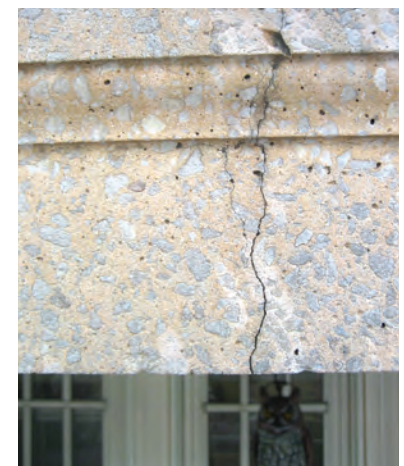
Fig. 6.10.11 (below)

Crack in the architrave component of the portico. Courtesy: Nelligan White Architects

During the 2011 campaign, observations found cracking at the center of the portico at the architrave (Fig. 6.10.11). The same was true for many of the PS 121 Q sister schools. This cracking was found to date back to at least 2006, and had not grown appreciably over the years. Exposed rebar was also observed in the capital. The crack appeared to be from excessive flexure (downward deflection), as it was widest at the bottom of the architrave and diminishing towards the top. There was some evidence, from the cracked patching mortar at the seam between the architrave and the frieze, supporting the possibility that the architrave was sagging on its own, without the frieze block above sagging as well. Exposed rebar was found at the top of an already once repaired capital.

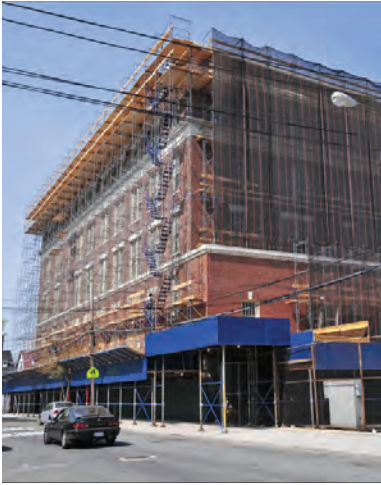
**Fig. 6.10.18**

Construction progress of exterior masonry repairs. Courtesy: Nelligan White Architects

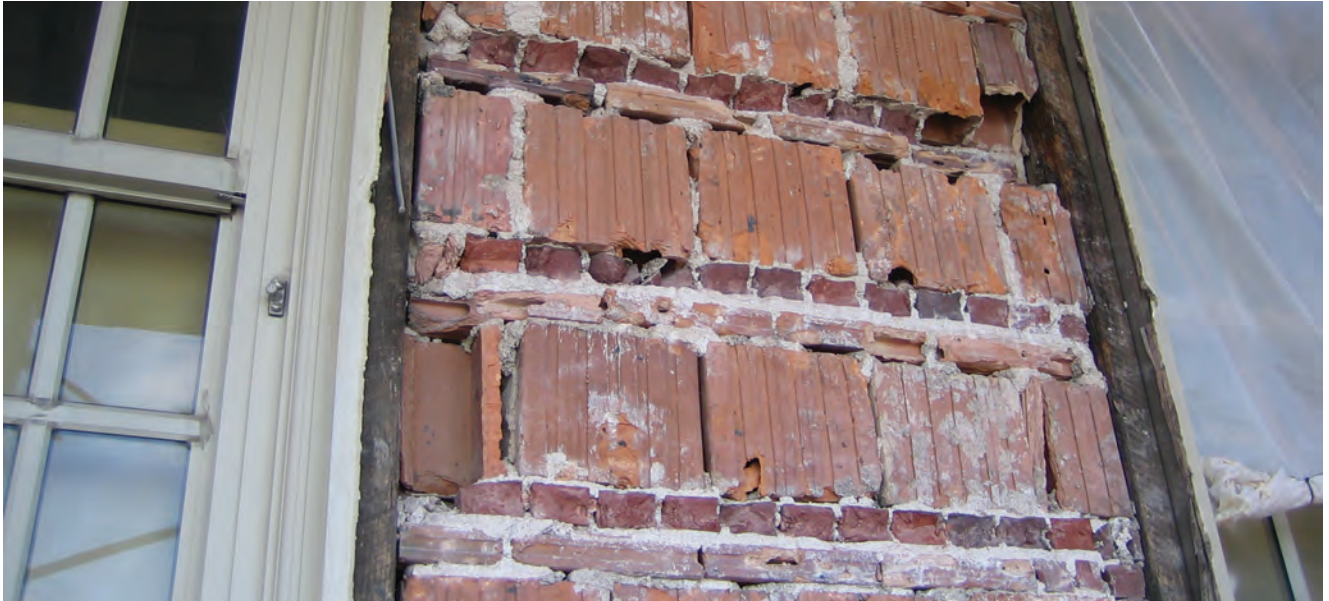
**Fig. 6.10.20**  
Backup masonry exposed during demolition.  
Courtesy: Nelligan White Architects

- Replace brick at localized areas of damaged brick (Fig. 6.10.20 & 6.10.22)
- Replace deteriorated steel lintels at fifth floor (Fig. 6.10.21)
- No terracotta is to be replaced under this LLW No.
- Refinish areaway grates; blast clean paint, shop prime and repaint with high build epoxy paint; reinstall with stainless steel anchors set in epoxy

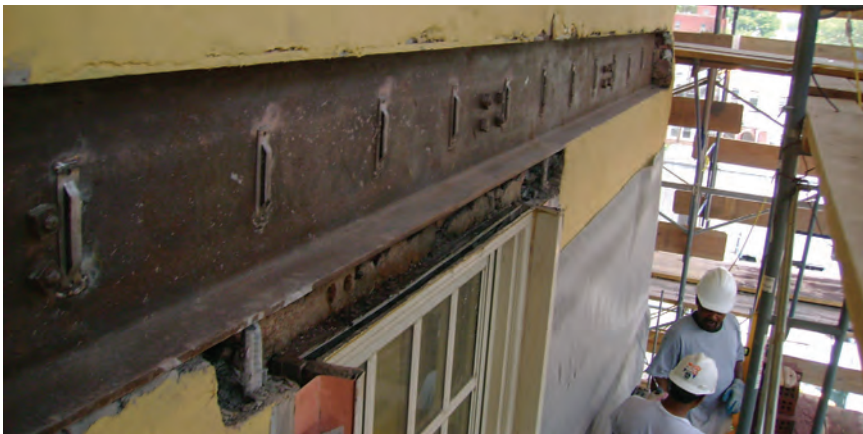
**Fig. 6.10.21**  
Fifth floor lintels to be replaced. Courtesy: Nelligan White Architects

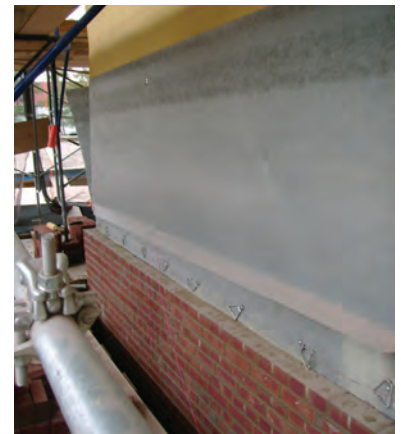
**Fig. 6.10.22**  
Weep cavity installation. Courtesy: Nelligan White Architects

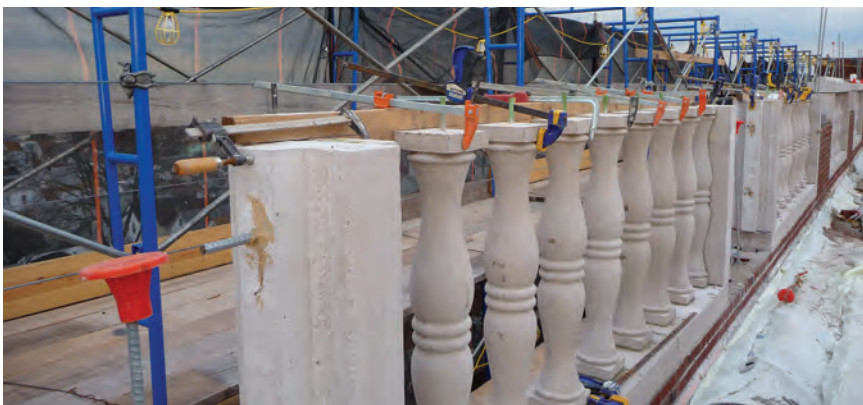
**Fig. 6.10.23**  
Cast-stone balustrade replica installation. Courtesy: Nelligan White Architects

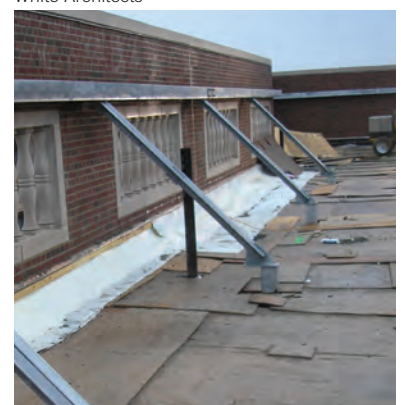
**Fig. 6.10.24**  
Steel reinforcing for new parapets. Courtesy: Nelligan White Architects

- Provide vertical steel reinforcing for new parapets
- Replace balusters, emblem panels, and disks with cast-stone replicas; properly flash and secure with stainless steel anchors; adequately saturate with water, prior to setting to achieve proper mortar bond

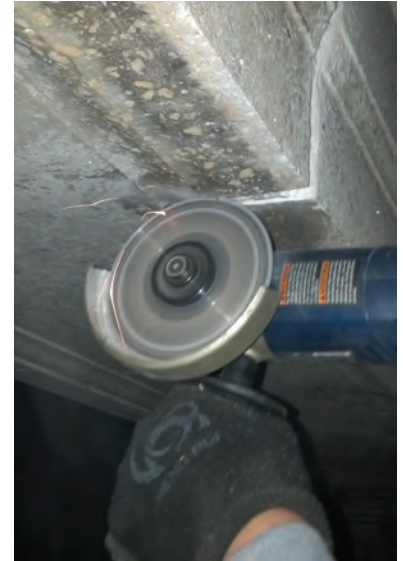
**Fig. 6.10.27**

Routing out of crack for repair. Courtesy: Nelligan White Architects

### 1. Architrave (Fig. 6.10.27, 6.10.28 & 6.10.29)

- Repair cracks to prevent moisture ingress and resultant freeze/thaw stress
- Install and observe crack monitors and/or periodically survey the deflection using control points, to determine if the cracks and deflection increase
- Additional probes at this school or a sister school would be required, if further validation of the assumptions above are required by SCA.

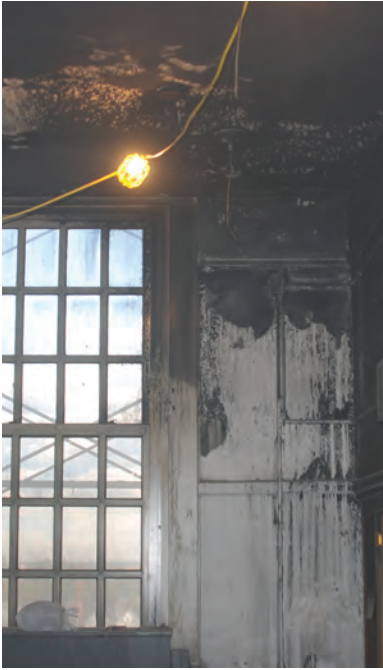
**Fig. 6.10.30**  
Fire damage at the fourth floor. Courtesy:  
Nelligan White Architects

In October 2008, a fire erupted on the scaffolding on the fifth floor. It was found by the SCA, as well as confirmed by field observations, that the fire was started by the construction operations related to exterior masonry work. In a concerted effort to make the school functional again, work proceeded rapidly. This made a review of all damage impossible, as most of the heavily damaged areas had already been demolished and much of the fourth floor smoke and water-damage had already been painted over. Three existing windows were damaged and the replacements that were installed by the SCA's emergency contractor, did not match the finish of the existing windows and did not possess the same number of window panes (Fig. 6.10.31). In addition to the wrong color and number of panes, the sealant around the windows was not properly installed and would likely be a source of water-penetration. It was understood that the damage caused by the fire required decisive and immediate action in order to minimize the stress placed on the teachers and students, however, the inadequate installation of the windows compromised the integrity of the work in the exterior masonry contract.

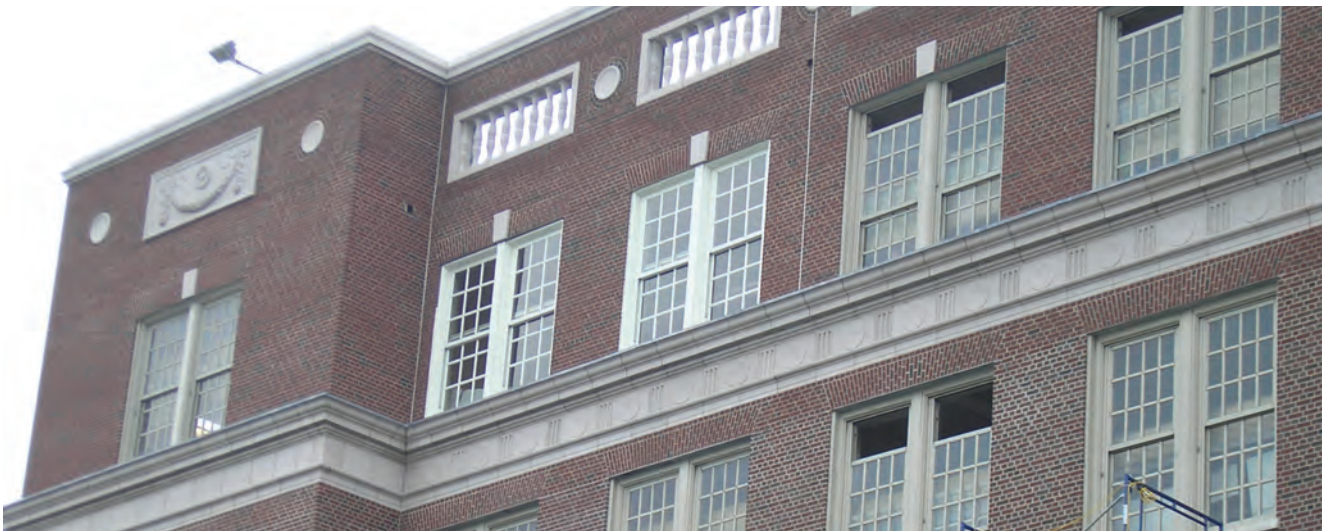
Fig 6.10.31

**Fig. 6.10.31 (below)**

The two windows toward center of the photo were a part of the emergency repairs after the fire. These windows not only were inaccurate in color and pane number but also suffered from poorly done seals. Courtesy: Nelligan White Architects

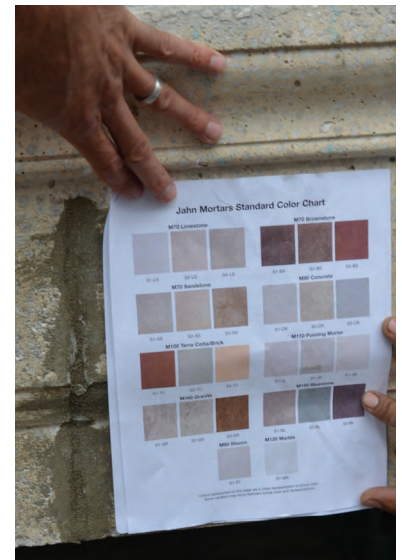
**Fig. 6.10.32**

After the first repair, the mortar used did not match the approved color. It would be routed out and an approved color used. Courtesy: Nelligan White Architects

In 2011, a campaign was undertaken to analyze a significant crack in the architrave of the entry portico. After Ground Penetrating Radar (GPR), X-ray radiograph, and along with visual observations were employed, it was determined that the cracking and deflection observed would not increase, as the loads are presumed to be supported by another load path. Interior probes of the portico also confirmed this was the primary risk in the future for this architrave and for similar conditions at sister schools was corrosion of the internal structure if left untreated. At the time, it was recommended that the architrave not be replaced only repaired. The first repair of the architrave and column yielded unsatisfactory results. Mortar used did not match the existing. The crack in the architrave was routed out and replaced with appropriate color (Fig. 6.10.32).

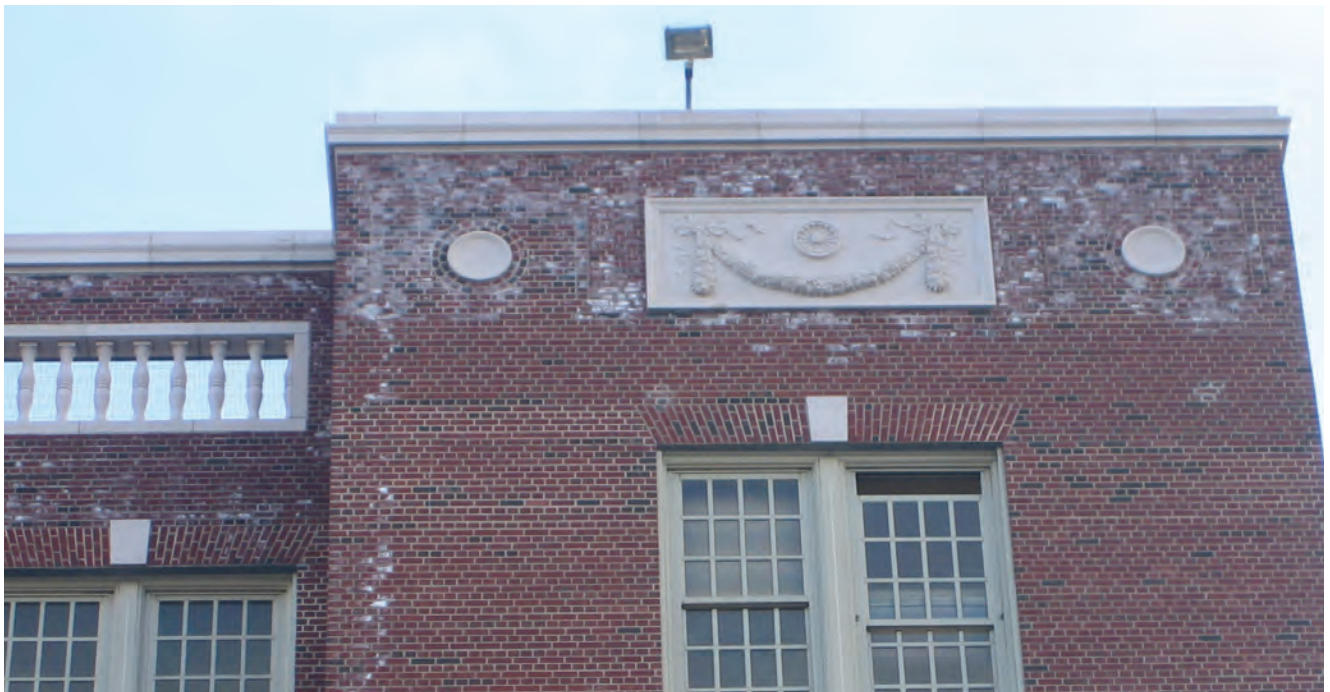
**Fig. 6.10.33**

**Fig. 6.10.33 (below)**

Efflorescence became apparent on the newly installed face brick. It was to be cleaned off and samples taken for further testing to determine if any further repairs were needed. Courtesy: Nelligan White Architects

Efflorescence on the surface of the new masonry from the fourth floor string course up to the top of the new parapets on each facade was observed in January 2010 (Fig. 6.10.33). Efflorescence is the result of salt contaminants present in the construction materials during construction or embedded during the manufacturing process. The presence of efflorescence could signify that substandard masonry was used for the face-wythe, there is a significant source of water in the masonry wall creating a condition known as “*super-saturation*,” or that the flashing, anchors, etc., have become contaminated. The contractor’s brick submittals were reviewed, confirming that they meet all the required SCA quality standards. In light of this confirmation, the possibility of substandard masonry being delivered to the project site was present. Another potential cause of the efflorescence could be that the masonry was simply cleaned at the wrong temperature. The existing efflorescence was to be removed with a stiff fiber brush and an SCA approved masonry cleaner. In conjunction with the cleaning, a probe was recommended to be conducted and samples taken for laboratory testing to verify if contaminants are present in the masonry and determine whether efflorescence would be a continued problem.
