# New York City's Historic Schools

A History and Guide to Rehabilitation

NYC SCHOOL CONSTRUCTION AUTHORITY

This Guide has been developed as a practical and technical resource to assist in the evaluation and design for the restoration of historic school buildings (more than 45 years old). It is worth noting that over half of our public school buildings are more than 60 years old! It is our intention to facilitate strategies for these projects that will target cost effective solutions while at the same time respecting their historic standing as landmarks in the community.

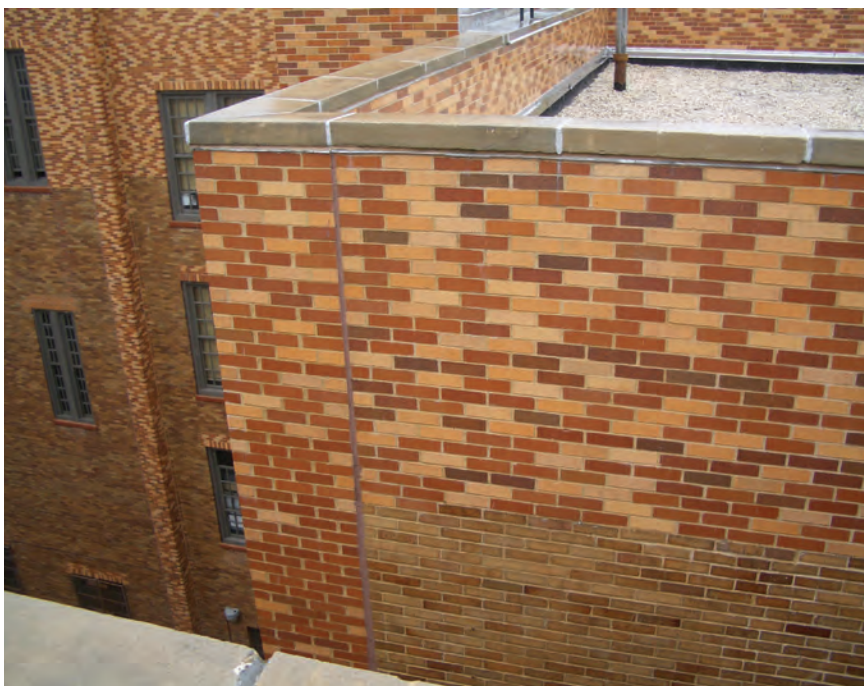
Fig. 6.11.11

**Fig. 6.11.11 (left)**

Visual inspection of the building masonry showed evidence of replacement work in multiple areas. Portions of the building's exterior appear to have original brick, while in other areas there appeared to be brickwork from the 1929 & 1937 additions, from the 1961 modernization and also from the 2000-2003 repair work. Courtesy: Nelligan White Architects

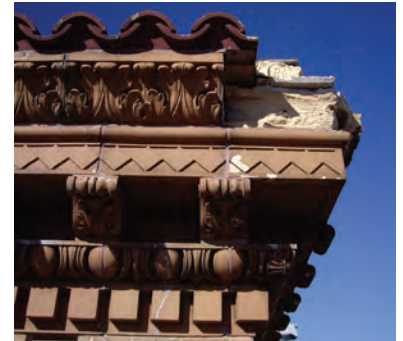
**Fig. 6.11.9**

South-east corner of the building where a large piece of terracotta fell in 2004 prompting sidewalk sheds to be erected immediately. Courtesy: Sylvia Hardy

The deterioration of the cornice became severe enough, that a large piece of the terracotta fell from the south-east corner of the building (Fig. 6.11.9). Sidewalk sheds were erected immediately. After that damage, a new campaign and investigation was launched.

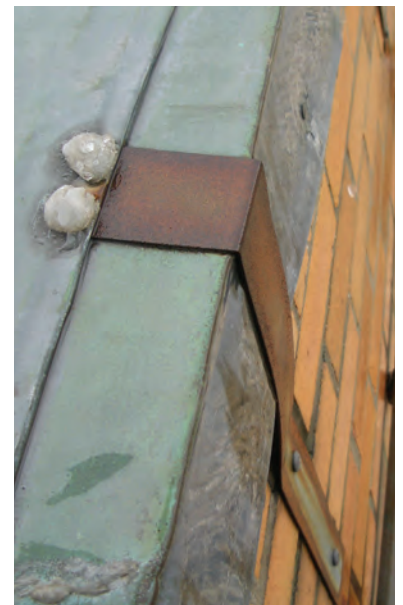
**Fig. 6.11.10 (above)**

Observation of the east wing, courtyard facade revealed several areas where the building masonry had been secured in place using structural wall ties to compensate for the missing brick headers. Courtesy: Nelligan White Architects

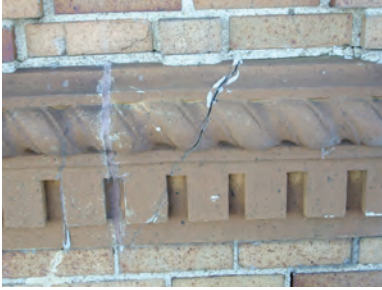
**Fig. 6.11.12**  
Cracked terracotta string course at the base of the cornice. Courtesy: Nelligan White Architects

Directly below the cornice, additional building deterioration was noted in the diamond patterned decorative brick band. Separation of the joint between the corners and the start of the patterned brick was observed at each of the building corners that were inspected. The patterned brick was typically uneven, with open and separated joints and cracked bricks. This damage also appeared to be the result of the rusting, structural steel parapet system (Fig. 6.11.12 & 6.11.14).

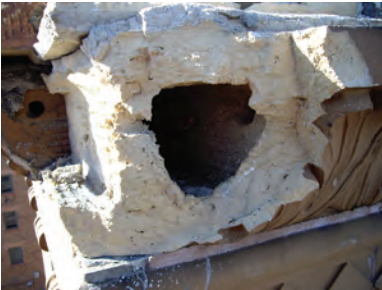
**Fig. 6.11.13**  
South-west corner of building where a large piece of the decorative terracotta cornice fell in 2004. The remaining cavity could be inspected to gather more information about the deteriorating structural steel anchorage system supporting the cornice. Courtesy: Nelligan White Architects

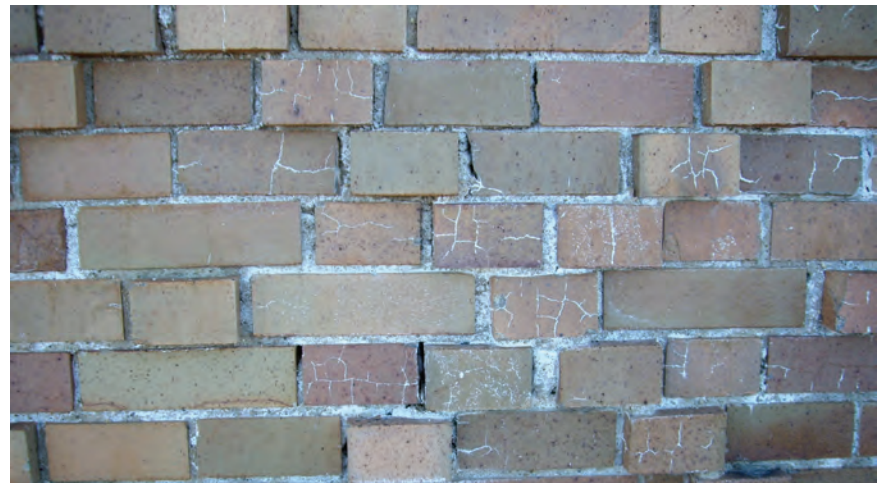
Fig. 6.11.14

**Fig. 6.11.14 (right)**  
Building deterioration found in the diamond patterned brick-band wrapping the south elevation. Joint separation at both ends of the patterned brick band was noted. Courtesy: Nelligan White Architects

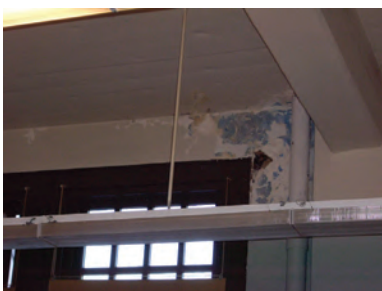
**Fig. 6.11.16 (below)**  
Interior water-damage observed at window heads opposite rusted lintels on the west elevation. Courtesy: Nelligan White Architects

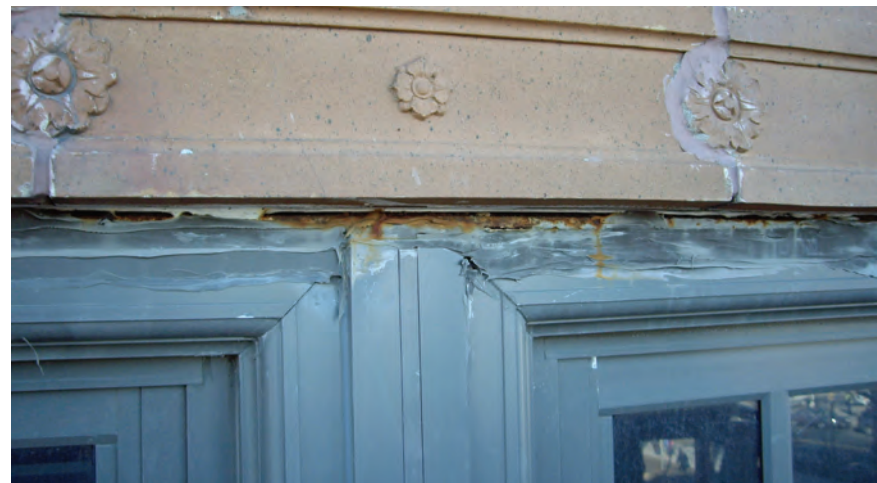
Fig. 6.11.15

**Fig. 6.11.15 (below - right)**  
Typical rusted lintel, east elevation. Within the interior near the rusting lintels, typical instances of water-damage were found at the window heads. Courtesy: Nelligan White Architects

A closer inspection of the metal window lintels from the lift revealed rusting at most locations which had not been repaired previously (Fig. 6.11.15). This observation was a strong indication that rusting of the lintels had been the cause of the jacking and cracking occurrences, observed in the terracotta window surrounds. Within the interior of the building near the rusting lintels, typical instances of water damage were found at the window heads (Fig. 6.11.16). Deeper inspection throughout the school's interior, uncovered additional water-damage found in the stairwell at the rear south-east corner of the west wing. Final observations noted additional cracks found in the terracotta copings at the parapets along the west wing.

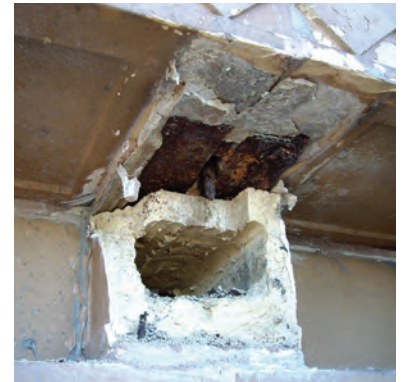
Fig. 6.11.17

Cavity left where a support scroll broke away during sounding tests, exposing part of the rusted steel straps securing the cornice to the top of the building. Courtesy: Nelligan White Architects

When sounded, several of the support scrolls broke apart entirely and fell from the building (Fig. 6.11.17, 6.11.19 & 6.11.20). Cracks were also noted in the terracotta string course at the base of the cornice, around the entire sounded area of the north elevation.

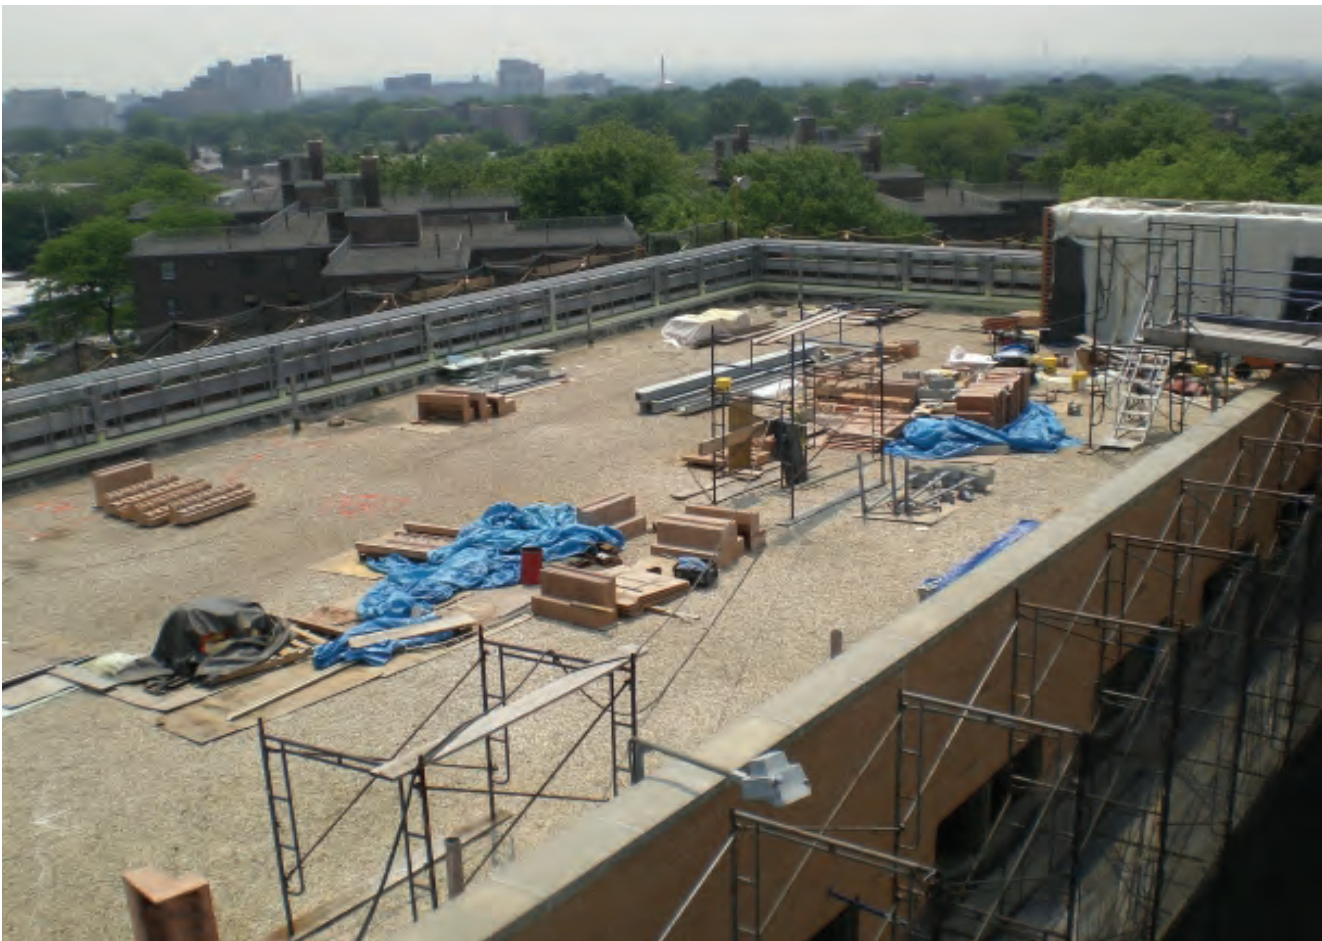
Fig. 6.11.21

**Fig. 6.11.21 (below)**

General view of Roof Area A looking South-east. Several regions of each roof area were blocked by obstructions and had to be worked around when scanning for wet insulation in the roof membrane. Courtesy: Nelligan White Architects

It was noted that due to the presence of building materials and debris that were being stored on the roof at the time of the survey, only about 85% of the roofing areas were accessible to the survey team (Fig. 6.11.21). To assist in interpreting the result of the survey, it was also noted that on its own this method was not able to specifically determine either the cause of the moisture and its specific point of entry or the efficiency of the roofing system, its waterproof membrane or insulation.

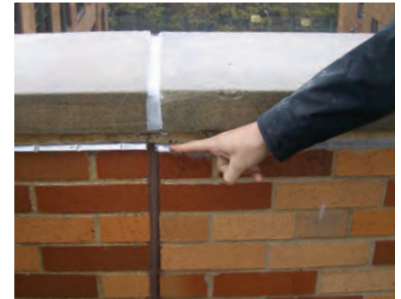
**Fig. 6.11.22**

Break in flashing observed at roof parapet replacement. Improper waterproofing done by previous repair work, may be at fault for wet insulation identified around perimeter of roof membrane. Courtesy: Nelligan White Architects

Most anomalies are associated with the perimeter of the roof along the foot of the parapet walls. It is assumed that the waterproofing/flashing at the base of the parapet walls may be at fault in allowing rainwater to get below the waterproof membrane (Fig. 6.11.22). A few patches of wet insulation that occurred in isolation from the parapets may be due to small, localized failures within the membrane.

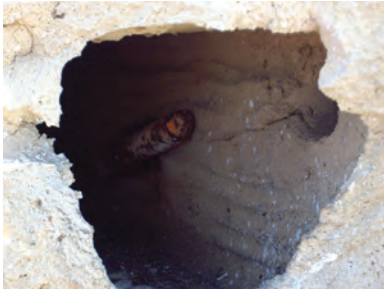
**Fig. 6.11.24**

Inspection of the cavity left where a piece of cornice fell from the south-east corner of the building revealed rusting steel anchorage rods and ties. Courtesy: Nelligan White Architects

Following the preliminary site visit in October of 2005, probes were requested at PS 89 X to evaluate the condition of the existing terracotta cornice, structural steel anchorage system and building columns, spandrels, and lintels at areas where considerable water infiltration was observed on the building's interior. Probes were opened in the exterior face-brick and terracotta at the building's south-east corner revealing rusting on the top flange of the roof spandrel. Closer inspection of the probed terracotta where a large piece of the cornice had fallen in 2004, revealed rusting steel anchorage rods and ties (Fig. 6.11.24).

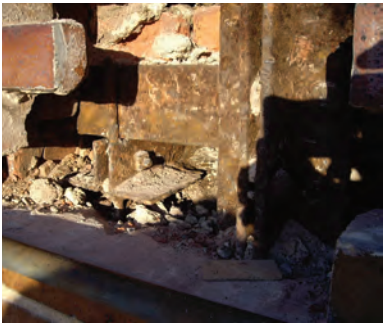
**Fig. 6.11.25**

Considerable deterioration found on steel members within the parapet support system. The extent of deterioration was so much that the flange of one of the angle eroded entirely through. Courtesy: Nelligan White Architects

Opposite the probes of the lintel and roof spandrel, two additional openings were made to evaluate the parapet steel support system of the original building. Similar to what was found within probes of the roof spandrel and terracotta anchorage system, considerable deterioration was discovered on each member of structural steel. The extent of deterioration was so much that the flange of one of the angle had eroded entirely through.

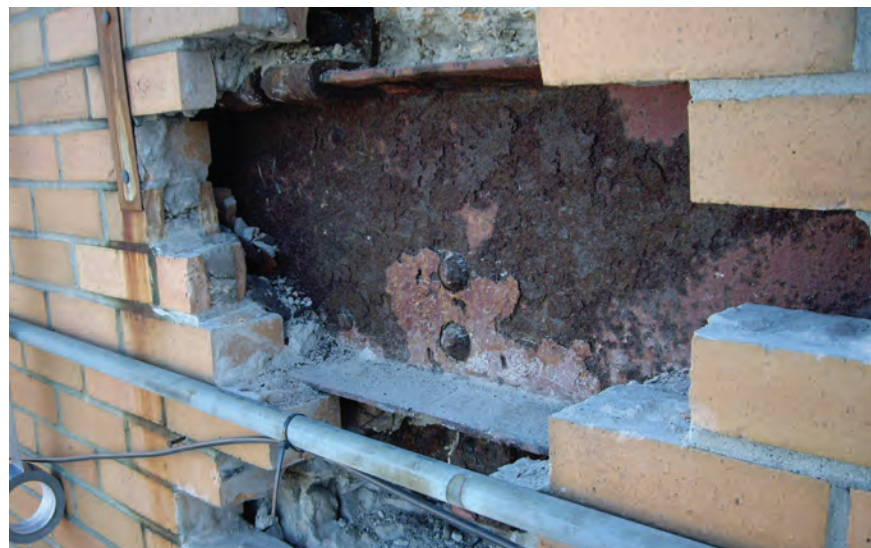
**Fig. 6.11.26 (right)**

Roof side, at the back of the parapet cornice, rust and deterioration of the primary horizontal support channel and cantilevered angles was discovered upon opening. Courtesy: Nelligan White Architects

Additional probes were opened from the roof side at the back of the parapet cornice. Upon opening, extensive rust and deterioration of the primary horizontal support channel and cantilevered angles was discovered. Between the backs of the support angles, roughly one inch of rust scale was measured (Fig. 6.11.25 & 6.11.26).

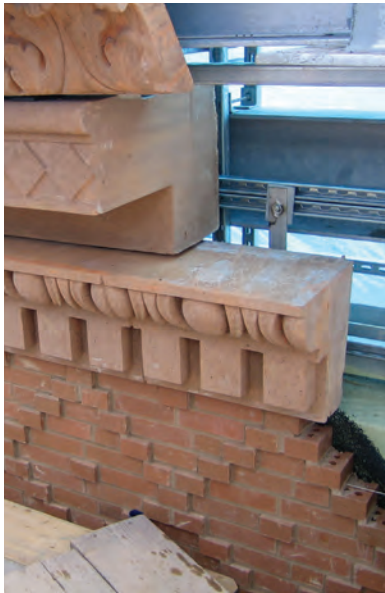
**Fig. 6.11.44**  
Replacement terracotta and structural support during construction. Courtesy: Nelligan White Architects

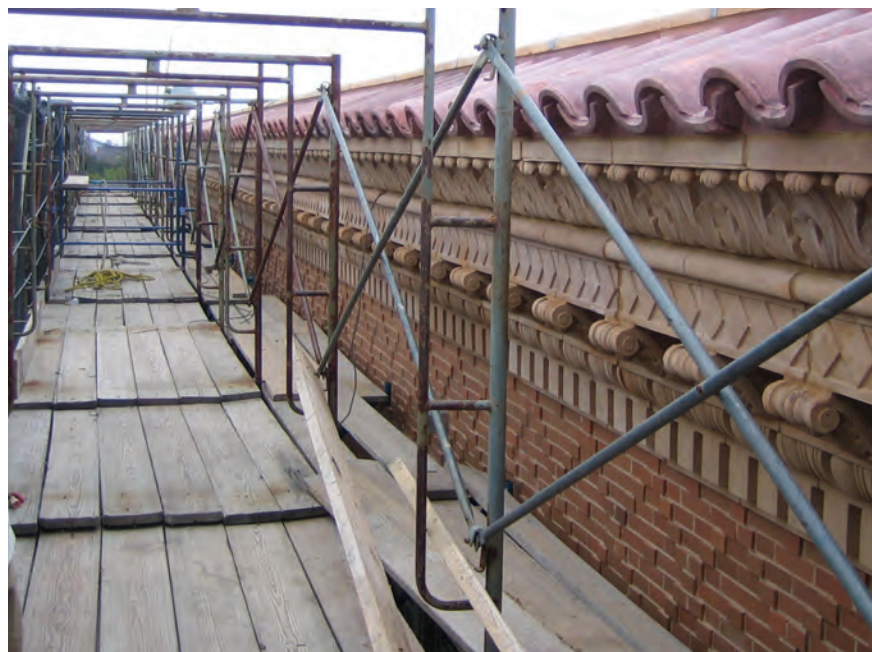
**Fig. 6.11.46 (below)**  
Damaged GFRC to be replaced. Courtesy: Nelligan White Architects

During the construction phase, it was found that many of the GFRC (Glass Fiber Reinforced Concrete) suffered from defects during the manufacturing process and needed to be replaced (Fig. 6.11.46). In addition, many other pieces were damaged during installation and suffered from efflorescence. These pieces were also ordered to be replaced.

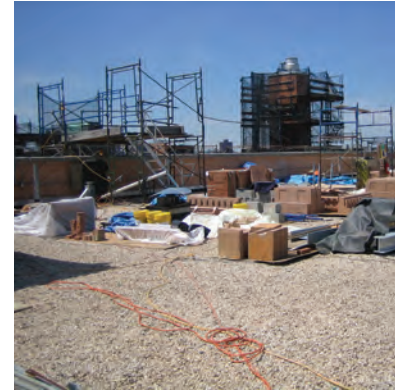
**Fig. 6.11.47**

Staging and storage of construction material had made it impossible to fully inspect the roof with thermal imaging. Courtesy: Nelligan White Architects

During the initial construction process, only the perimeter of the roof was to be replaced in relation with the new parapets. Thermal imaging was only able to be done on part of the roof due to the staging and storage of construction materials (Fig. 6.11.47). Further investigations revealed the roof to be 25% saturated, harming the performance and life span of the roofing assembly.

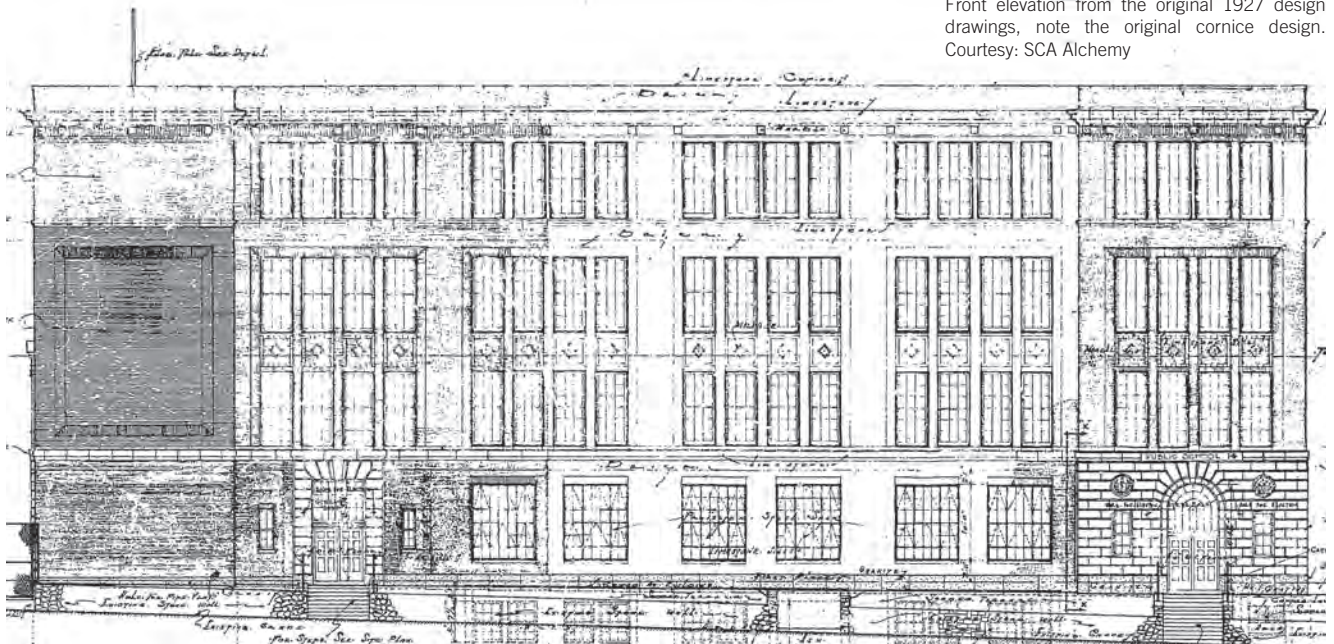
Fig. 6.12.5

Front elevation from the original 1927 design drawings, note the original cornice design. Courtesy: SCA Alchemy

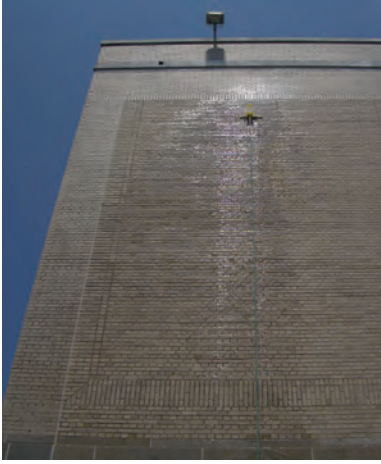
**Fig. 6.12.11**

Spray testing conducted at exterior walls.  
Courtesy: Nelligan White Architects

In addition, spray testing was conducted at the school and no moisture was observed to be penetrating directly through the previously repaired masonry (Fig. 6.12.11). However, the moisture tests performed identified approximately 43 windows that appeared to be leaking (Fig. 6.12.12). Leaks were identified at the joint between the panning and frame, and at the lower frame miter joint. Remedial measures had included injecting the void between the panning, window frame, and the masonry opening with sealant, which did not appear to have been successful.

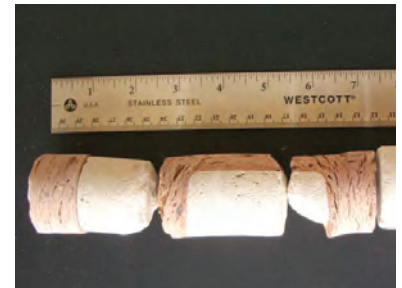
**Fig. 6.12.13**

Core sample taken shows while the terracotta was typically filled with grout the terracotta was found to be full of pores, cracks, and sponge like. The grout and terracotta did not have a proper bond throughout. Courtesy: SWN Architects, LLC

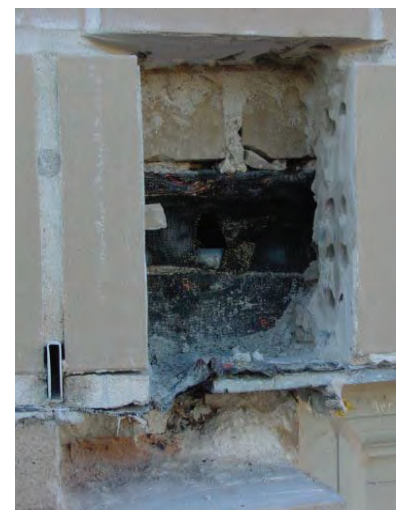
**Fig. 6.12.14 (below)**

Lintel above window was observed to be tipped toward the interior allowing water to become trapped. Courtesy: Nelligan White Architects

The windows were installed in a 1990 campaign and a face-brick was removed from a typical lintel to reveal the wall construction. It was observed that the lintel tipped towards the interior of the building allowing water to become trapped (Fig. 6.12.14). In the area between the metal jamb sections of the window against the old wood weight pockets, loose batt insulation was observed without any vapor barrier. As observed the original wood had become saturated by the failure of the window panning/flashing, and subject to mold, mildew, rot and decay. No flashing was installed nor identified at the head, jambs, or sill.

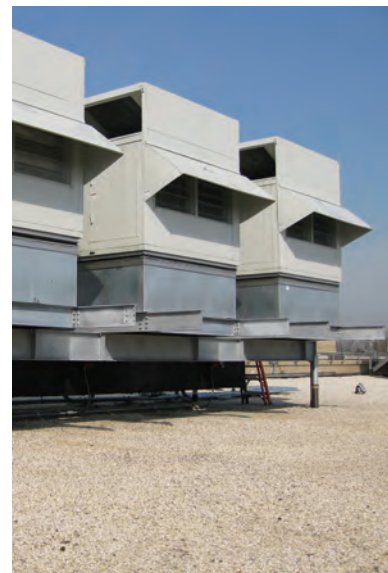
**Fig. 6.12.16 (below)**

New rooftop HVAC system. Courtesy: Nelligan White Architects

- Provide new rooftop ventilation make-up air unit of 100% tempered outside air; 11,700 cfm for classrooms, 5000 cfm required for balance of school
- Unit shall be custom type constant volume, with gas-fired heating section and chilled water cooling coil, pre-filter and 90% secondary filters
- Provide new ductwork, exposed in corridors from rooftop ventilator with fused fire dampers at all floor penetrations and supply register in classrooms
- Provide new rooftop acoustic mechanical enclosure and all necessary structural dunnage and flashing, for unit's proper mounting and waterproofing.

While testing showed the air quality to be similar to the outside and posed no real health hazard, negative air pressure was observed. This negative air pressure was thought to be a contributor to the water infiltration particularly at the leaking window perimeters. The lack of makeup air had resulted in poor circulation, leading to musty stagnant air throughout the building. In order to provide the necessary makeup air to balance out the pressure, improve circulations, and eliminate the need for the windows to be opened rooftop ventilation make-up air units were provided. In addition, the new rooftop units would provide heating and cooling.

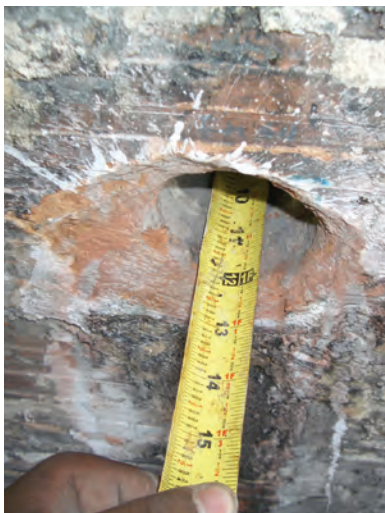
**Fig. 6.12.17**  
Depth of core taken from wall. Sensors would be placed in wall to monitor humidity and temperature. Courtesy: Nelligan White Architects

Further testing involved the placement of sensors into the walls, existing interior finishes were removed at parts of several rooms and a hole was made with a core drill to place the sensor (Fig. 6.12.17). These sensors recorded relative humidity and temperature for 22 days.

When the wall cores were removed to place the sensors, it was revealed that grout normally filled the terracotta cores, but the terracotta itself was found to be full of pores, cracked, and friable. Improper bonds were also found in some places in which the grout fell away from the terracotta.

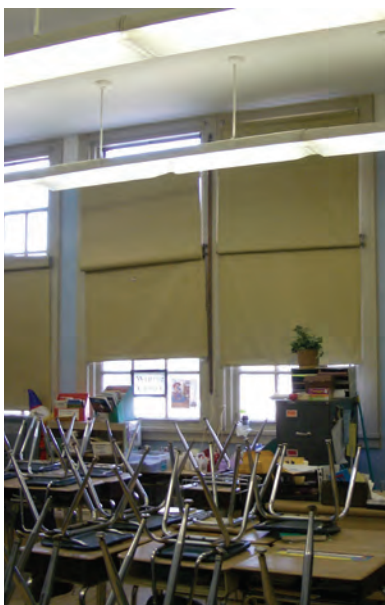
**Fig. 6.12.18**  
Classrooms have large windows letting in plenty of light, but the opening of them was intolerable due to the highway adjacent to the school. Courtesy: Nelligan White Architects

Schools like PS 14 X were typically provided ventilation via an exhaust ventilation system. Each classroom typically has two exhaust registers. At PS 14 X, makeup air was provided, by opening the windows to replace the exhausted air. While the exhaust system was functioning, the windows were kept shut to reduce the noise and possible pollution from the Bruckner Expressway built decades after the school was (Fig. 6.12.18).

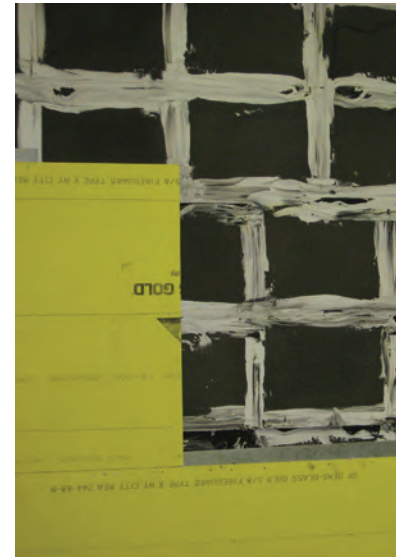
Fig. 6.12.19  
Progress of wall assembly retrofit. Densglass gypsum wall board is installed over the XPS. Courtesy: Nelligan White Architects

A solution to quell the water-infiltration was the use of a wall assembly retrofit on the interior. This started with the spray application of a waterproofing membrane on the exposed terracotta backup. The wall assembly consisted of XPS rigid insulation, metal studs, and finally a finish of Densglass and paint. This was intended to create a barrier to prevent any water-ingress into the interior.

The mock-ups were tested over a short duration to mimic yearlong conditions. At the Guidance Office, the first strategy using the XPS, was overwhelmed by bulk-water leaks. Water began to pour onto the floor around the edges of the XPS a short time after the test began. While water and vapor cannot pass through the XPS itself, the joints have limited resistance to bulk-water penetration. This was further compromised by the quality of installation that can be expected, even with reasonably adequate supervision. For this reason, it was decided that a membrane needed to be placed on the interior face of the terracotta to stop bulk-water penetration, and if the water penetration was significant, the membrane needed to provide drainage back to the outside of the wall. At the same time, it was clear that the application of rigid insulation is the best method to reduce humidity at the interior finish in general. A further simulation was created combining both strategies; the use of liquid applied membrane and XPS rigid insulation. It was found that the performance of the wall was not affected negatively with the combination of the membrane with the XPS (Fig. 6.12.19 & 6.12.20)

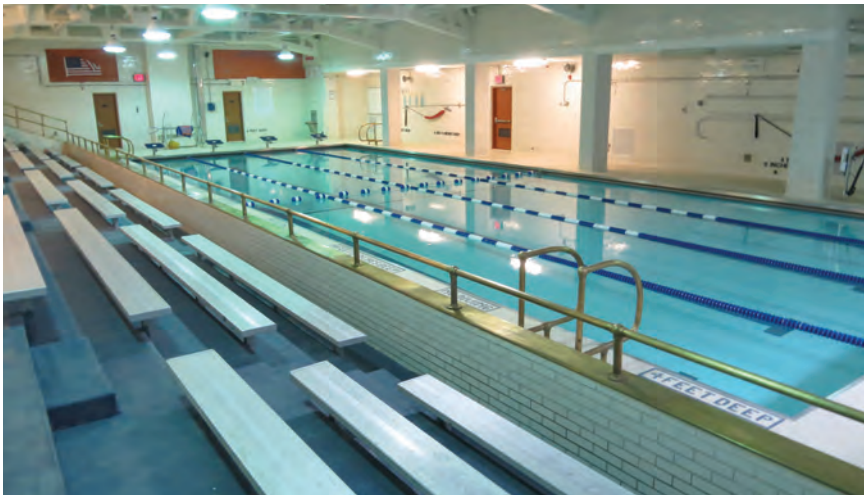
Fig. 6.13.3

**Fig. 6.13.3 (left)**  
Bayside's Natatorium after renovation.  
Courtesy: SuperStructures Engineers + Architects

Prior to the 2013 repair campaign, the school Natatorium was served by an Heat and Ventilation Unit, installed in 1937, with all major components of the original system in place. The system was a heating only constant air flow, recirculation system with pneumatic controls. Since 2013, the HVAC system has undergone a complete upgrade through the installation of a new air distribution and chlorine exhaust ventilation system.

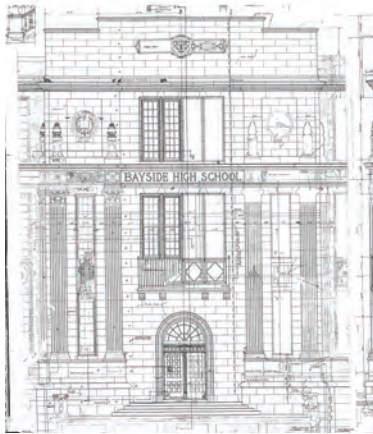
**Fig. 6.13.5**  
Original 1933 building elevation drawing detailing the front entry of Bayside High School with an accompanying building section directly adjacent to the elevation. Courtesy: SCA Alchemy

Prior to proceeding with scope and design, information regarding the building's original construction was obtained through the School Construction Authority's Alchemy database. The database contained 186 drawings from the original 1934 design as well as drawings from ten other repair campaigns carried out at the school between 1985 and 2009.

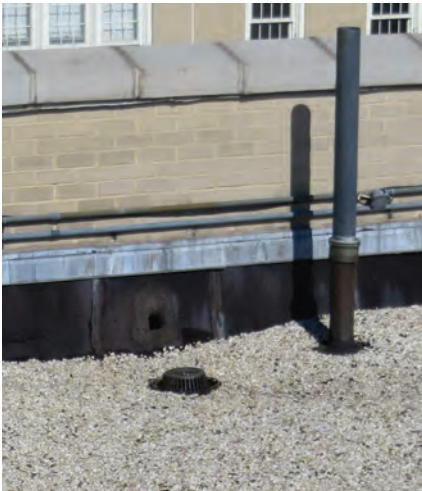
Fig. 6.13.7

**Fig. 6.13.7 (far left)**  
Roof system failures at base flashing adjacent to the existing roof drain on Roof 1 was found to be the primary cause of water infiltration and subsequent damage to interior finishes within the 3<sup>rd</sup> Floor Library. Courtesy: SuperStructures Engineers + Architects

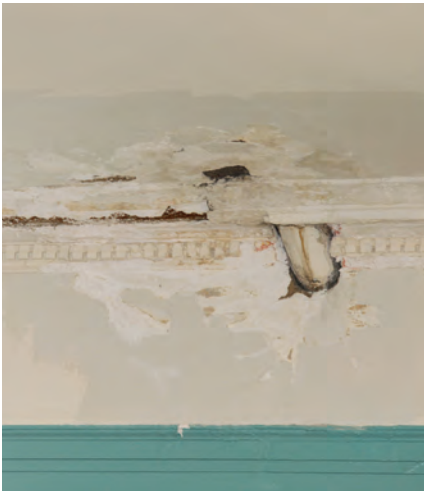
Fig. 6.13.8

**Fig. 6.13.8 (left)**  
Water damage at the ceiling of the 3<sup>rd</sup> Floor Library. Custodial staff repeatedly repaired the area but without stopping the cause of the water infiltration, continuous damage of this area was imminent. Courtesy: SuperStructures Engineers + Architects

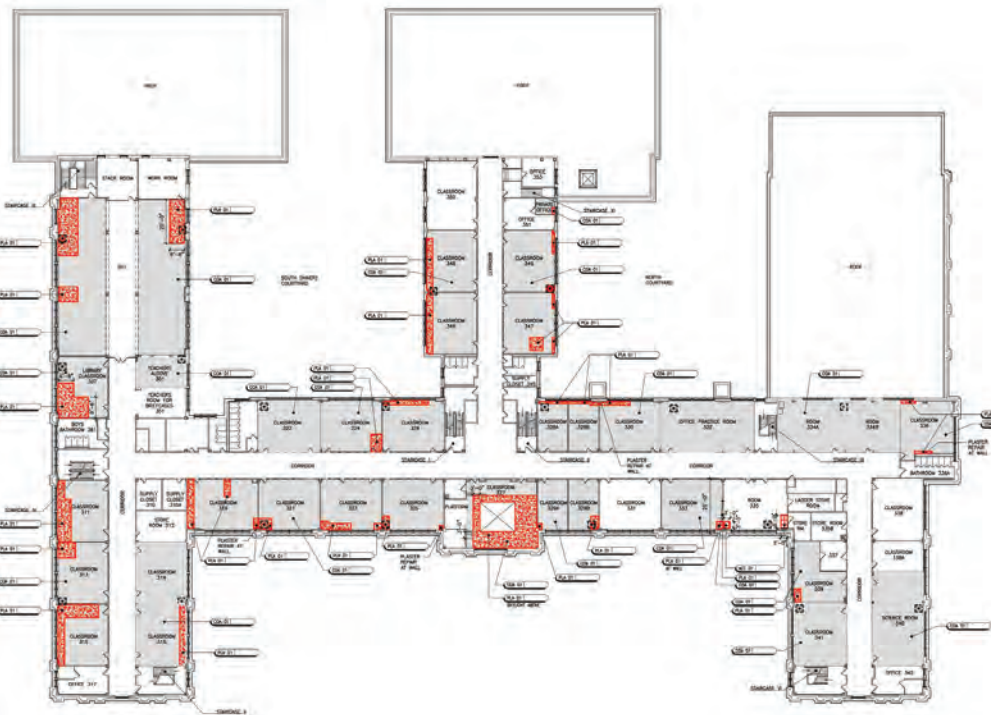
Fig. 6.13.9

**Fig. 6.13.9 (below)**  
Damage mapping drawing of the 3<sup>rd</sup> floor. Courtesy: SuperStructures Engineers + Architects

The first overall analysis using the Building Condition Assessment Survey (BCAS) reports were obtained through the NYC DOE website. BCAS reports were issued for Bayside High School in June 2011. Items within the report relating to the exterior building envelope were evaluated in the field through extensive photography and field-note documentation, using the original design drawings as base drawings. These investigations aided in the facilitation of quantifying deficient items and determining the scope of work at the site.

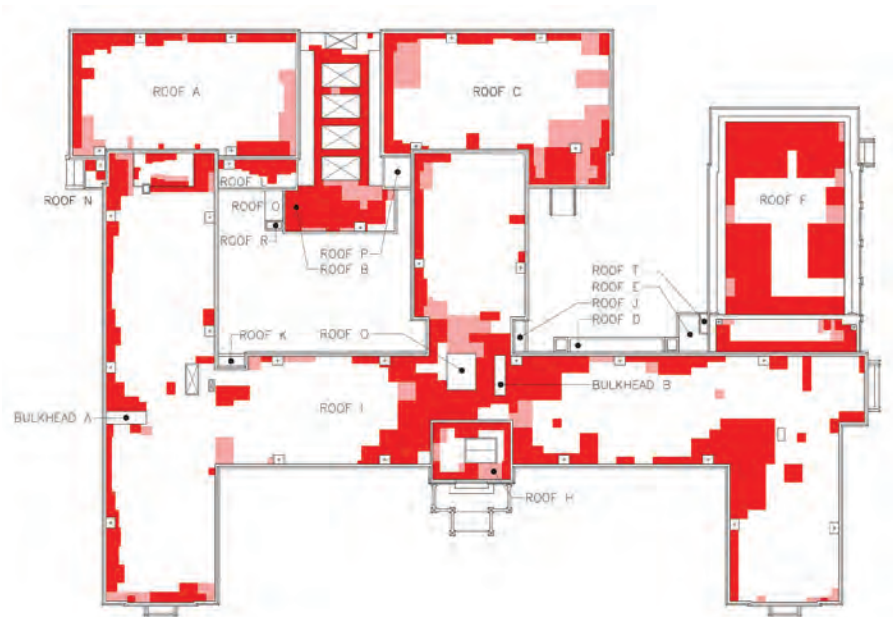
Fig. 6.13.11

**Fig. 6.13.11 (left)**  
Sub-surface moisture testing results for the fourteen roofs tested. Courtesy: SuperStructures Engineers + Architects

Subsurface moisture testing was performed at fourteen of the existing twenty roof levels. At the basement, four wall regions were inspected through thermographic means. Ground penetrating radar mapping was utilized at the pool's concrete enclosure. Video-scoping of seven existing drain lines at the exterior rear yard were also performed. These were the specific non-destructive testing technologies requested and obtained for Bayside High School.

These tests were used to validate or in some cases nullify the visual predictions made during the observation mapping phase of the project. In the case of the data presented below the terracotta sounding, subsurface moisture testing at the roof levels and thermographic inspection of a basement location validated our assumptions.

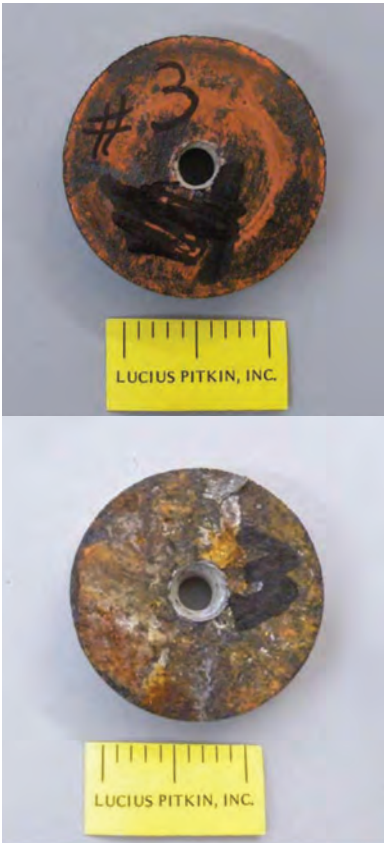
**Fig. 6.13.18**  
Images of the steel coupons to be tested after extraction from the building. Courtesy: SuperStructures Engineers + Architects

In addition to non-destructive and exploratory probes, material testing samples were requested. This type of testing was selected as a means to analyze the feasibility of being able to weld new steel reinforcement members to the existing structure. Samples were extracted from the steel framing beneath the Natatorium. Continued water-infiltration from the pool deck above, considerable high humidity and continued deterioration from the caustic chlorine environment were all factors leading to the breakdown of the steel.

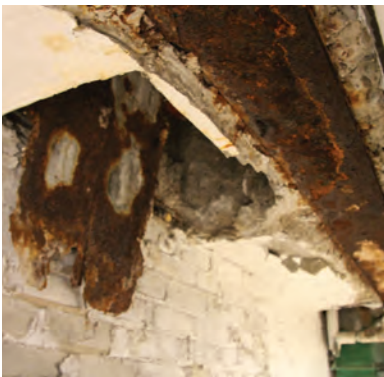
**Fig. 6.13.20 (below)**  
Condition of the existing steel beams within the Blower Room beneath the Natatorium. Courtesy: SuperStructures Engineers + Architects

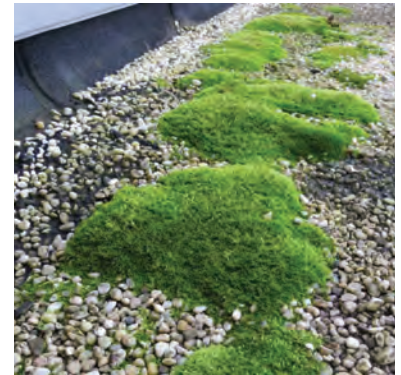
**Fig. 6.13.21**  
Biological growth observed. Courtesy: SuperStructures Engineers + Architects

Based on the building code requirements, extensive failures observed at roof membranes throughout, confirmation of membrane saturation through destructive and non-destructive site testing and visual observations of biological growth, and considering at least 11,000 SF of roof replacement would be required directly adjacent to the parapet edge to facilitate proper replacement, full roof system replacement was recommended. Additional discoveries at roof levels throughout prompted the following additional recommendations:

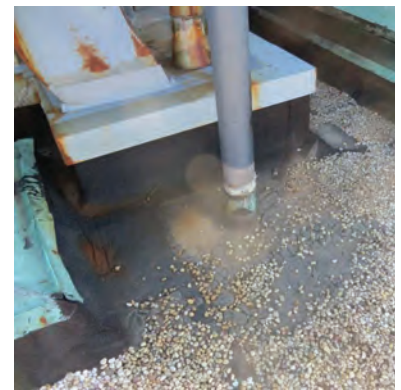
**Fig. 6.13.22**  
Exposed, cracking roofing membrane. Courtesy: SuperStructures Engineers + Architects

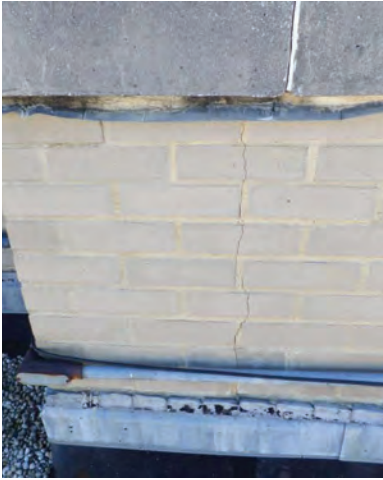
**Fig. 6.13.24**  
Existing parapet deterioration. Courtesy: SuperStructures Engineers + Architects

Findings at the parapets through visual inspections included horizontal, vertical and step cracks in brickwork; expansion joint failure; mortar joint leeching at interior and exterior faces; aliphatic membrane installations over brickwork installed in an attempt to reduce water-ingress, and parapet heights less than the NYC Building Code requirements of 3'-6" minimum at high points. Coping stone observations included spalled and cracked units, which were leading to biological growths. Failed sealant throughout allowed water-ingress into joints and ultimately traveled under flashing into the coping mortar bed and further into the parapet's interior wythes. Sandy mortar beds and mortar beds were not fully bonding to the coping stones. Exploratory probes confirmed saturation at the interior of parapets, insufficient or improperly installed flashings, voids within the mid-wythe masonry construction, and insufficient sealant thickness at expansion joint installations. These discoveries prompted the following recommendations:

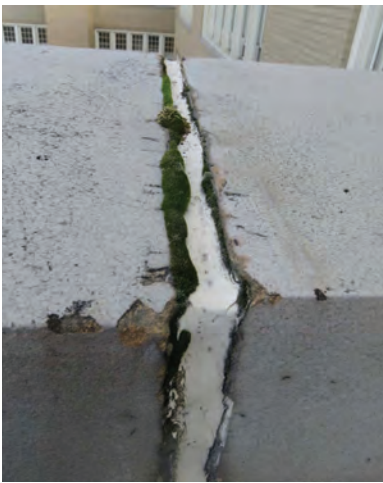
**Fig. 6.13.25**  
Biological growth beneath coping stone sealant. Courtesy: SuperStructures Engineers + Architects

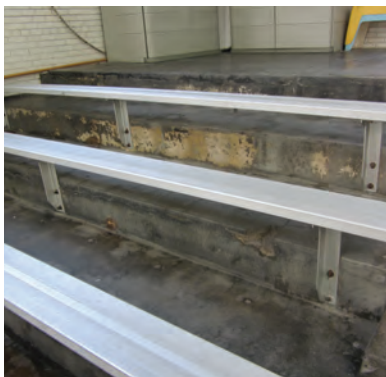
**Fig. 6.13.31 & 6.13.32 (above - below)**  
Before and after of bleachers in Natatorium.  
Courtesy: SuperStructures Engineers + Architects

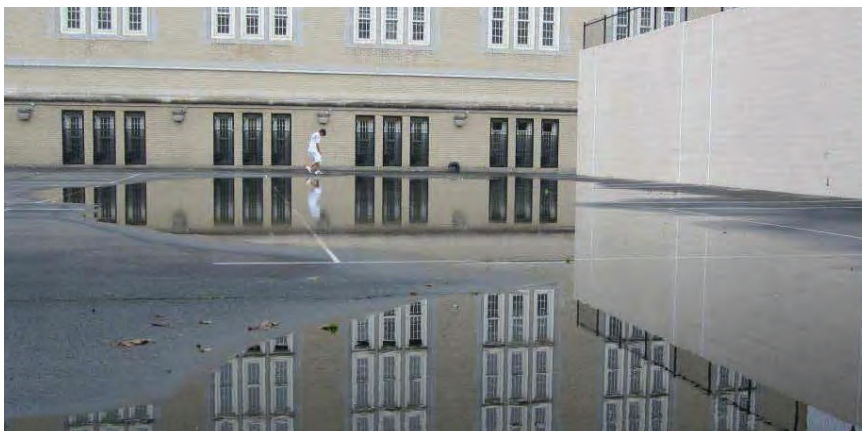
Fig. 6.13.35

Existing condition of handball courts at the rear elevated yard. Negative sloping along with clogged and broken drain piping is the cause of this excess water. Courtesy: SuperStructures Engineers + Architects

Findings through visual inspections revealed the existing site sloped towards the rear of the building. In addition to this, low basement level window sills and foundation wall damages accompanied by broken drain piping beneath the handball courts was causing water ingress into the basement levels of the building. Geotechnical investigation confirmed that groundwater was not the culprit as the static groundwater level was determined to be greater than 50 feet below grade. These findings prompted the following recommendations:

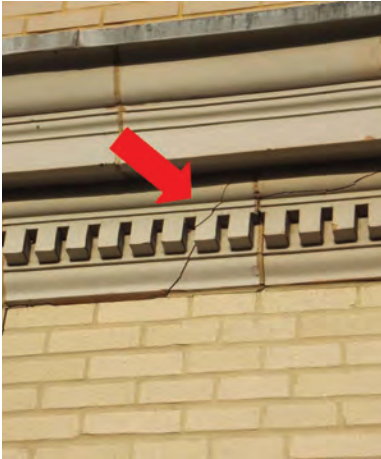
**Fig. 6.13.36**

Step cracking of the face-brick masonry from existing corner, continuing up through the ornamental terracotta dentil units. Courtesy: SuperStructures Engineers + Architects

Findings through visual inspections, those confirmed during the course of non-destructive testing, and exploratory probes proved the foremost causes of water infiltration at the exterior masonry was through failed sealant, failed mortar joints and cracked/failed brickwork. Cracked, spalled and displaced bricks at heads of window, louver and door openings were caused by deteriorated, delaminated and bowed steel lintels. Deficiencies were also observed throughout the existing ornamental terracotta units, more of which were discovered during construction after completion of sounding at 100% of the existing units. These findings led to the following recommendations:

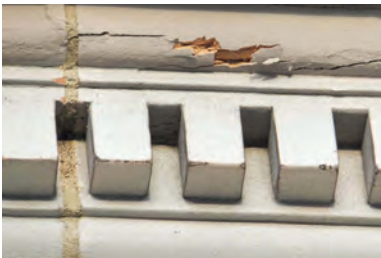
**Fig. 6.13.37**

Horizontal cracking and spalling of existing ornamental terracotta units. Courtesy: SuperStructures Engineers + Architects

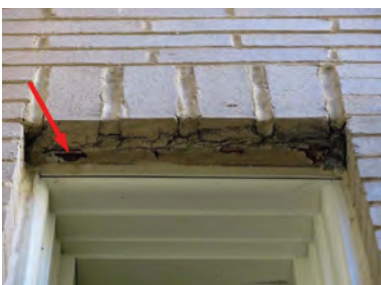
**Fig. 6.13.38 (below)**

Failing brick masonry face-brick units at window head locations directly associated with deteriorated and delaminating steel lintels. Courtesy: SuperStructures Engineers + Architects

- Provide brick masonry replacement at window and door heads in conjunction with lintel repairs
- Provide new sealant and backer rod at all existing corner control joints

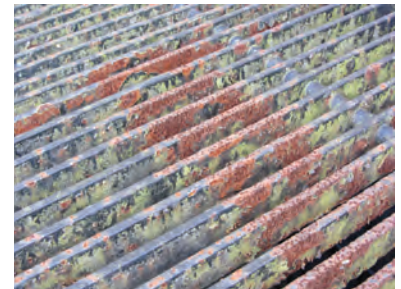
**Fig. 6.13.40 (above)**  
Deteriorated areaways. Courtesy: SuperStructures Engineers + Architects

- Provide epoxy coat paints systems at existing areaway gratings
- Provide stainless steel mesh at underside of existing areaway gratings
- Provide limestone replacement and crack repair at main entry stairs

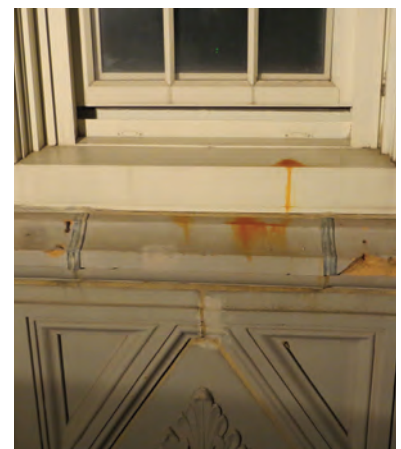
**Fig. 6.13.42 (below)**  
Damage and staining observed at terracotta panels and sills. Courtesy: SuperStructures Engineers + Architects

- Provide terracotta sill unit replacement and crack repair as shown in the drawings
- Provide raking and repointing of all terracotta units to remain
- Provide terracotta glazing as shown in the drawings

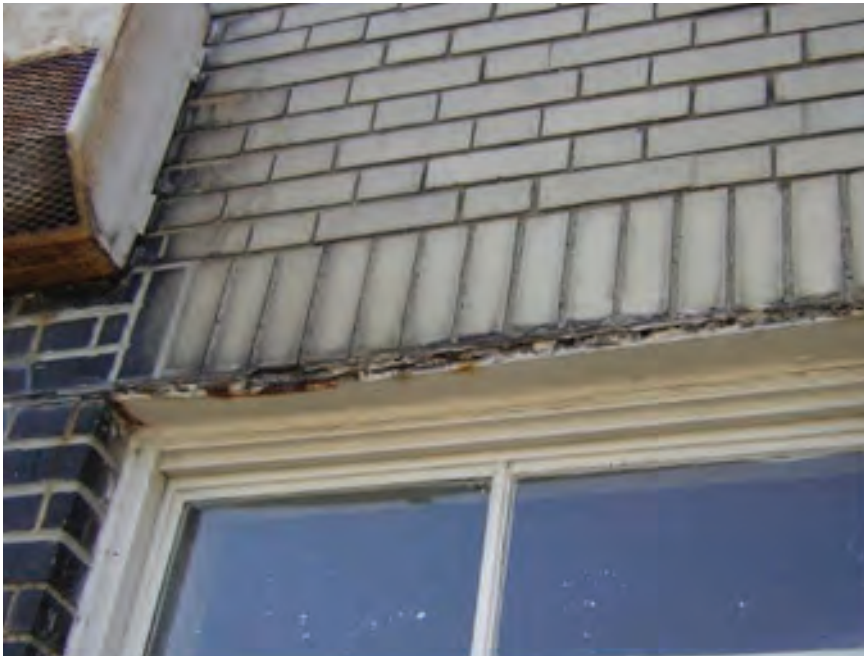
Fig. 6.14.9

**Fig. 6.14.9 (above left)**  
Deteriorated steel lintel and masonry. Courtesy:  
SuperStructures Engineers + Architects

- Remove four courses of brick masonry to replace lintels and support straps or clip angles as required
- Apply rust-inhibiting coating to the steel, install new masonry, including membrane flashing and weep holes
- Where spandrel repairs and lintel repairs occur in the same location, the repair detail will provide for the restoration of both the spandrel and the hung lintel in combination
- Prepare and coat all exposed portions of all lintels to remain.

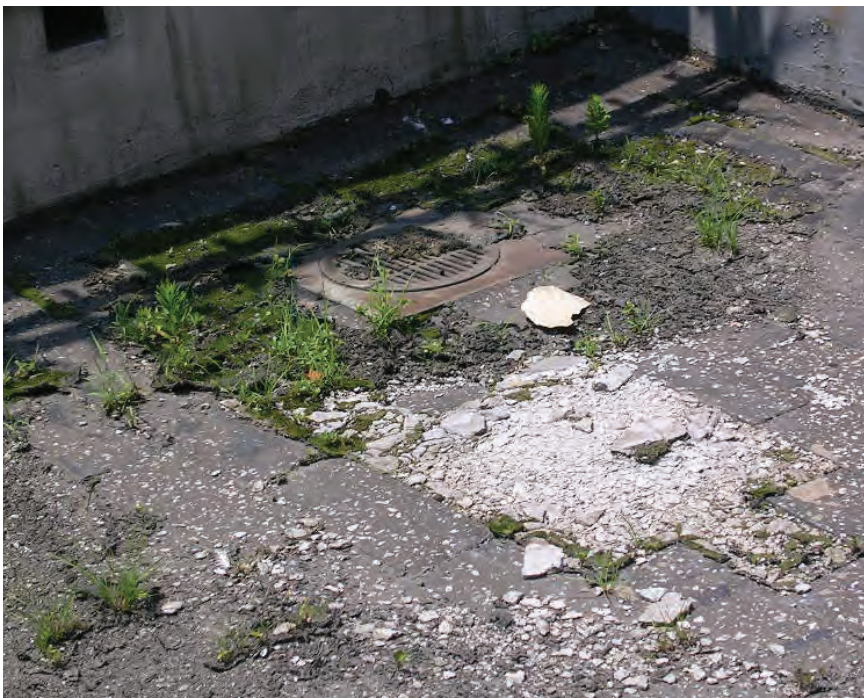
Fig. 6.14.10

**Fig. 6.14.10 (left)**  
Terrace drain before renovation. Courtesy:  
SuperStructures Engineers + Architects

- Remove existing construction down to structural slab and install new PMR roofing system consisting of vapor barrier, tapered insulation, plaza deck roofing membrane, filter fabric and quarry tile/pre-cast paver overburden
- Install perimeter membrane flashing and copper counter-flashing.
- Install new terrace drains at existing locations
- Replace door saddle with new, at three locations on 10<sup>th</sup> floor

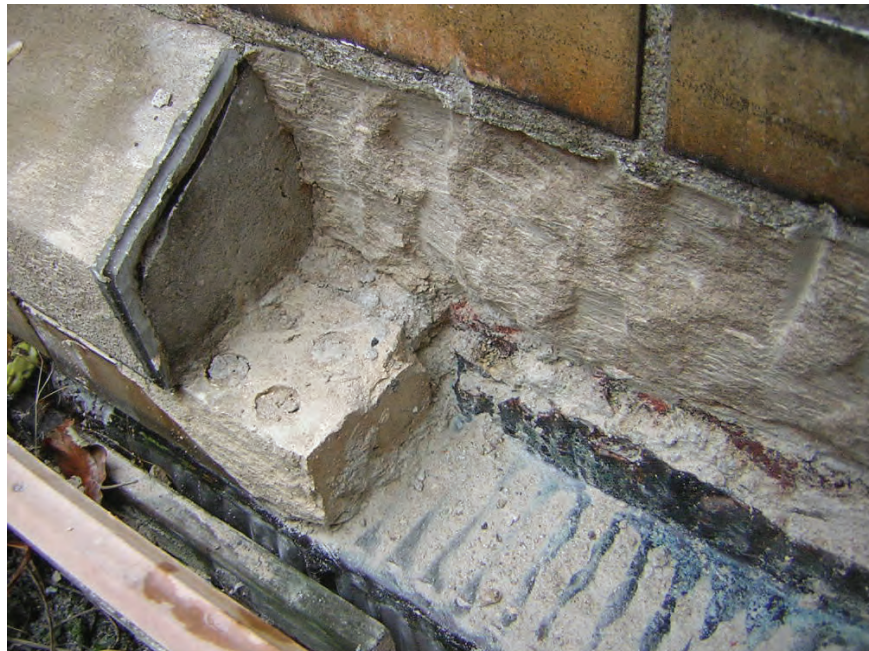
**Fig. 6.14.12**

**Fig. 6.14.11 (above) & 6.14.12 (right)**  
Masonry probe at stone ledge on parapet.  
Courtesy: SuperStructures Engineers + Architects

Probes were requested during the Scope Phase of the project and were provided by the contractor during the Design Phase. The six requested masonry probes were observed in November 2006 through accessible roofs and setbacks. They revealed that the parapet stone watertable was attached to the backup masonry with corroded steel anchors. They also revealed that the copper roof-flashing was adequately installed turned up between the outer wythe of brick and the interior wythe. The masonry was also found to be mostly in fair condition.

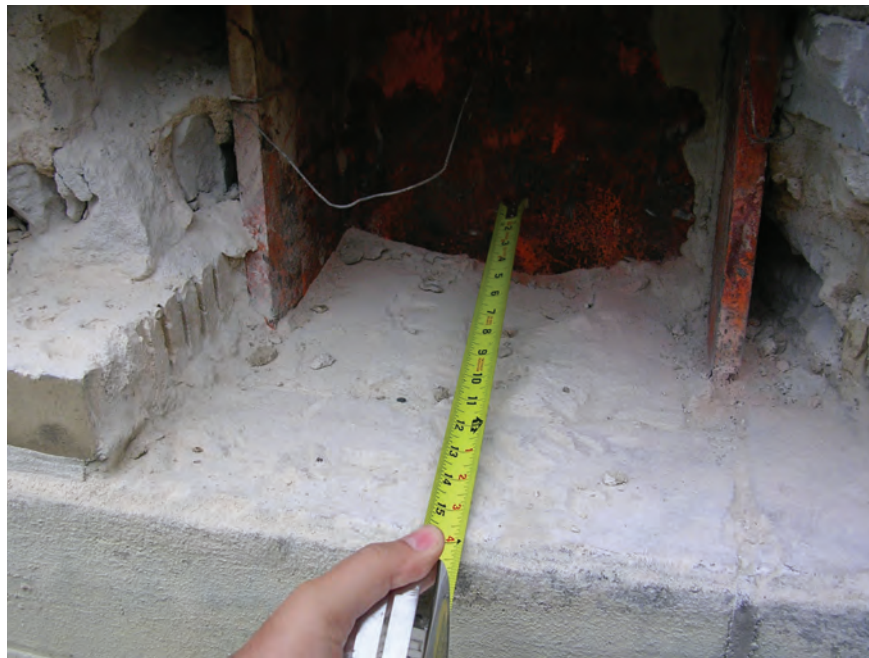
**Fig. 6.14.13**

**Fig. 6.14.13 (left)**  
Masonry probe at column. Courtesy:  
SuperStructures Engineers + Architects

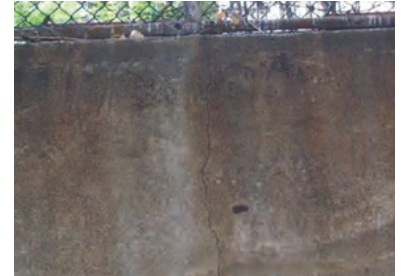
**Fig. 6.14.14**  
Before the repair of retaining wall. Courtesy: SuperStructures Engineers + Architects

- Concrete cracks shall be repaired with high modulus injection epoxy in to injection ports, starting from lower ports
- Remove injection ports and patch with surface sealer; apply finish coating at conclusion
- For large spalls, clean and prepare exposed reinforcing bars
- Repair spalls with modified repair mortar and coat wall with breathable concrete coating
- Remove existing backer rod and sealant at expansion joints and prepare surface; install new backer rod and sealant
- Restore railing posts by removing and reinstalling railing posts with new galvanized steel sleeves and setting posts in non-shrink grout

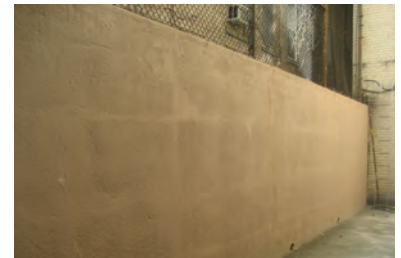
**Fig. 6.14.15**  
After the repair of retaining wall. Courtesy: SuperStructures Engineers + Architects
