# New York City's Historic Schools

A History and Guide to Rehabilitation

NYC SCHOOL CONSTRUCTION AUTHORITY

This Guide has been developed as a practical and technical resource to assist in the evaluation and design for the restoration of historic school buildings (more than 45 years old). It is worth noting that over half of our public school buildings are more than 60 years old! It is our intention to facilitate strategies for these projects that will target cost effective solutions while at the same time respecting their historic standing as landmarks in the community.

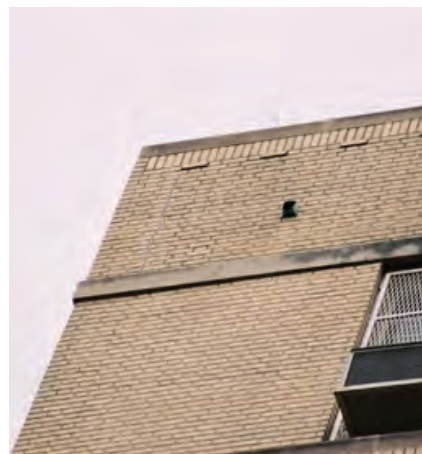
Fig. 6.14.21

**Fig. 6.14.21 & 6.14.22 (right - far right)**  
Cracked parapet brick masonry. Deteriorated limestone coping at the fifth floor roof terrace. Courtesy: SuperStructures Engineers + Architects

- Replace cracked face-brick masonry found at spot locations around the facades
- Replace brick masonry at areas of displacement observed at spot locations on the parapet at the eighth floor and tenth floor terraces at south and north street elevations
- At spandrels, remove masonry on each side of the vertical crack at a width and depth sufficient to fully expose the underlying steel column or beam
- After steel repair, install new masonry, including waterproofing, flashing, weeps, and anchorage to underlying steel

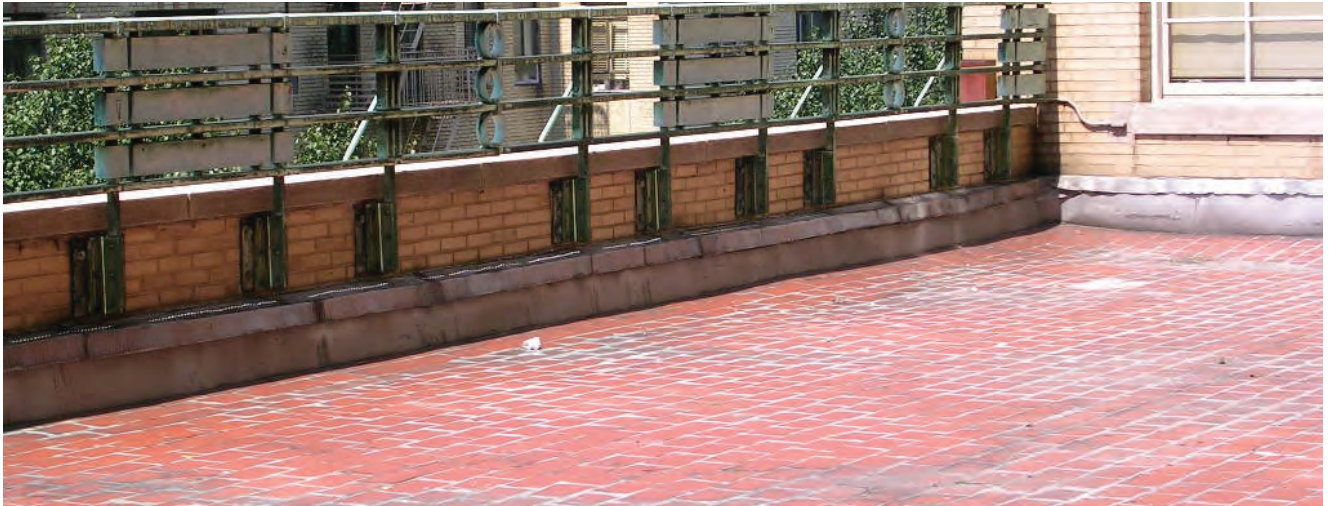
Fig. 6.14.23

**Fig. 6.14.23 & 6.14.24 (below - far below)**  
Typical terrace roof condition prior to renovation. Terrace after renovation. Courtesy: SuperStructures Engineers + Architects

- Remove existing construction down to structural slab and install new PMR roofing system consisting of vapor barrier, tapered insulation, plaza deck roofing membrane, filter fabric and quarry tile/pre-cast paver overburden
- Install perimeter membrane flashing and copper counter-flashing.
- Install new terrace drains at existing locations
- Replace door saddle with new, at three locations on 10<sup>th</sup> floor

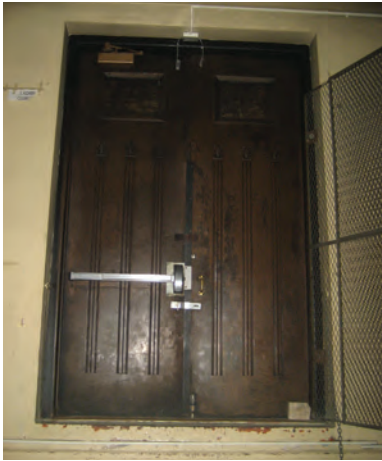
**Fig. 6.14.25**  
Bronze doors prior to refinish. Courtesy: SuperStructures Engineers + Architects

The exterior bronze doors were meticulously restored as part of the project. Years of grime accumulation and regular wear and tear had taken a toll on these exquisite doors. Restoration of the doors proved to be financially feasible instead of full replacements. The doors were removed from the frames and moved to the restoration contractor's shop. They were cleaned and stripped of their patina. They were then refinished with a toner to match the original statuary bronze finish.

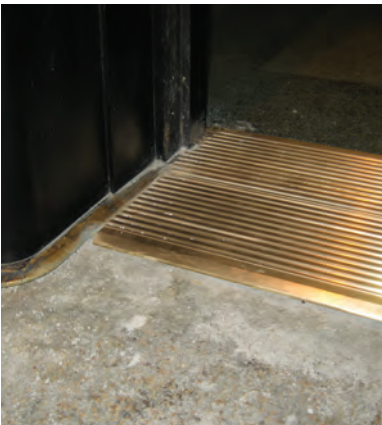
**Fig. 6.14.26 (above)**  
New bronze saddles and restored doors. Courtesy: SuperStructures Engineers + Architects

On site, the frames were left in place and also stripped and refinished; glazing on the transoms was replaced. The original sill was in poor condition and was to be fully replaced, however, it was installed under the frames and mullions. It could not be fully removed without affecting the jambs. Therefore, it was decided that the existing sill would be cut at the jambs and that mullions with an infill bronze sill would be installed. This solution allowed for the preservation of an original portion of the sill that was designed to intricately follow the form of the jambs and mullions.

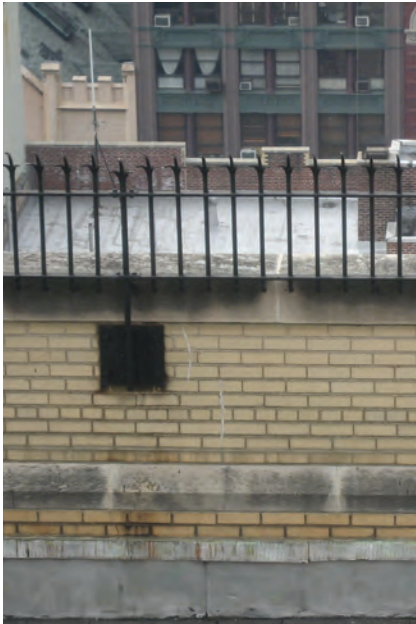
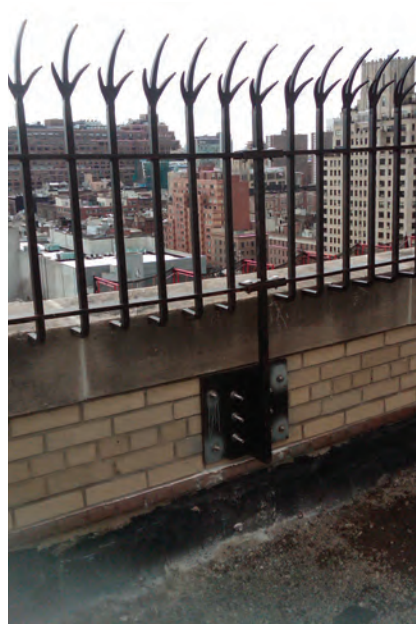
Fig. 6.14.28 & 6.14.29 (far left - left)

Original guardrail at parapet. New guardrail matches style of replaced guardrail but conforms with code requirements. Courtesy: SuperStructures Engineers + Architects

Due to roof-level changes, some parapets required the addition of fall prevention guardrails. There were existing guardrails at some parapet locations around the building, and new guardrails were designed in wrought iron to replicate the original, existing style. During construction, a mold was taken of the original guardrail to replicate the shape in the shop drawings. Where installed, the new guardrails blend seamlessly with the originals.

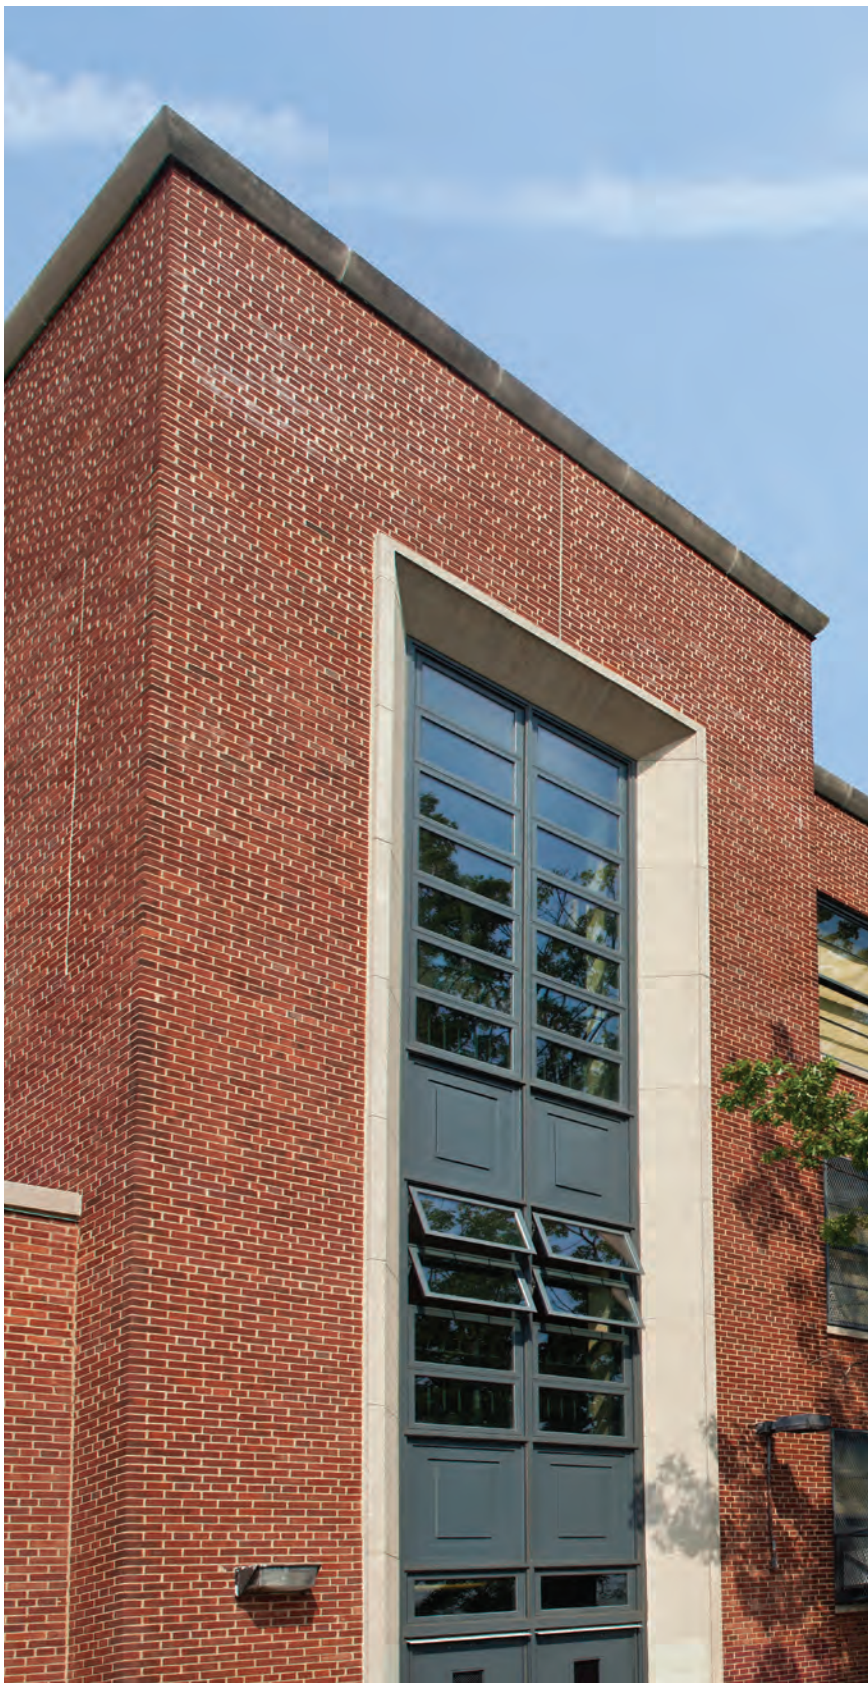
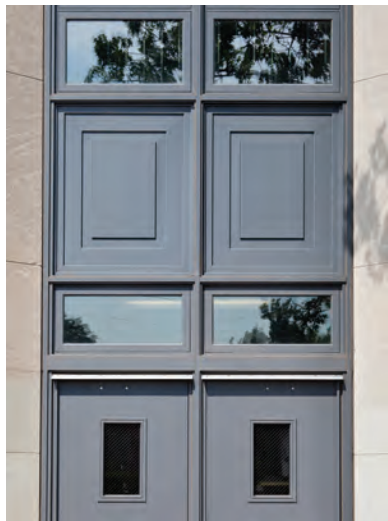
**Fig. 6.15.1 & 6.15.2 (above - right)**  
New curtain wall at the main entrances, painted to match the original color. Courtesy: Sylvia Hardy

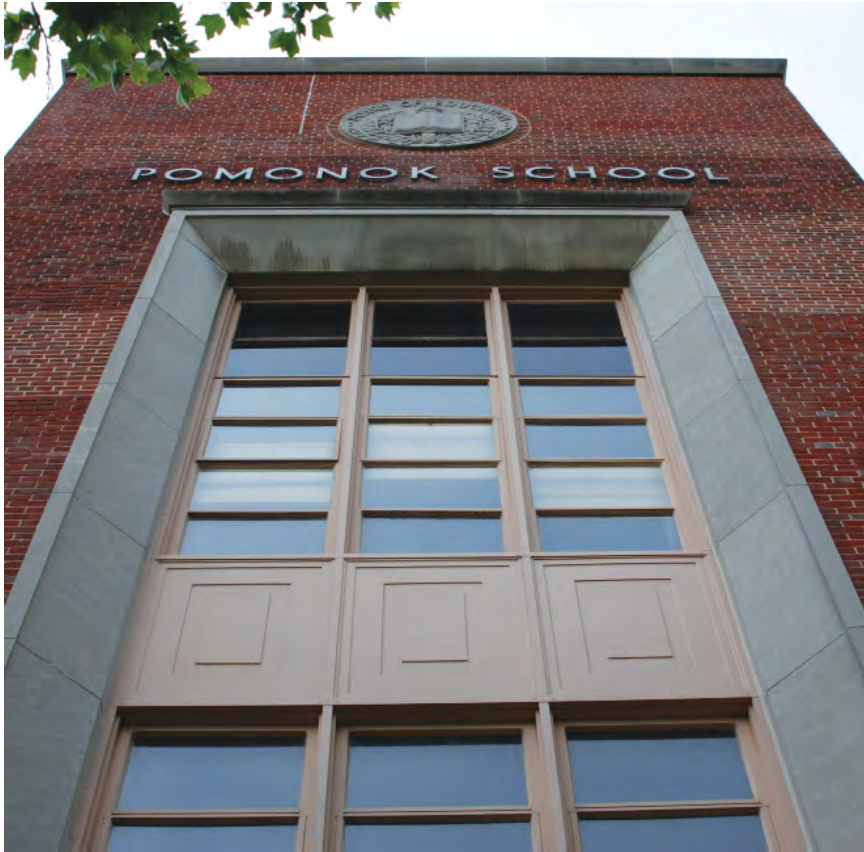
Fig. 6.15.5

**Fig. 6.15.5 (left)**  
The main entrance on Jewel Avenue before rehabilitation. The curtain wall was deteriorating, and had been painted over several times. Mismatched brick was visible on all facades. Courtesy: Nelligan White Architects

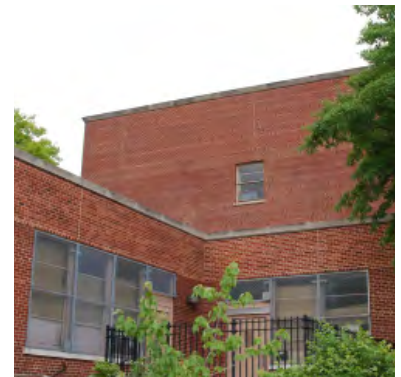
**Fig. 6.15.6**  
Mismatched bricks and noncontinuous expansion joints from a previous parapet repair. Courtesy: Sylvia Hardy

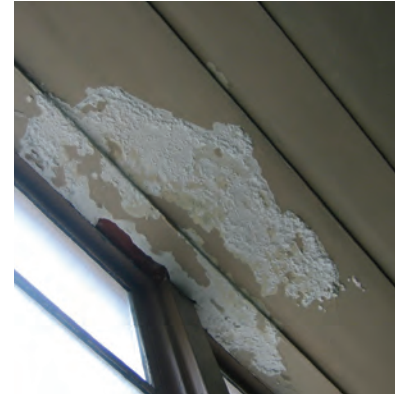
Fig. 6.15.12

Water damage at the head of a window opening. Courtesy: Nelligan White Architects

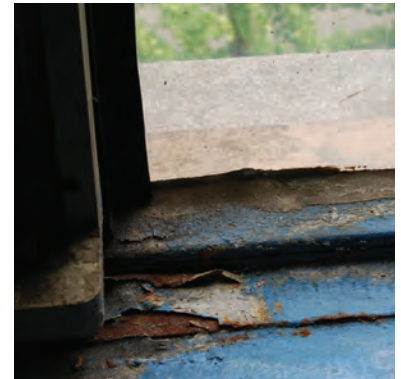
Fig. 6.15.13 (above) & 6.15.14 (left)

The windows at PS 200 Q were in a very deteriorated condition. Most were difficult to operate or inoperable due to rusting and broken counterbalances. Additionally, failed sealants allowed for water infiltration. Courtesy: Nelligan White Architects

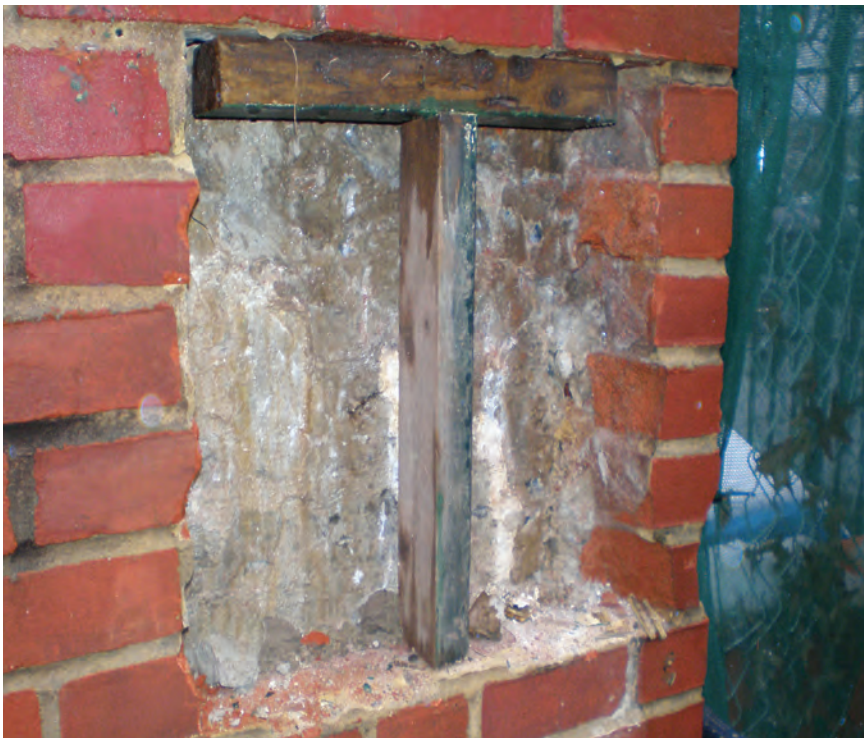
Fig. 6.15.21

**Fig. 6.15.21(left)**  
Exploratory ProbeNo.2, face-brick and backup was observed to be in good to fair condition. Courtesy: Nelligan White Architects

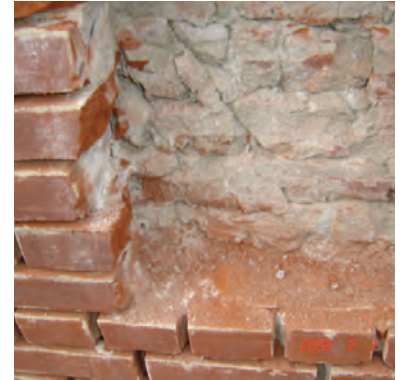
**Fig. 6.15.18 & 6.15.19 (above - below)**  
Exploratory Probe No.1, face-brick and backup was observed to be in good to fair condition. Courtesy: Nelligan White Architects

Probes were conducted to determine the condition of face-brick and backup. Findings confirmed that the existing masonry was mostly in good condition, likely due to the relatively young age of the building. However, several deficiencies were noted which most likely contributed to moisture infiltration or were determined to be problematic in the near future. Original mortar was in fair condition, though it crumbled when disturbed in some locations. Other areas of mortar did not crumble, but were not bonded to the adjacent brick, as evinced by cracks between the two materials. There were many voids in the pointing, and most joints were not concave, as is standard.

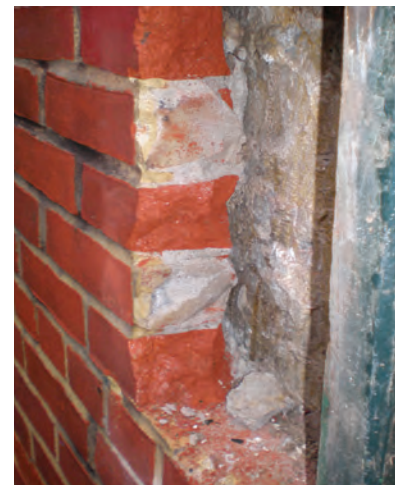
**Fig. 6.15.20 (above left)**  
Were face-brick had been coated mortar was observed to be in poor condition. Non-breathable coatings may exacerbate damage associated with moisture infiltration. Courtesy: Nelligan White Architects

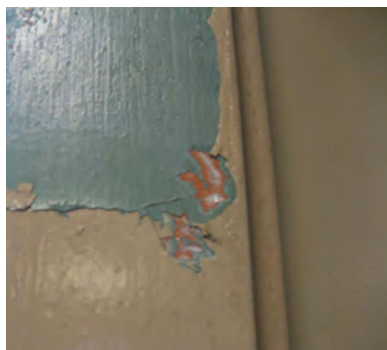
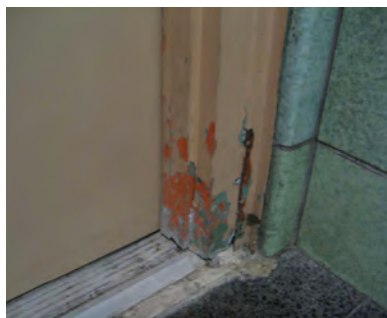
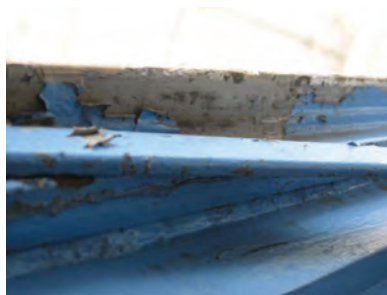
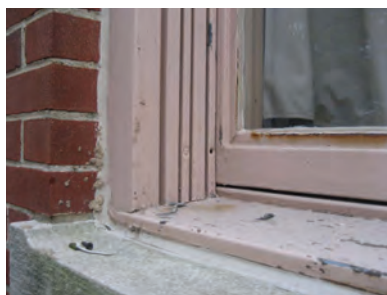
**Fig. 6.15.26 - 6.15.29 (below)**

Paint sample locations at door frames and window jambs. Courtesy: Nelligan White Architects

In addition to testing for lead based paint and asbestos containing materials, a paint analysis was conducted to determine the original color of the existing brake formed steel window systems. Samples of paint were removed from the exterior and interior of window casements and the main entrance door frame (Fig. 6.15.26 - 6.15.29). The magnified cross section of these samples were analyzed in natural daylight (Fig. 6.15.20 - 6.15.23). Paint layers were first matched to the Munsell Color Chart, then to a commercial paint chart provided by Benjamin Moore.

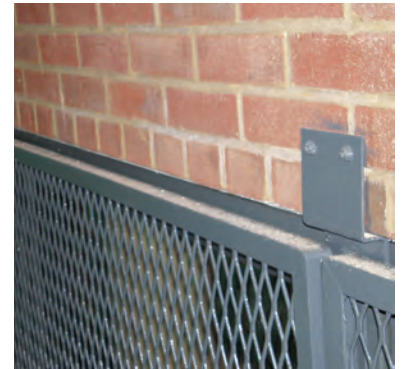
**Fig. 6.15.30**

To avoid damaging the windows and voiding their warranty, window guards were attached directly to the brick. Courtesy: Nelligan White Architects

### 2. Window Guards (Fig. 6.15.30)

- Remove and refinish all window guards
- Shotblast paint any rusty decorative window guards
- Coat galvanized window guards with a Kynar finish and reinstall directly to the brick masonry using stainless steel epoxy anchors

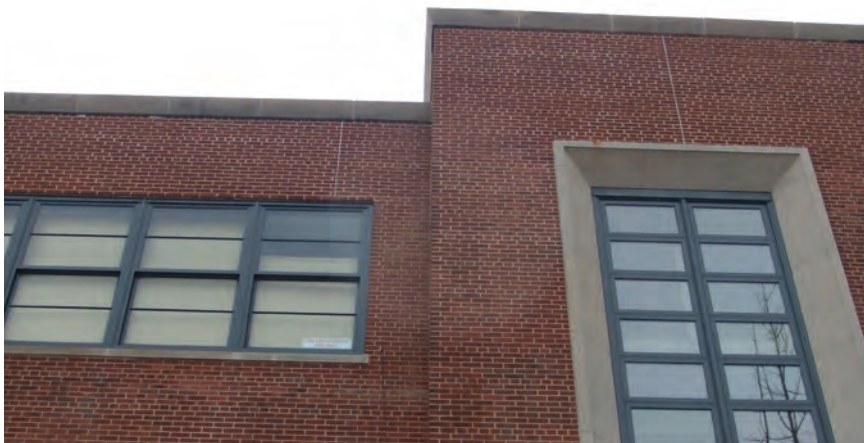
**Fig. 6.15.32 (left)**

Both window systems were replaced, and painted to match the original color as specified in 1953. Courtesy: Nelligan White Architects

- Replace all windows were with historically accurate aluminum windows
- Provide double-glazed windows to comply with contemporary energy standards, results in a thicker frame
- Coated new windows to match their original color

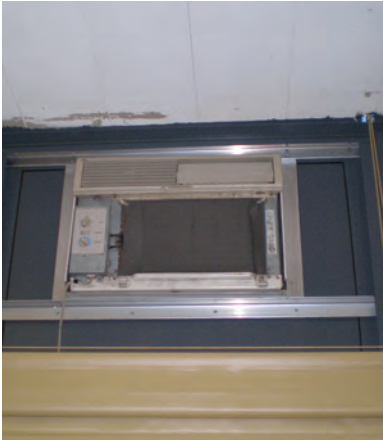
**Fig. 6.15.33**  
Newly weather sealed air conditioner unit.  
Courtesy: Nelligan White Architects

## 3. Air Conditioners (Fig. 6.15.33)

- Remove, store, and reinstall Air conditioners using extensive thermal and weather sealant

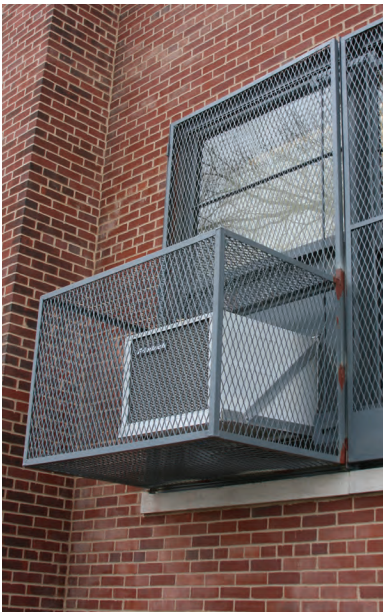
**Fig. 6.15.34**  
Resurfaced guard around air conditioner unit on the exterior. Courtesy: Nelligan White Architects

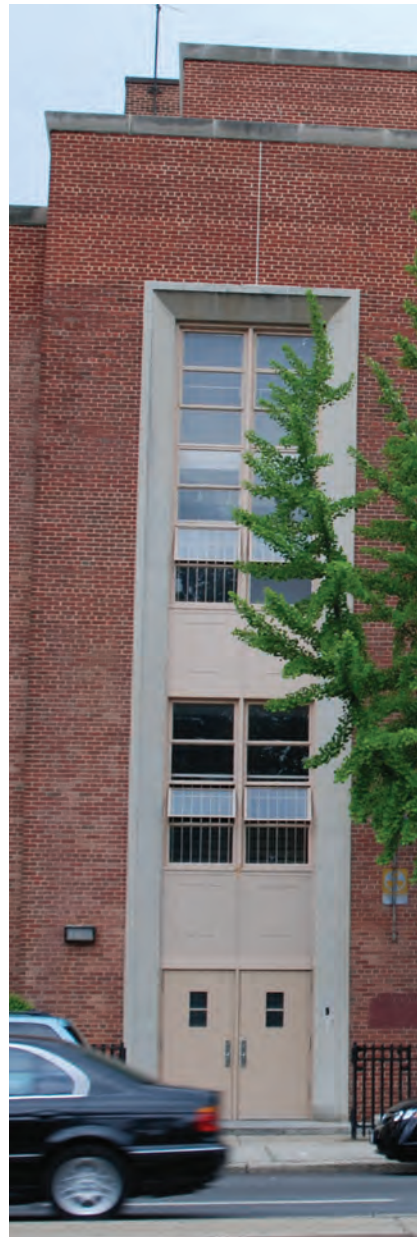
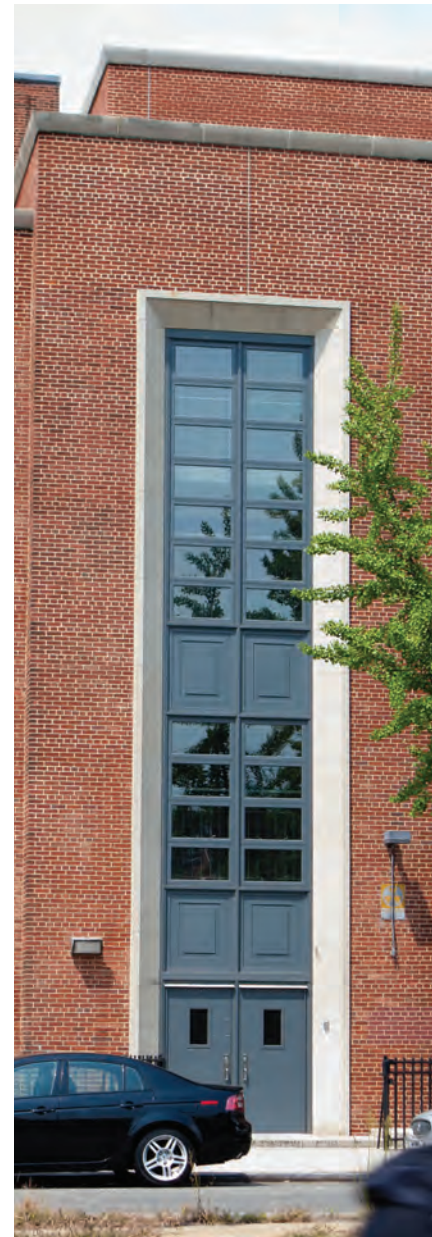
**Fig. 6.15.35 & 6.15.36 (right - far right)**  
Before and after images of the curtain wall at the 164<sup>th</sup> street entrance. Courtesy: Nelligan White Architects

## 4. Doors (Fig. 6.15.35 & 6.15.36)

- Remove doors, frames, hardware and supports at main entrances
- Provide heavy duty insulated hollow metal aluminum door leaves and frames, finish with the same Kynar coating as the windows
- Provide new institutional grade hardware, thresholds, weatherstripping and seals
- Protect, scrape, and paint existing door lintels
- Replace existing doors with vision lites with insulated hollow metal aluminum and matching lites

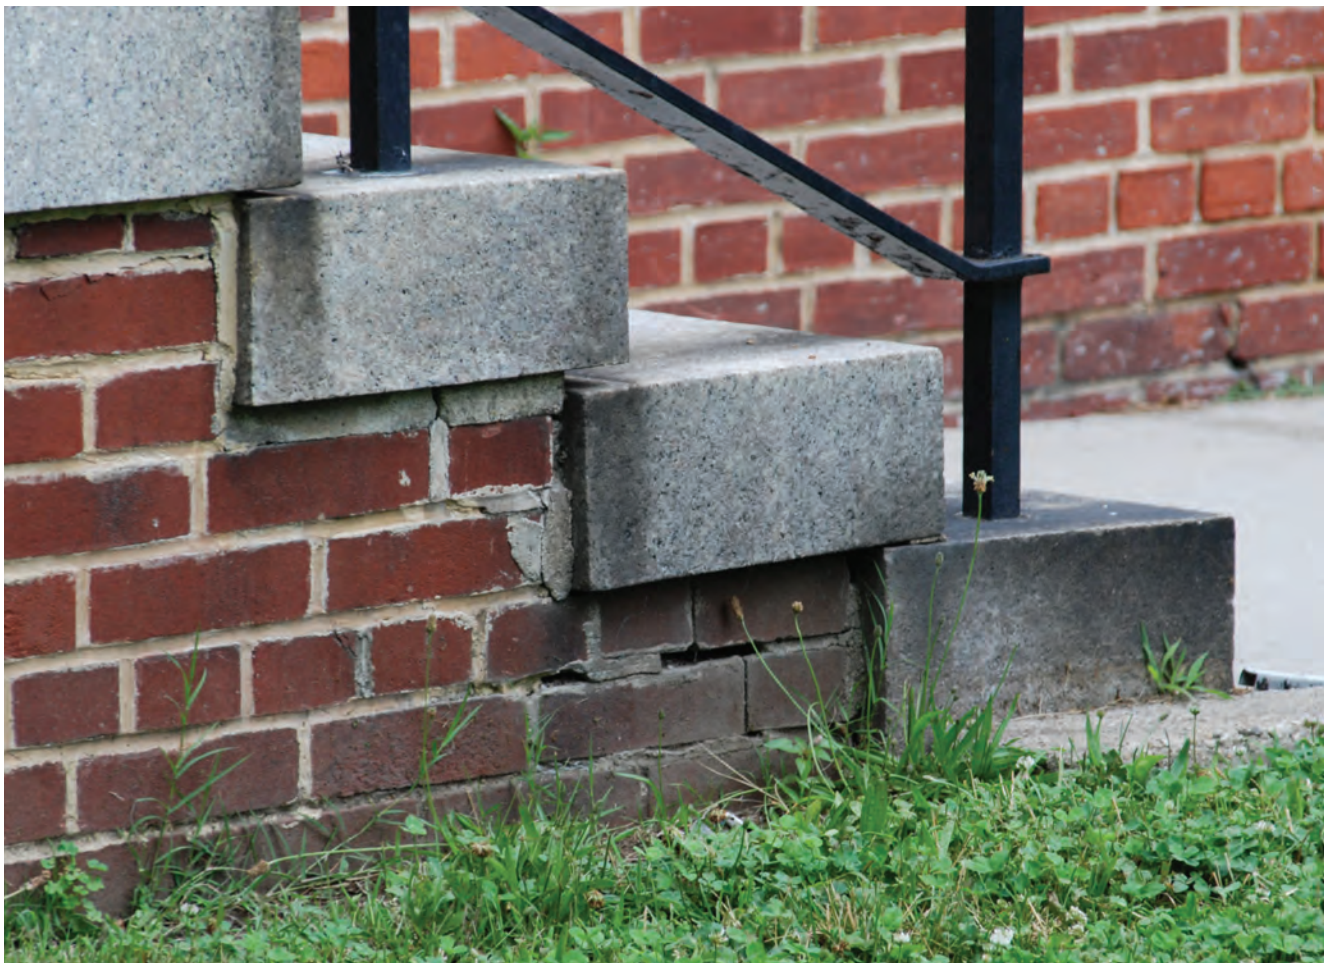
**Fig. 6.15.38**

**Fig. 6.15.38 (below)**  
Missing mortar from face brick joints at the south-east entrance. Courtesy: Nelligan White Architects

There were several defects at the south-eastern entrance, including worn masonry steps, missing mortar from brick joints, signs of efflorescence, and loose bricks and cracks in the masonry (Fig. 6.15.38). One concrete entry slab had a long crack, and the slab was pitched to an area with no drain causing a crack to develop at that corner. In addition, the fences were rusting and in need of replacement. At the interior, leaking and plaster-damage was observed at the windows and adjacent ceilings at all floors and classrooms. There were also signs of water-infiltration at the fan room walls and ceiling. Additional water-damage occurred at the cafeteria and gymnasium ceiling, damaging the acoustic ceiling tiles. These findings prompted the following scope items:

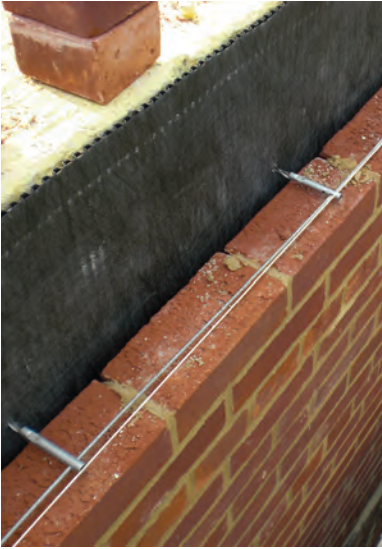
**Fig. 6.15.39**  
Seismic masonry anchors installed at the new parapet. Courtesy: Nelligan White Architects

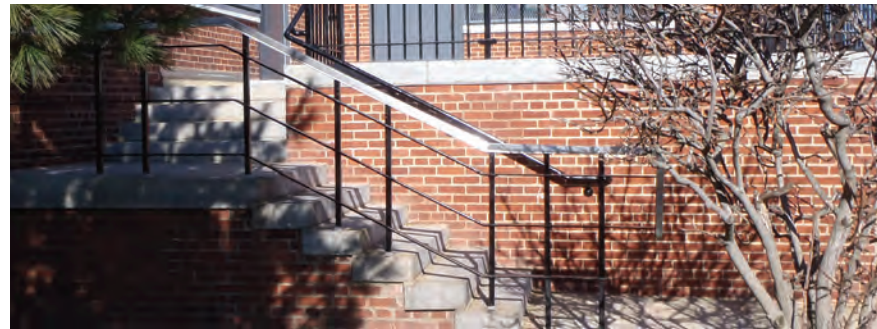
Fig. 6.15.40

**Fig. 6.15.40 & 6.15.41 (right - below)**  
Photograph and construction documents of new steel fence and railing at southeast entrance.

- Replace, in-kind, all exterior masonry steps, platform slabs, wall surrounds, stone curbs, steel fencing and railings at the south-eastern building entrance
- Replace, in-kind, all entry platforms to provide positive drainage, and include a membrane underlayment
- Remove sealant from all control joints on north, south, and east sides of platform and replace with new sealant.

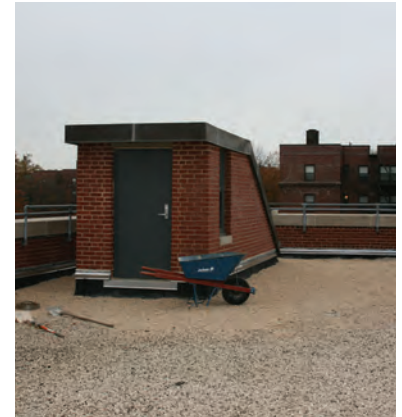
Fig. 6.15.42

Roof bulkhead with newly replaced door, face brick and base flashing. Courtesy: Nelligan White Architects

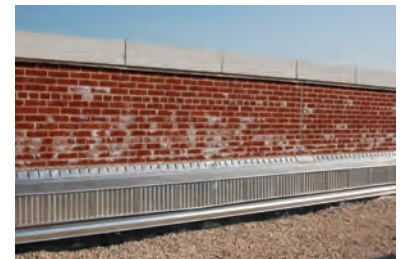
Fig. 6.15.43 (above)

New cap flashing at the parapet. Courtesy: Nelligan White Architects

### 2. Parapets (Fig. 6.15.43 & 6.15.45)

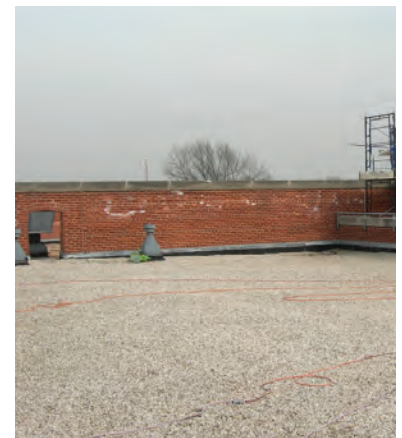
Fig. 6.15.44 (above)

A low wall separated the main roof from the fan areas at the gymnasium. No drains were present inside this area, only a few scuppers were present to drain water to the main roof area. Drains were provided inside this area as part of the remediation. Courtesy: Nelligan White Architects

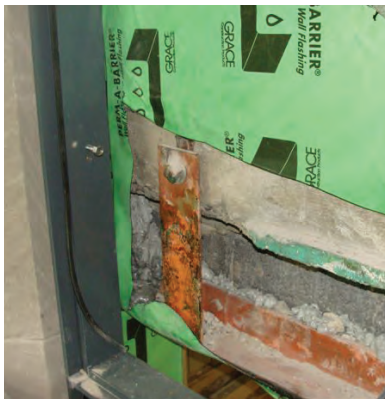
**Fig. 6.15.46**  
Relieving angle and straps at the slab behind the curtain wall. Courtesy: Nelligan White Architects

Where the second floor slab meets the curtain wall, a relieving angle was found supported by metal straps directly into the slab (Fig. 6.15.46). This discovered condition was in conflict with the clearance requirements of the replacement curtain wall. Additionally, the edge of the floor slab was not parallel with the proposed curtain wall, but deviated by about ½" over its length.

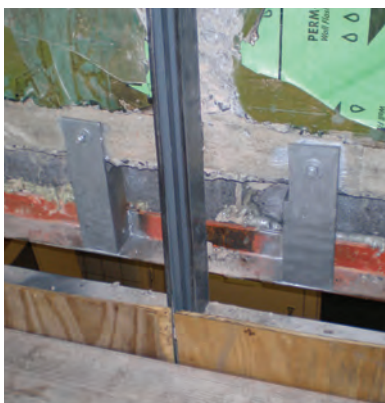
**Fig. 6.15.47**  
New curtain wall mullions at the slab which has been chipped back for clearance of the curtain wall assemblies. Courtesy: Nelligan White Architects

This site condition should have been present during the shop drawing phase and the surveys which preceded it, and thus, a design should have reflected them. It was decided that the concrete floor slab should be chipped back where in conflict with the window mullions (Fig. 6.15.47). Prior to this demolition, a shop drawing was to be submitted showing the locations where concrete was to be removed.

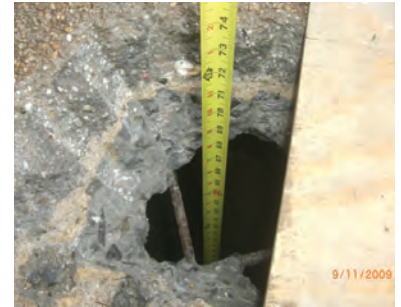
**Fig. 6.15.49**

The existing concrete slab was found to have a crawlspace below, and was not adequate to support the new live loads. Courtesy: Nelligan White Architects

The concrete slab at the kindergarten entry assumed to be on grade was to be replaced in kind. During demolition, it was discovered that there was no soil beneath this slab (Fig. 6.15.49). Original drawings were consulted, showing a crawlspace rather than a slab on grade. It was determined that the existing slab was not structurally adequate to support the live loads which would be imposed on it, therefore could not be replaced-in-kind as specified in the contract documents. A new reinforced concrete slab as designed in consultation with the engineer. This new slab included metal decking below the reinforced slab supported by relieving angles at its edges, and a new reinforced beam at the center of the span.

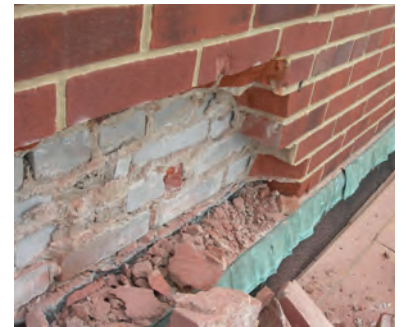
**Fig. 6.15.50**

During demolition of the bulkhead, the wall was found to be solid masonry with no cavity. Courtesy: Nelligan White Architects

Face-brick was to be removed from a roof bulkhead for replacement, but during demolition, it was discovered that no cavity existed, that the wall was solid masonry (Fig. 6.15.50). The contractor thought there would be no space for waterproofing or a drainage plane, and proposed that the wall be replaced in-kind.

The contract documents did not call for a standard cavity wall, but a narrow drainage plane designed to fit within a 3/8" collar joint. The narrow drainage plane included a liquid applied membrane over a parge coat, a narrow cavity drainage plane, and flashing/weepers at all terminations. This was to be stabilized by seismic anchors at 16" O.C. and installed in line with the roof cap flashing, so that any moisture would drain directly off the flashing and onto the roof.

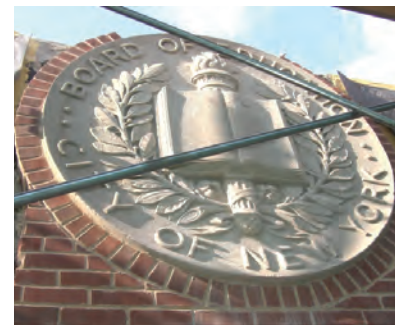
**Fig. 6.15.51**

The contract documents called for the removal and re-installation of the seal; as a precaution an impression was made in case of breakage. Courtesy: Nelligan White Architects

The contract documents called for the existing cast stone Board of Education seal above the school's main entry be removed, cleaned and replaced after providing a continuous waterproof membrane over the backup. During demolition, the General Contractor and Cast Stone Manufacturer advised that the seal should remain in place, as it would most likely break during removal due to age (Fig. 6.15.51). A detail was proposed which installed waterproofing around the entire seal, though this was denied as any weak points in water resistance is one more location where moisture may infiltrate.

As a resolution, the Contractor was directed to take an impression of the existing seal as a precaution. The Contractor was then directed to either safely remove the seal and install per contract documents after submitting a removal/re-installation rigging plan to the Architect prior to removal, or to provide a new cast-stone seal identical to the existing.

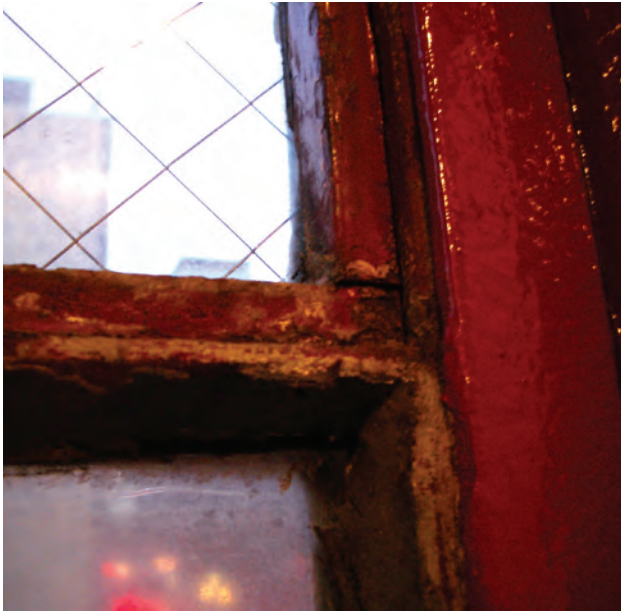
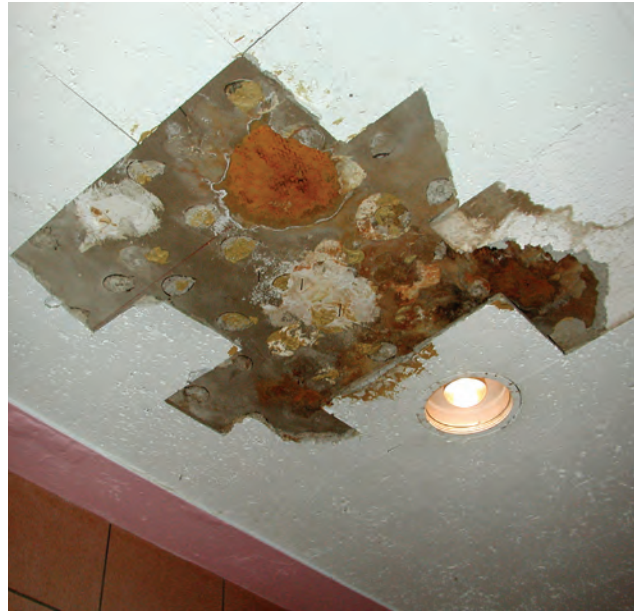
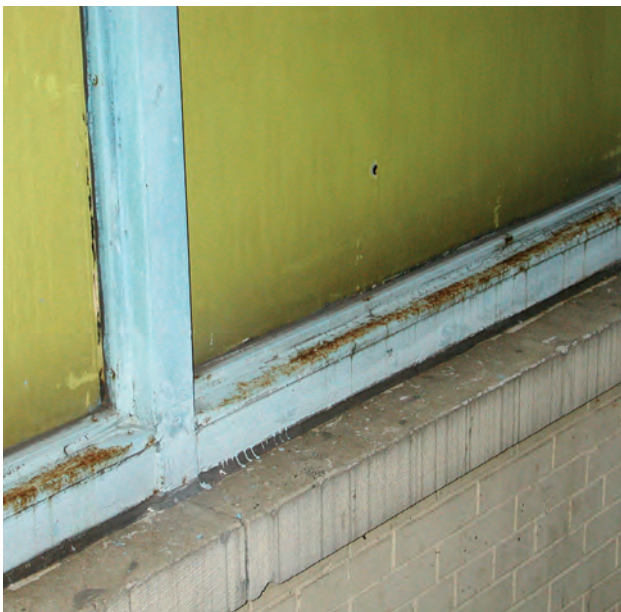
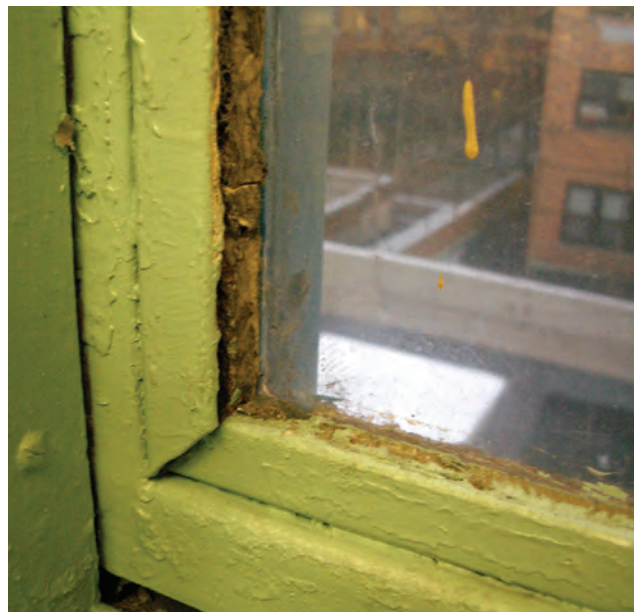
Visual observation of damages notes during survey. While moisture damage was noted at ceilings in specific locations, the primary cause of moisture infiltration and environmental discomfort was associated with the rusted windows. Courtesy: Nelligan White Architects

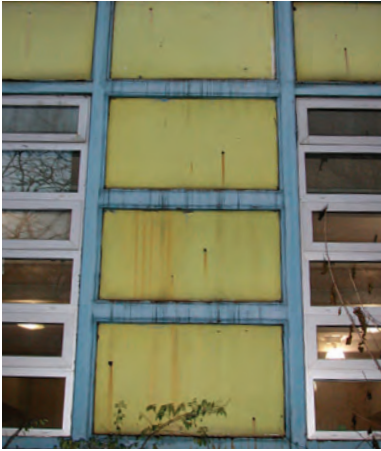
**Fig. 6.16.11**  
The window wall system at the one-story cafeteria and playroom wing before rehabilitation. Metal panels were rusting through the enamel, and windows did not operate properly. Courtesy: Nelligan White Architects

The framing, steel enamel panels and window units which comprise the window wall system exhibit deterioration throughout. Steel framing was rusted, had holes, and was further compromised by the inset aluminum windows, causing galvanic action between the dissimilar metals. None of the components of the window wall system were thermally broken or insulated. Steel enamel panels were rusting, spalling and blowing out the enamel on their face. The window units themselves were in fair condition, though they were only single glazed. These findings prompted the following recommendations:

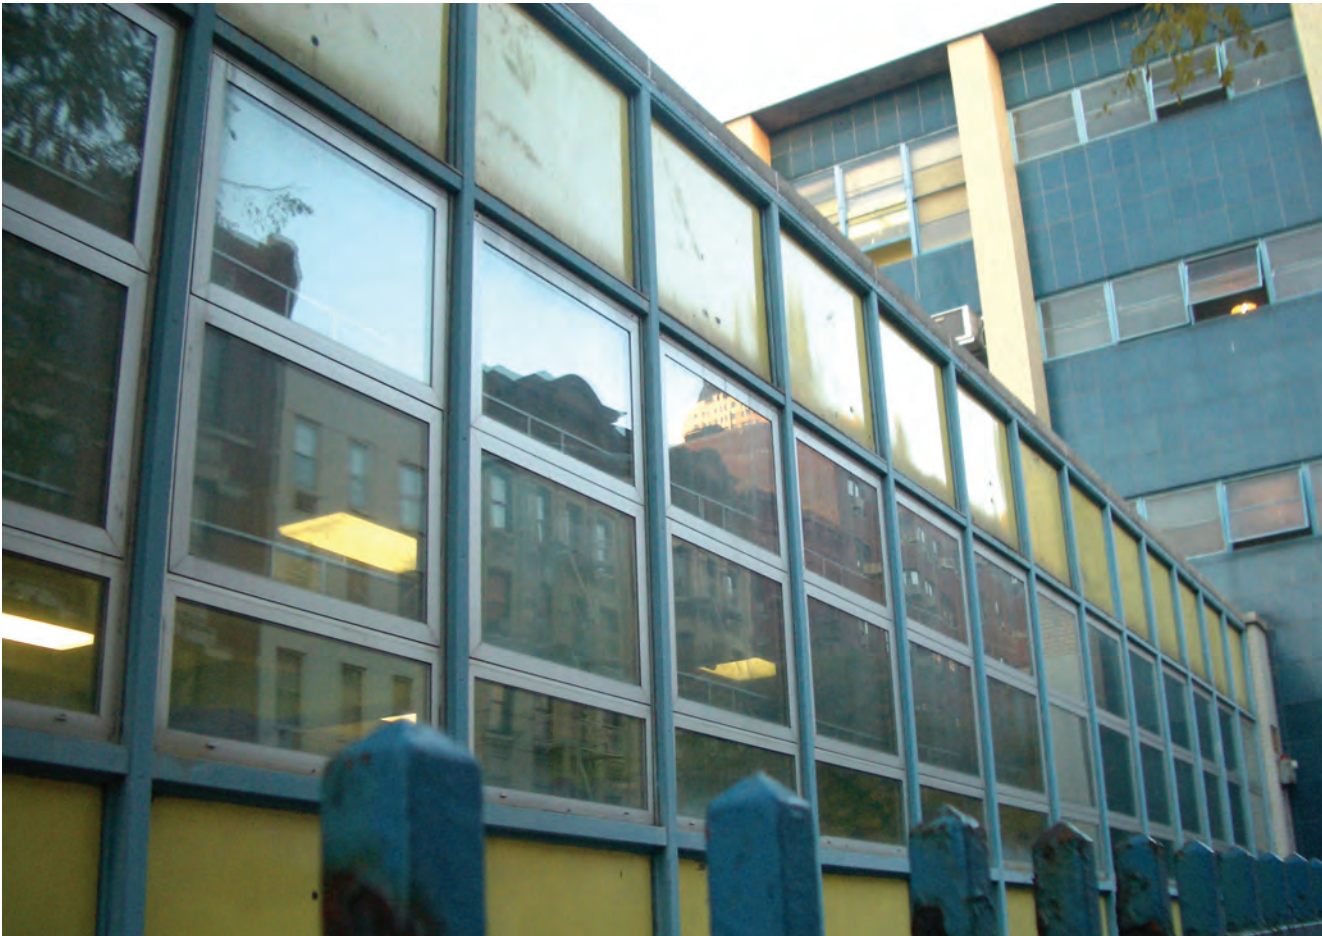
Fig. 6.16.12

**Fig. 6.16.12 (below)**  
The window wall system and the window infill system at the main classroom block during photographic survey. Courtesy: Nelligan White Architects

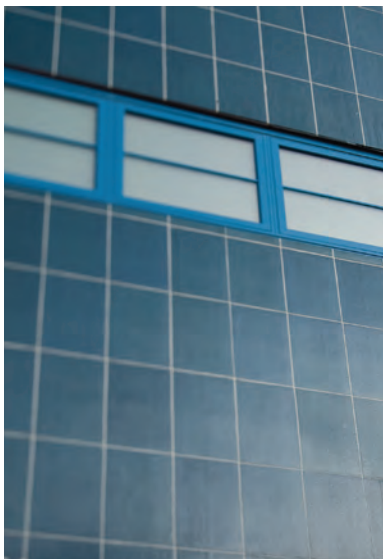
**Fig. 6.16.16 (above)**  
Window infill system after rehabilitation.  
Courtesy: Nelligan White Architects

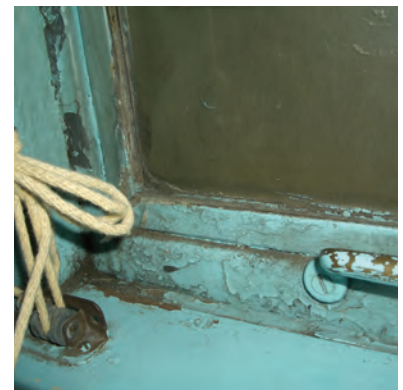
**Fig. 6.16.19 (above)**

Years of rust and layers of paint had made many windows inoperable. Courtesy: Nelligan White Architects

It was observed that the steel frames and hardware of the infill window system had been painted over several times leaving many windows inoperable. Some were rusty and dysfunctional leaving windows drafty. At the spandrels, architectural terracotta panels were chipped and spalling in many places. Deterioration was frequent near ground level, where physical impact and abuse combined with freeze-thaw cycles had aggravated spalling. Many panels had been replaced with ceramic tiles of a differing size and color, standing out as obvious repairs. These findings prompted the following recommendations:

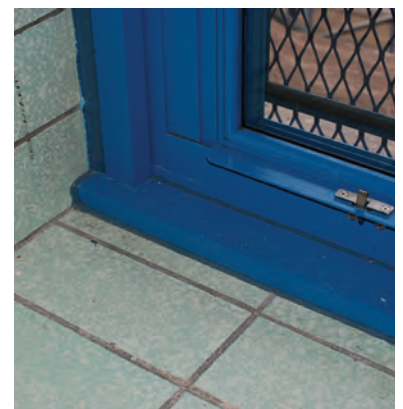
**Fig. 6.16.20 (below)**

Fully replaced window. Courtesy: Nelligan White Architects

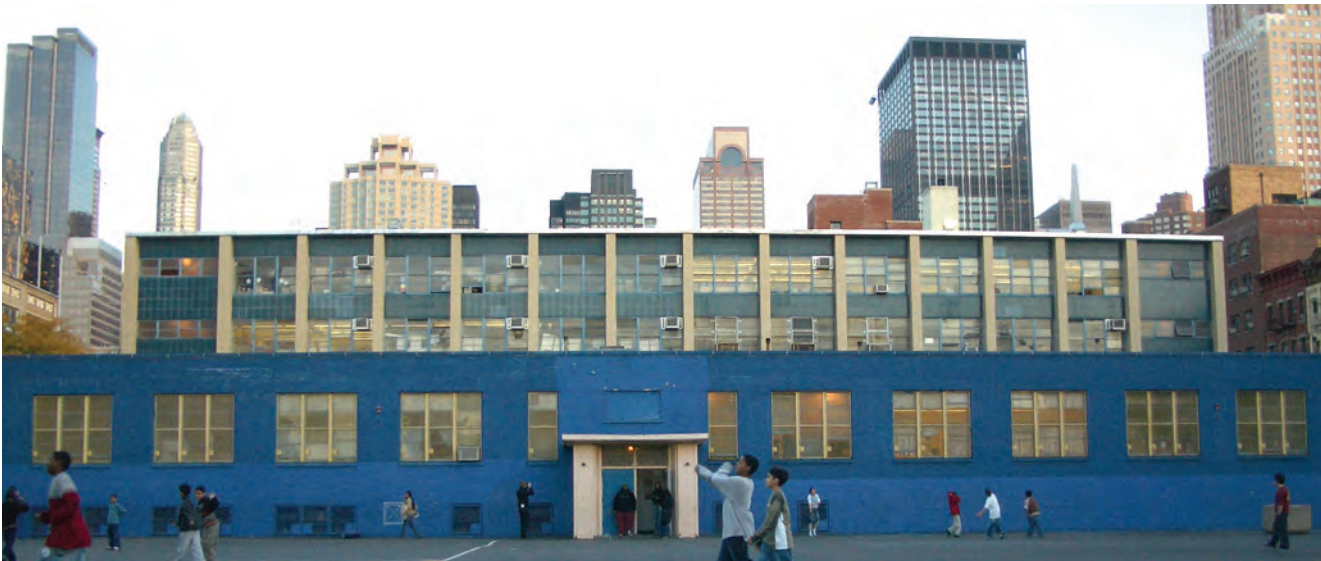
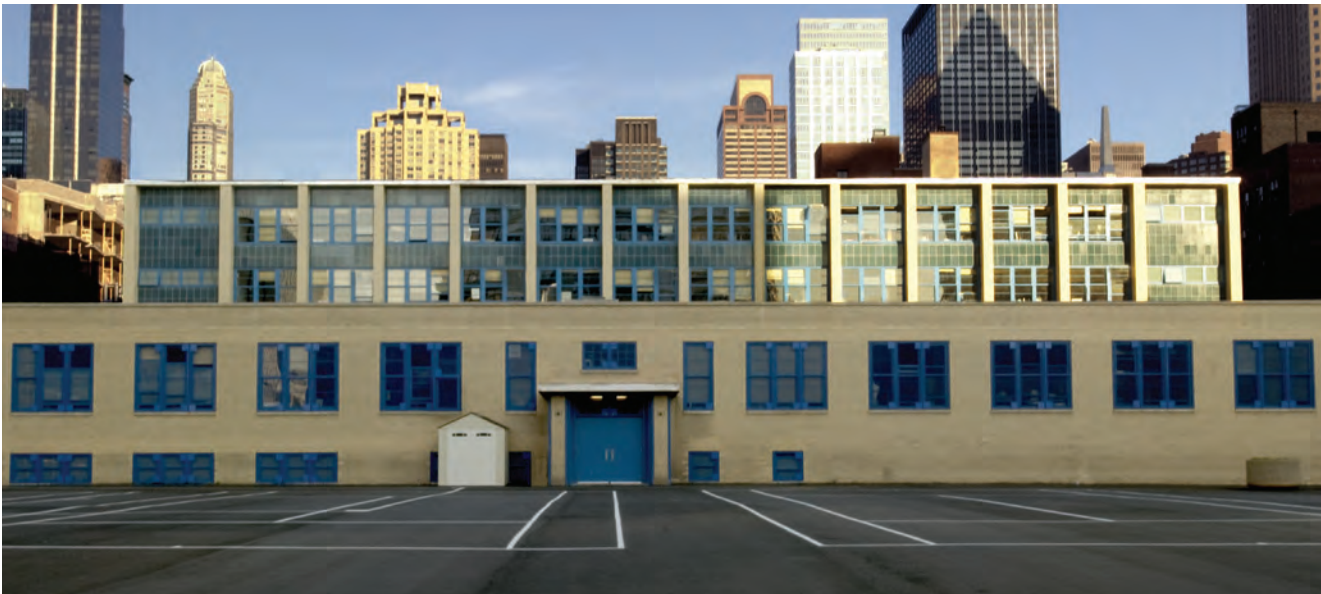
**Fig. 6.16.23 & 6.16.24 (left page - below - far below)**

Before and after rehabilitation. Courtesy: Nelligan White Architects

At PS 111 M, three categories of windows were quantified; curtain wall, window infill system, and punched windows. For the curtain walls rust and punctures had compromised the system along with the galvanic reaction between the inset aluminum windows and steel frames. Additionally the system was not energy efficient due to the lack of thermally broken or insulated components. The entire system was replaced with new extruded aluminum framing and double glazed energy efficient windows. As a part of the replacements no steel components were used to prevent any future reactions between the two metals.

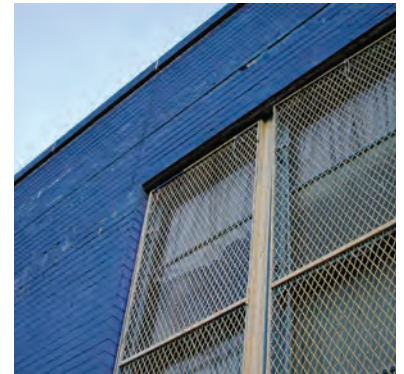
**Fig. 6.16.25 (above)**

Window lintels suffered from degrees of rust, flaking, and corrosion. The steel window guards, while in fair condition, were fastened directly to the windows creating a path for water to infiltrate. Courtesy: Nelligan White Architects

Loose lintels were visible above all windows at punched openings, along the western facade near the large playground. Steel angles were not galvanized and showed signs of corrosion including rusting, flaking and expansion. Carrier angles are shown to be fully flashed in the original drawings, and because they are not directly exposed to the elements they were expected to be in fair condition, however, this could not be visually confirmed. These findings prompted the following recommendations:

Operable window guards existing at the first and second floor windows were observed to be in fair condition. In some locations guards were painted to match the surrounding building while others were galvanized. Window guards were installed directly into the face of window frames with metal screws, forming a path for water to leak into the window frame. These findings prompted the following recommendations:

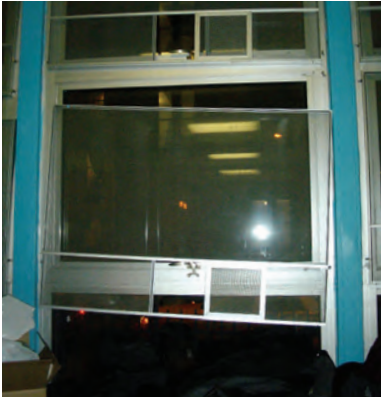
**Fig. 6.16.27**  
Window screens at the lunch room were a retrofit that exhibited minor tears. Courtesy: Nelligan White Architects

Windows at the southern end of the lunch room were previously retrofitted with window screens which remain in fair condition, though some screens showed minor tears. The robustness of their installation however, seems to be insufficient for the amount of traffic exposed to them. These findings prompted the following recommendations:

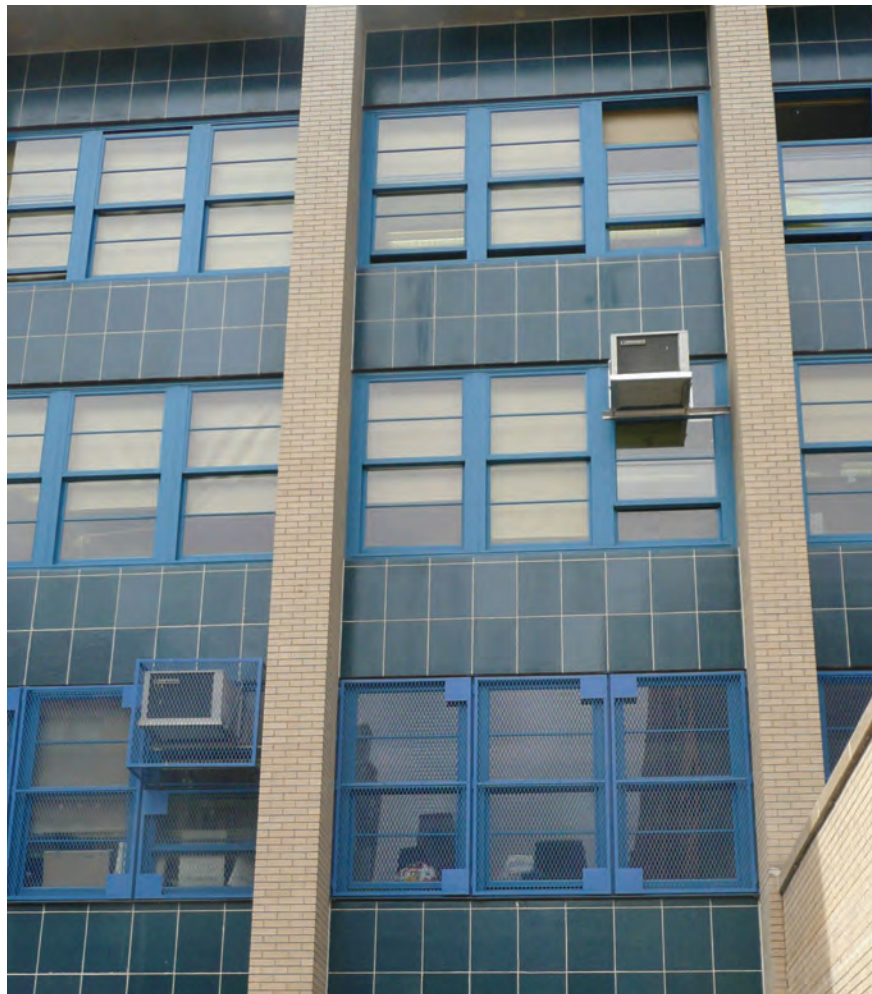
Fig. 6.16.28

**Fig. 6.16.28 (right)**  
Partial view of the window infill system after rehabilitation. Courtesy: Nelligan White Architects

At the window infill system, many were inoperable due to rusting and multiple layers paint. The terracotta panels at the spandrels were chipped and spalling while previously replaced panels were a different size and color. All infill windows were replaced with double glazed energy efficient windows. Damaged masonry panels were patched to match existing while the inaccurate panels were replaced to match existing.
