# New York City's Historic Schools

A History and Guide to Rehabilitation

NYC SCHOOL CONSTRUCTION AUTHORITY

This Guide has been developed as a practical and technical resource to assist in the evaluation and design for the restoration of historic school buildings (more than 45 years old). It is worth noting that over half of our public school buildings are more than 60 years old! It is our intention to facilitate strategies for these projects that will target cost effective solutions while at the same time respecting their historic standing as landmarks in the community.

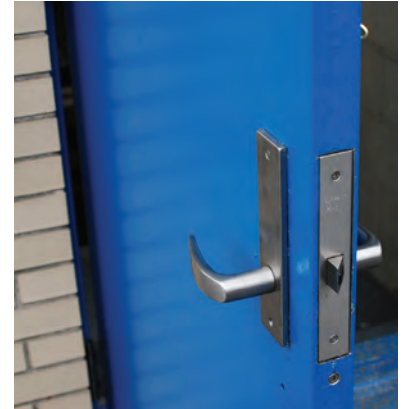
**Fig. 6.16.29**

The near constant use of exterior doors had degraded them significantly. Heavily used doors were replaced while the remaining were repaired. Courtesy: Nelligan White Architects

The existing doors and frames to the exterior were in near constant use. They suffered from corrosion, rust, and general wear and tear. Doors and frames found to be the most used were replaced with heavy duty insulated aluminum doors and frames. Other doors were removed and refinished then reinstalled.

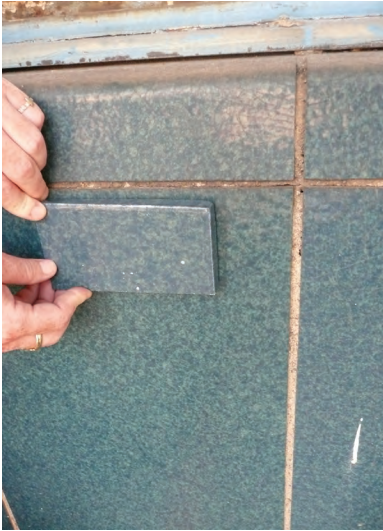
**Fig. 6.16.30**  
Color verification of ceramic panels. Courtesy:  
Nelligan White Architects

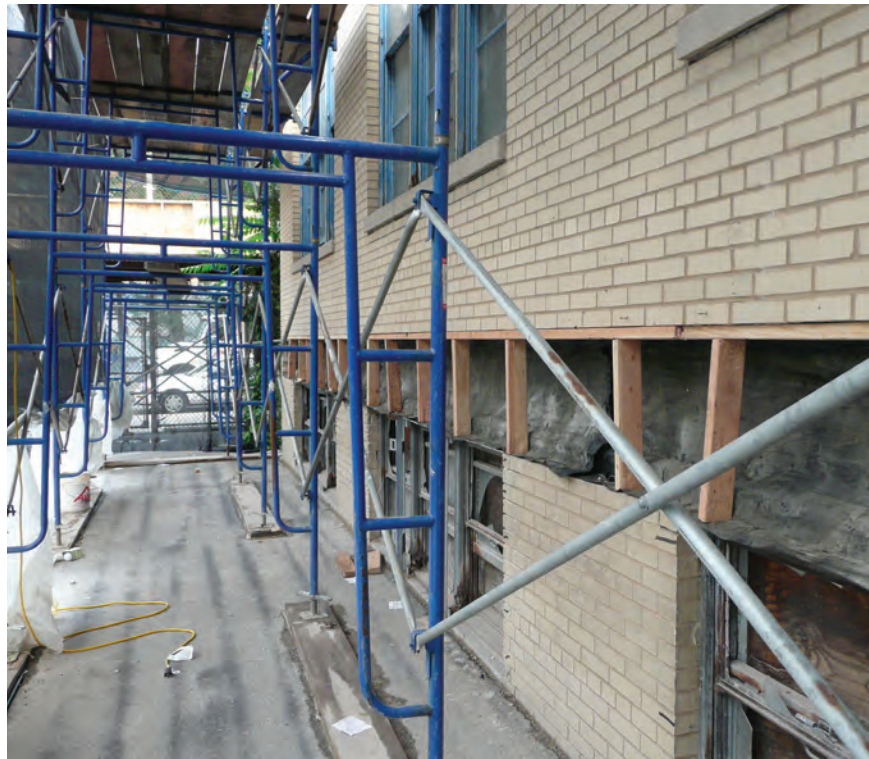
Fig. 6.16.31

**Fig. 6.16.31 (right)**  
Construction progress of the replacement  
of punched windows and associated lintels.  
Courtesy: Nelligan White Architects

The punched windows system suffered from deteriorated paint, rust, and in some locations broken panes. Like the other window systems, they were single glazed and not energy efficient. All of the windows were replaced with aluminum double glazed units.

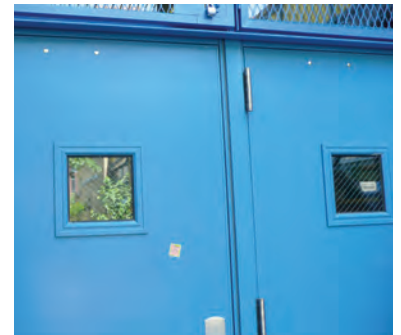
**Fig. 6.16.33 (above )**

Finished doors at entry. Courtesy:  
Nelligan White Architects

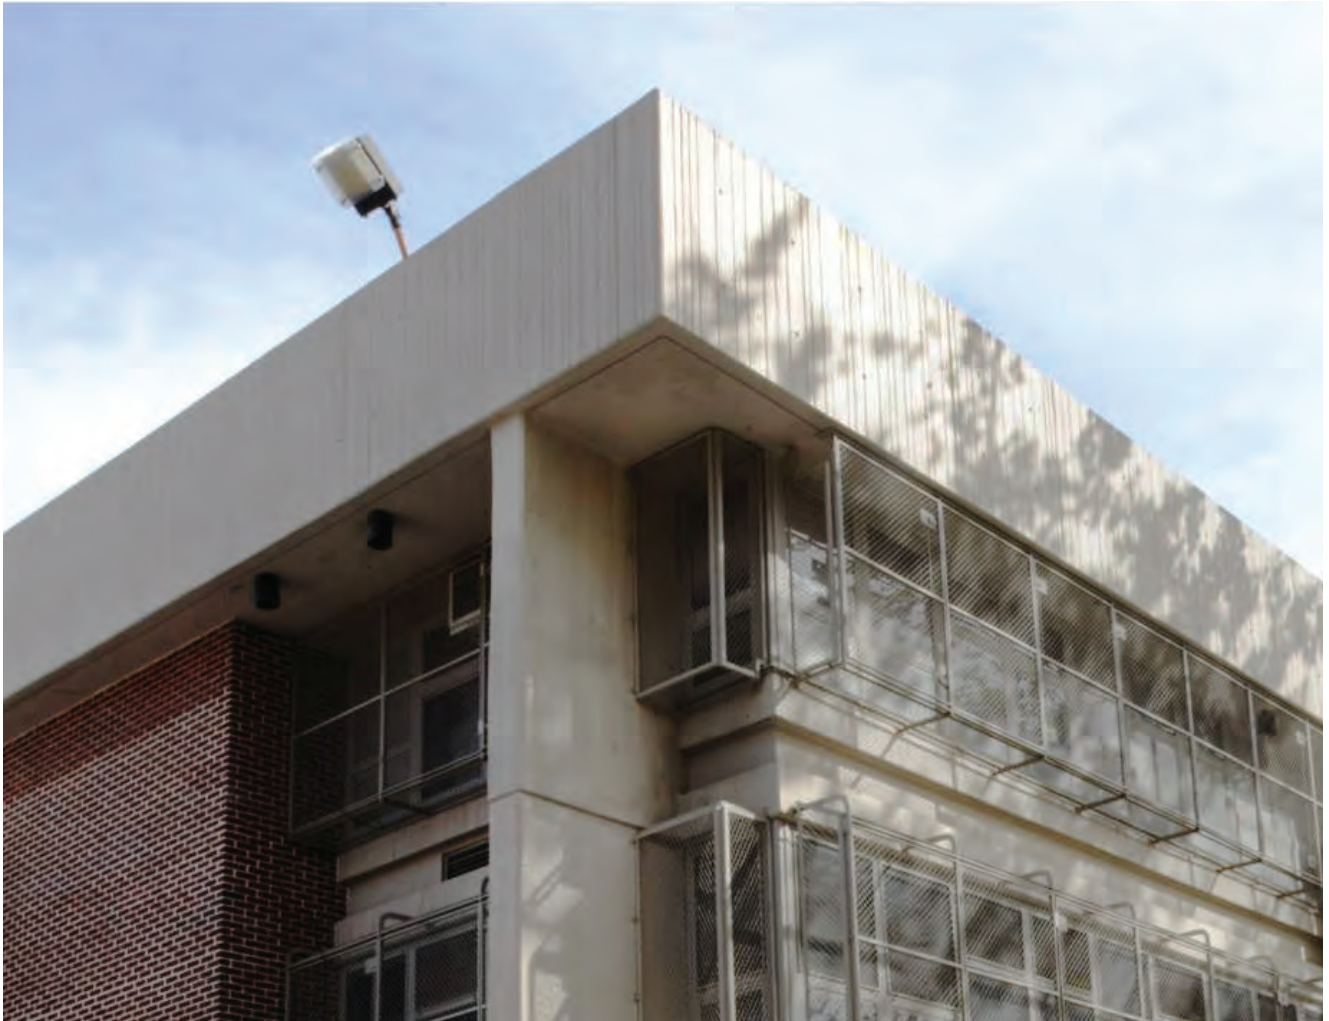
Fig. 6.17.2

**Fig. 6.17.2 (above)**

Parapet on south facade after rehabilitation. Once active concrete deterioration had been mediated the entire concrete structure had to be restored to a consistent color and texture. Since the original cover was insufficient, up to three inches of new cover had to be added to the structure. Courtesy: Nelligan White Architects

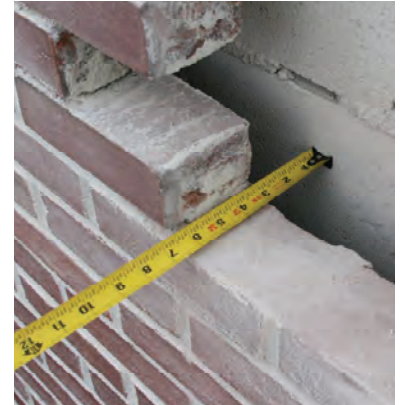
Fig. 6.17.9

Masonry was noted to be in fair condition, although the absence of weep holes was considered problematic. Additionally, masonry anchors could not be inspected, as they were covered with mortar, and some were observed to not reach out to the wall for a proper connection. Courtesy: Nelligan White Architects

Masonry cavity walls were opened and noted to be in fair condition, although the condition of anchors could not be assessed as they were covered with mortar. There were no weeps observed at the cavity wall, which may have contributed to any masonry deterioration which was present.

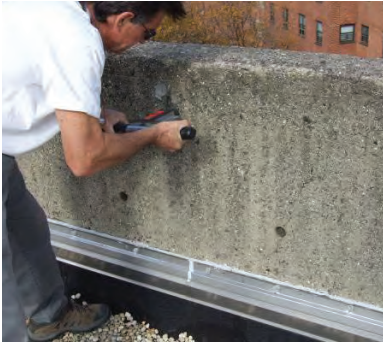
**Fig. 6.17.13**

The Windsor Pin apparatus is a spring-loaded device which drives a steel pin into the surface of the concrete or mortar using a controlled amount of energy, and the depth of the penetration is measured. The depth of the penetration is inversely proportional to the material surface hardness. Courtesy: Atkinson-Noland & Associates, Inc.

A series of tests intended to evaluate the roof, concrete and reinforcing conditions at PS 36 M were conducted, relating to roof moisture intrusion, concrete compressive strength and composition testing, and reinforcing location and composition. These tests at the roof included infrared thermography and capacitance moisture detection at the roof. Tests analyzing the concrete and reinforcing included cover-meter testing, half-cell potential and corrosion section loss measurements, Windsor Pin, core compression testing and crack monitors.

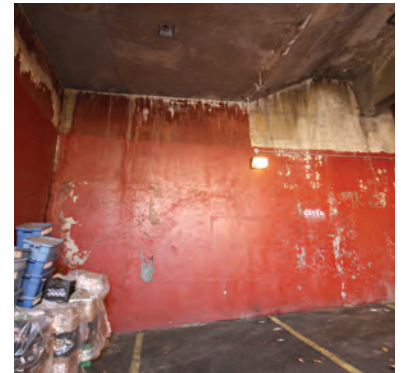
**Fig. 6.17.16**

The loading dock before rehabilitation: showed rusted and exposed reinforcing bars, concurrent with spalling concrete. Concrete cover was so minimal in some areas that rusting bars and stirrups could be seen without any significant spalling. Long cracks were visible as well. Courtesy: Nelligan White Architects

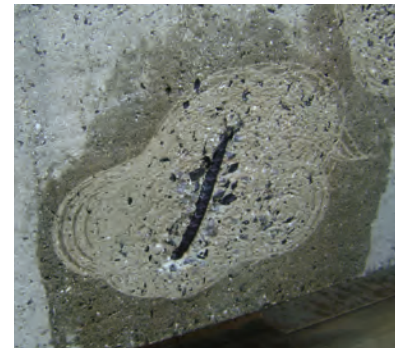
**Fig. 6.17.17**

Exposed steel bars were hydro-blasted, using a high pressure water jet, to expose and clean the bar. Where reinforcing had deteriorated beyond repair, new bars were spliced in and a migrating corrosion inhibitor was applied to surfaces, helping to protect embedded reinforcement from future corrosion. Courtesy: Nelligan White Architects

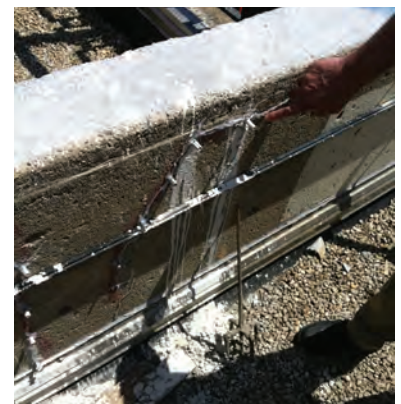
**Fig. 6.17.18**

Epoxy injection grout was used to repair cracks in structural elements. Courtesy: Nelligan White Architects

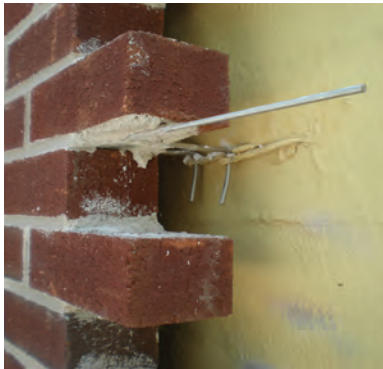
**Fig. 6.17.20**  
Brick cavity wall installation with seismic anchors and spray applied waterproofing membrane.  
Courtesy: Nelligan White Architects

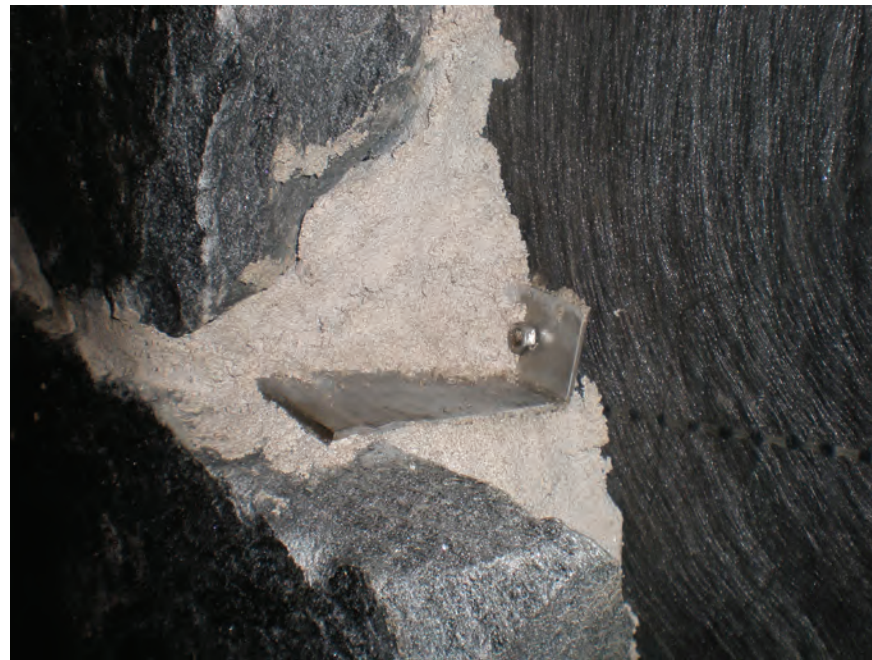
Fig. 6.17.22

**Fig. 6.17.22 (right)**  
Stainless steel ties installed at new stone masonry walls, which included the installation of a narrow cavity drainage plane and waterproofing membrane. Courtesy: Nelligan White Architects

- Remove all unsound/cracked stone veneer and replace in kind
- Provide stainless steel masonry ties

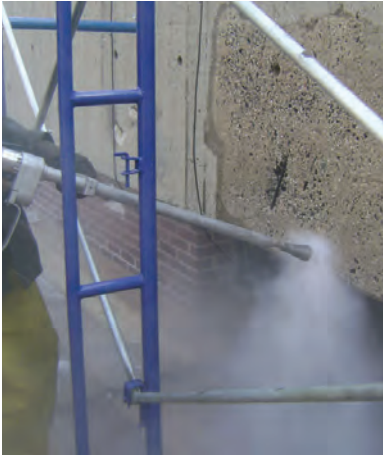
**Fig. 6.17.21**

Parapets were hydro-blasted, using a high pressure water jet to exposed and clean reinforcing bars, and the concrete surface. Courtesy: Nelligan White Architects

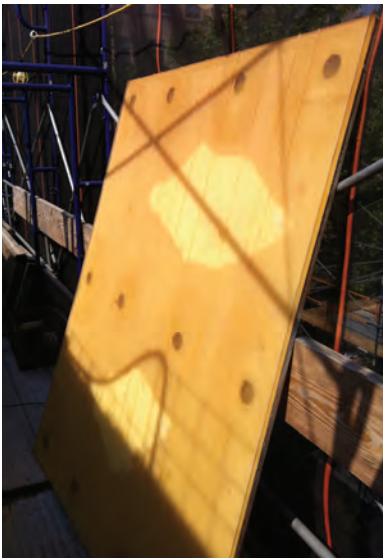
**Fig. 6.17.22**

A series of custom fiberglass form liners were manufactured to serve as form work for the new parapet face. Courtesy: Nelligan White Architects

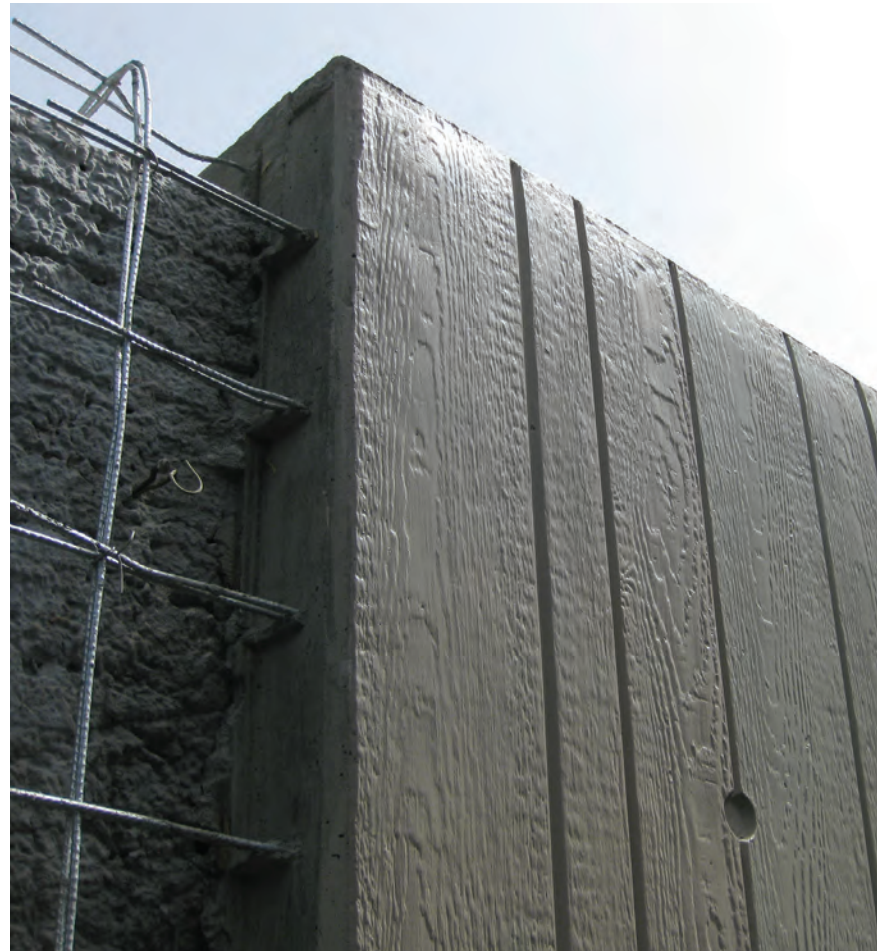
**Fig. 6.17.23 (right)**

At the parapet, individual pours had to be staggered to prevent further cracking due to initial expansion of concrete. Courtesy: Nelligan White Architects

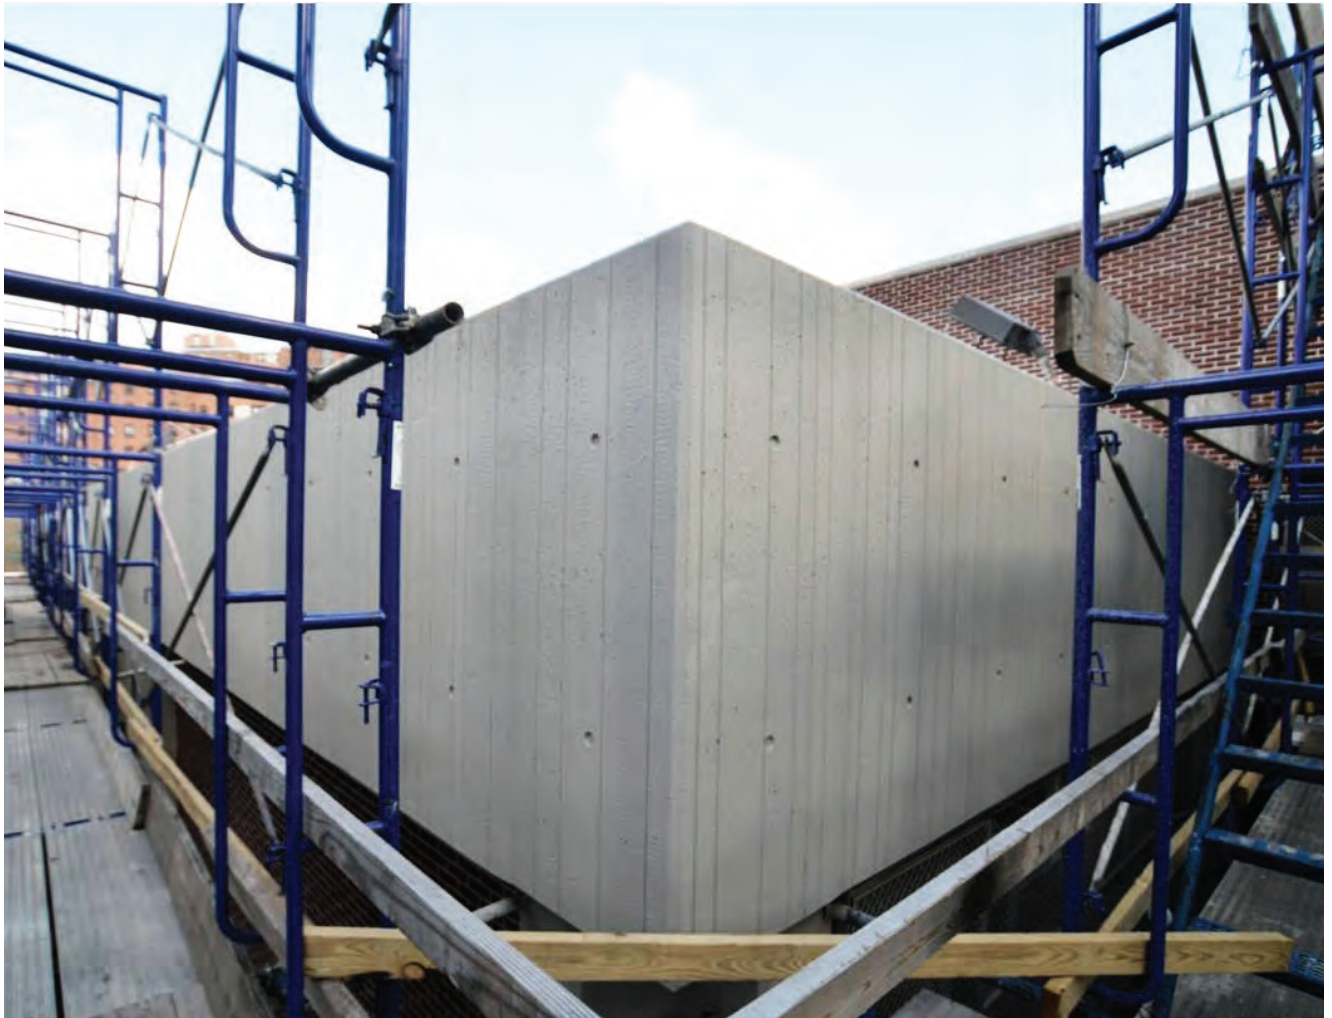
Fig. 6.17.24

**Fig. 6.17.24 (below)**

A finished section of the new parapet. Courtesy: Nelligan White Architects

Once active concrete deterioration had been mediated by hydro-scrubbing, replacement of corroded reinforcement, and application of a migrating corrosion inhibitor, the entire concrete structure had to be restored to a consistent texture and color. Since the original cover was insufficient to prevent corrosion, up to three inches of new cover were poured over the entire building. In order to maintain the original wood pattern at parapets, an original feature resulting from the wood used in the original formwork, a series of custom fiberglass form liners were manufactured for the new parapet face. Individual pours were staggered to prevent further cracking due to initial expansion of the concrete, resulting in a clean, safe, code compliant parapet, which maintains the structures original textural features.

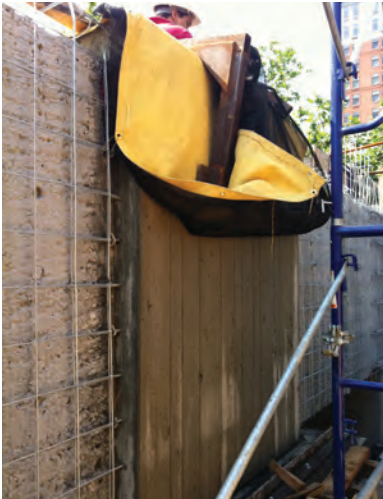
**Fig. 6.17.25**

Concrete deterioration by hydro-scrubbing.  
Courtesy: Nelligan White Architects

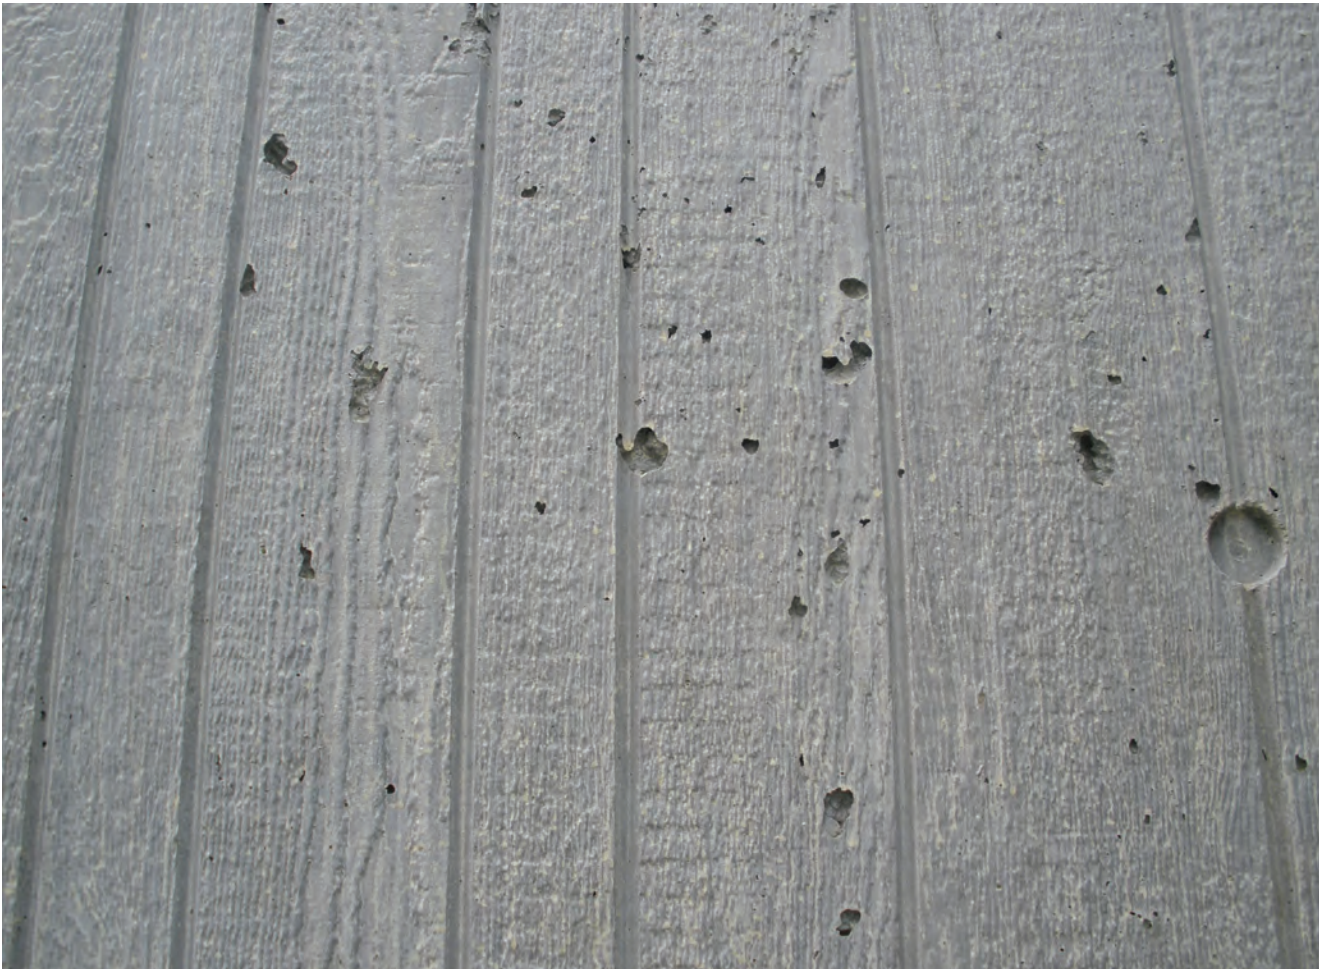
Fig. 6.17.26

Bugholes observed in the concrete after the formwork was removed and the required coating applied. Courtesy: Nelligan White Architects

While the pouring of the additional 3" of cover over the entire building, was both an aesthetic and structural success, *'bugholes'* were observed in the concrete after the formwork was removed and the required coating applied. These bugholes are small pockets that allow water to collect and freeze within them, exposing the surface to a freeze/thaw dynamic. Despite these deficiencies, it was determined that since the coating had already been applied, patching would cause even greater problems during freeze thaw cycles, and this work was eventually accepted.

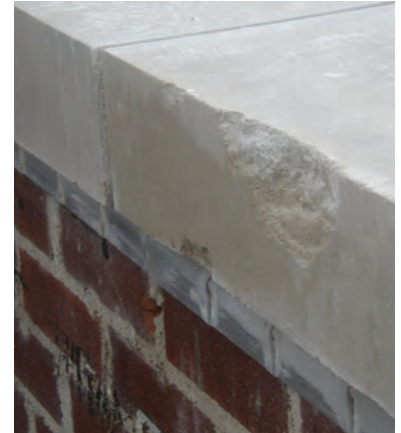
**Fig. 6.17.27**

Damaged cast stone copings at the parapet. It was determined that the cast stone was not allowed to cure for the required amount of time, significantly reducing its strength. Courtesy: Nelligan White Architects

It was observed on-site that the cast-stone copings at the top of the brick parapets had been damaged and chipped during installation. These chips ranged from 2" – 8" wide and up to 1" deep. The contractor was directed to remove and replace the damaged coping stones, as patching was not acceptable per the specification. Additionally, based on the way the stones were damaged, it was assumed that the materials did not meet the standards of the specification.

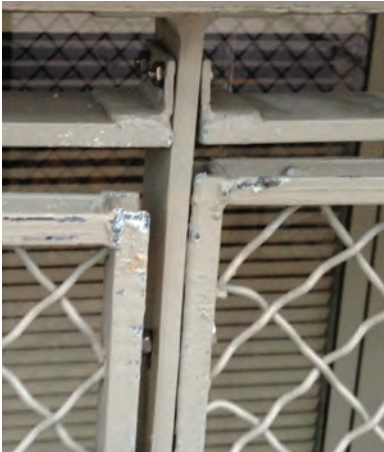
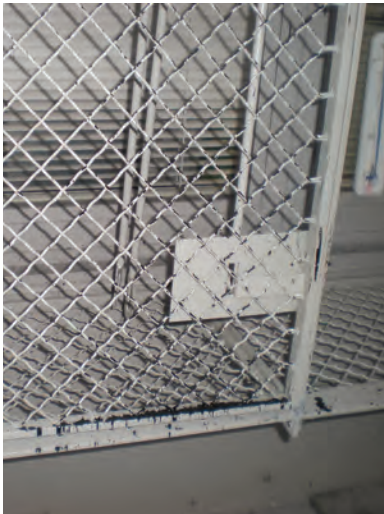
**Fig. 6.17.29 & 6.17.30 (above - below)**  
 Scratched and uneven coating at the window guards after their first installation. Courtesy: Nelligan White Architects

Following refurbishment, window guards were first reinstalled on the building, though their finish did not meet the standard of the approved mockup. The finished painted surface was uneven and bumpy, indicating that the surface preparation was not adequate before the primer and paint was applied. Additionally, paint and primer was scratched and chipped in many locations both at the guards that had been installed, and the guards being stored at ground level.

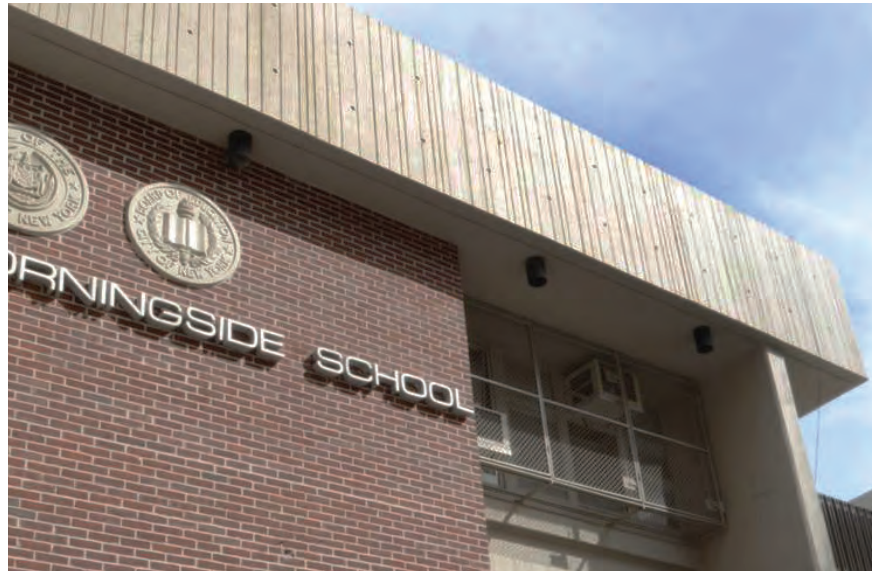
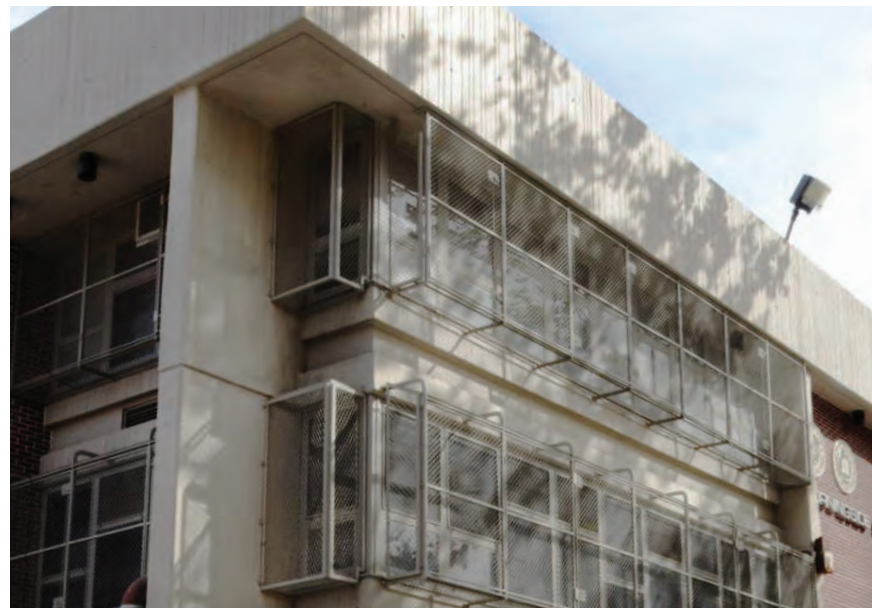
**Fig. 6.17.31 & 6.17.32 (above right - right)**  
 Final images of the completed window guards in their correct, Fire Department compliant locations. Courtesy: Nelligan White Architects

Once the refinished guards were installed it was found that they were in the wrong locations, thus, inhibiting Fire Department access. Window guards must be installed with Fire Department access panels in locations with removable window panes. These guards had to be removed, and reinstalled in their correct locations.

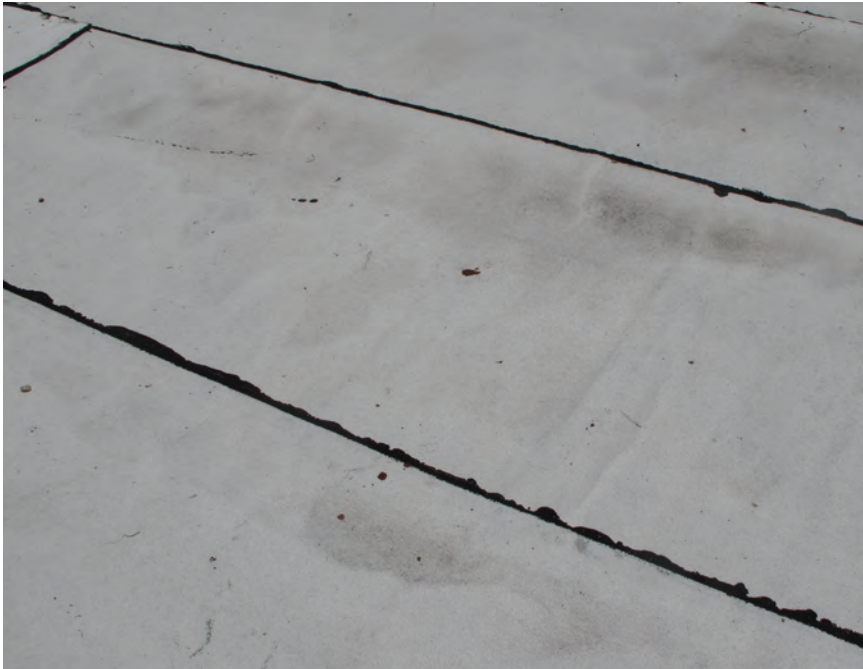
Fig. 6.17.34 (left)

Ridges and buckles were found across the cap sheets, indicating that they were improperly installed and unadhered at the bottom. Courtesy: Nelligan White Architects

During construction, it was noted that the SBS modified Bituminous Roofing System had failed. At several locations, the cap sheet had buckled, creating creases across the roof. In these locations, the cap sheet was not adhered to the layer below. Additional layers of ply were used to patch these locations; this did not remedy the problem. Upon inspection areas of shiny asphalt were present underneath the cap sheet, thus, demonstrating sites of no-adhesion between layers. A bulletin was issued mandating that areas where blistering was present and where Infrared Analysis showed moisture was present should be cut out, and patched with dry materials. The final roofs were to have an entirely new cap sheet installed, though it was eventually agreed that a method of cutting out the deficient sections and patching with new material was sufficient.
