Washington Irving Campus Building Rehabilitation

Informational Meeting with NYC Council Member Rosie Mendez and the NYC SCA.

April 24, 2017

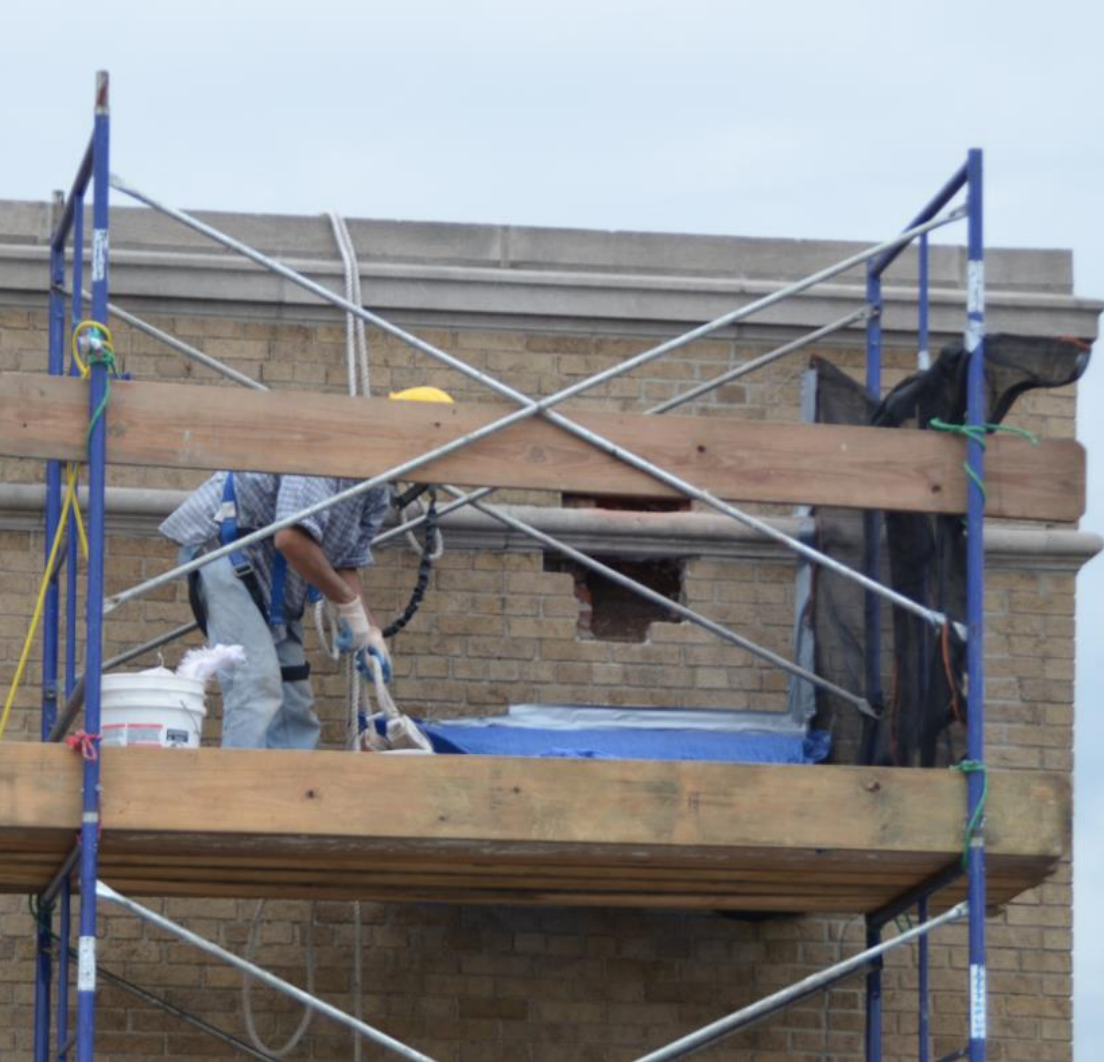
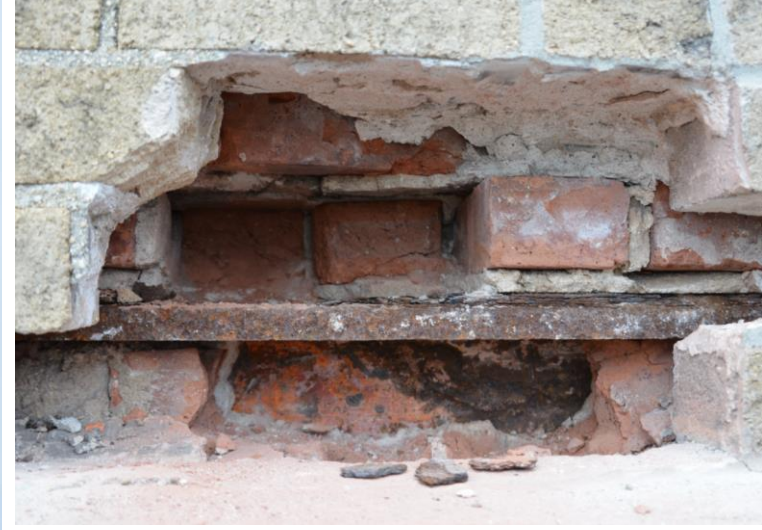
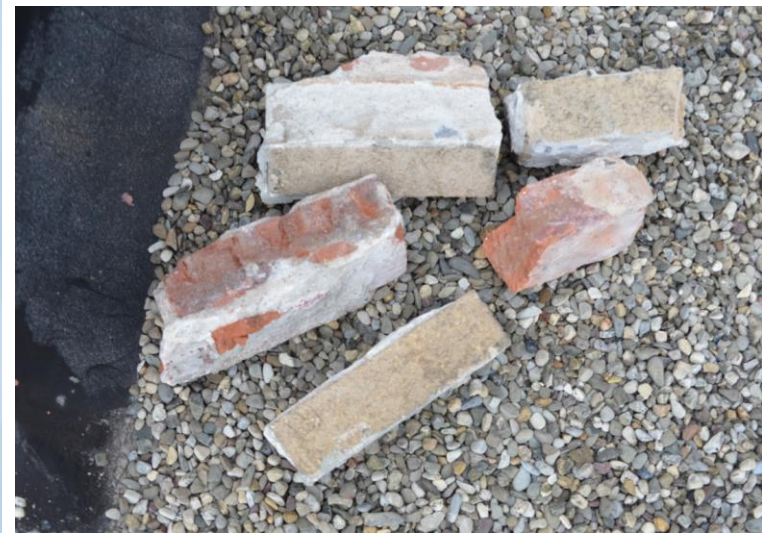
EXTERIOR EXPLORATORY PROBE AT THE BULKHEAD

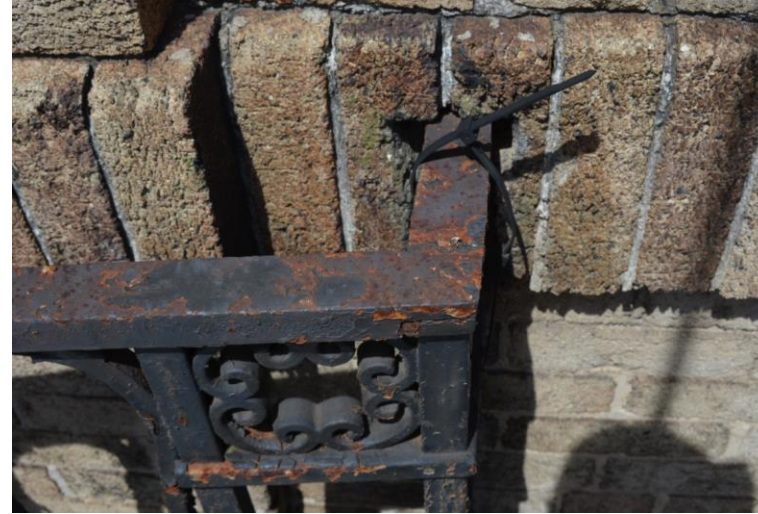
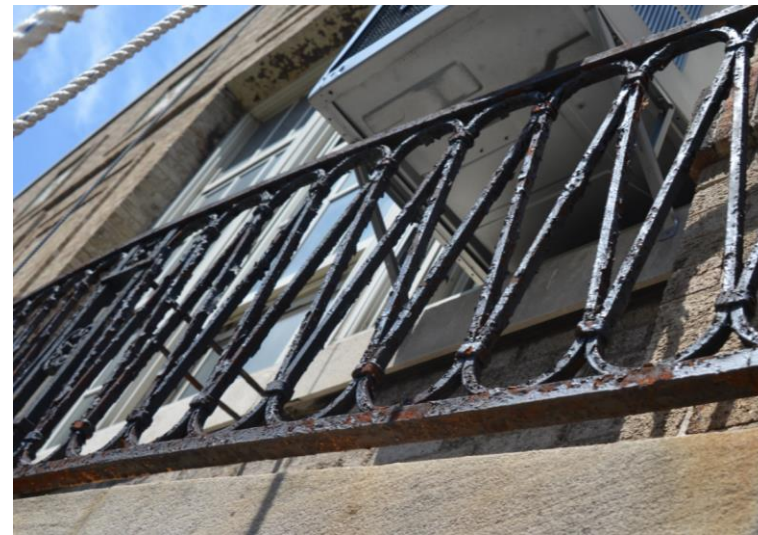
West Elevation, Irving Place

RUSTED GUARDRAIL

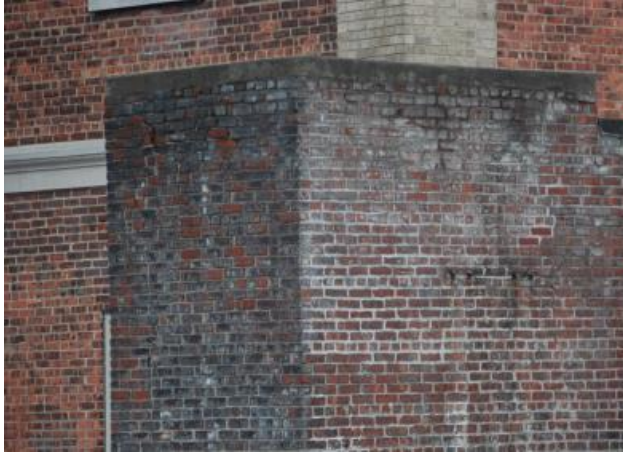
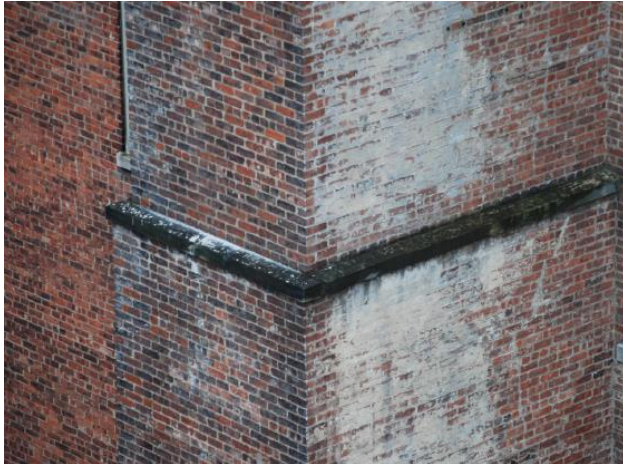
Additional Building, South Court Facade

BADLY WORN, STAINED AND EFFLORESCING MASONRY
